As requested Bruce Haroldson and George Mullen conducted a site visit (November 12th, 2015) to vaults located in Livingston, MT. Specific vaults were investigated and the following report will discuss items noted in field.

Livingston Vaults
November 16, 2015
Page 2

**Paoli & Brown Law Offices 116 W. Callender St.
The Wok 102 North 2nd St.**

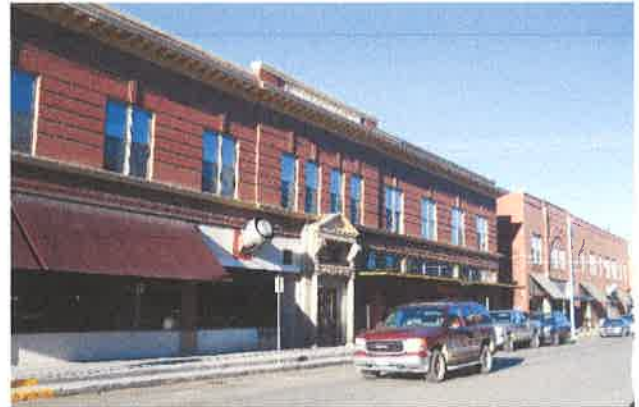
Photo #1: The Wok- Paoli & Brown Building

Vault Lid: The vault concrete lid is leaking and is in poor condition. The concrete slab is approximately 6". The Wok vault lid was placed as an arch between concrete encased steel beams. The encased steel beams are corroded and additional shoring and bracing was required. Additional wood shoring was placed to provide support to the vault lid, however considered temporary. The Paoli & Brown vault lid was placed with a flat ceiling. There is currently wood and steel framing supporting the vault lid. The top surface of the vault lid is extensively cracked and allows water infiltration.

The 'Gardener- Miles 1904' stamp on the sidewalk may be difficult to saved, the lid is severely cracked. The entrance concrete decorative posts add complexity to the project and will require coordination to remove and replace for any vault or sidewalk upgrades.

Conclusion: The vault lid is in poor condition and needs to be replaced. The Wok and the Paoli & Brown Law office vaults are considered good candidates for maintain the vaulted area. Though some of the street side and end walls are damaged the majority of the foundation walls are in good shape. The steam tunnel could be infilled, however this should be coordinated by the city engineers.

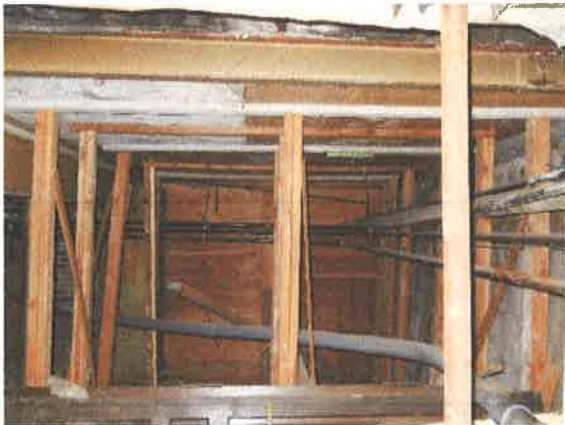
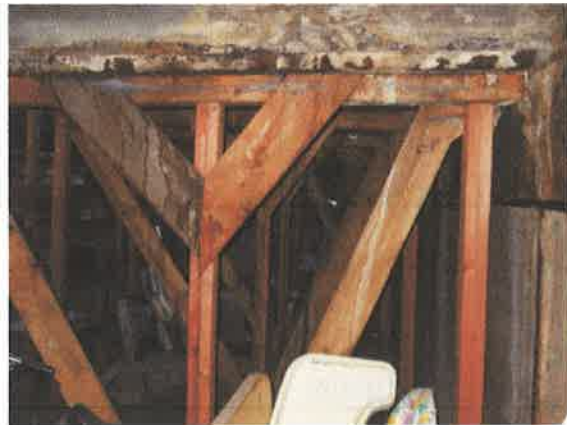
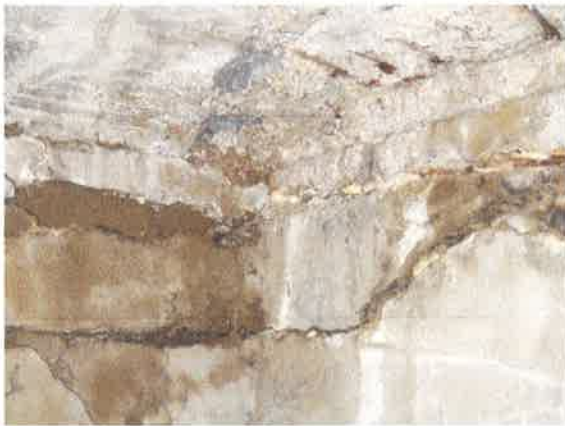
Additional Images Below:
Shoring and Utility Pipes in the Vaults.

Street Wall Intersection of 2nd and Callender St.
Steam Vault under Callender St.

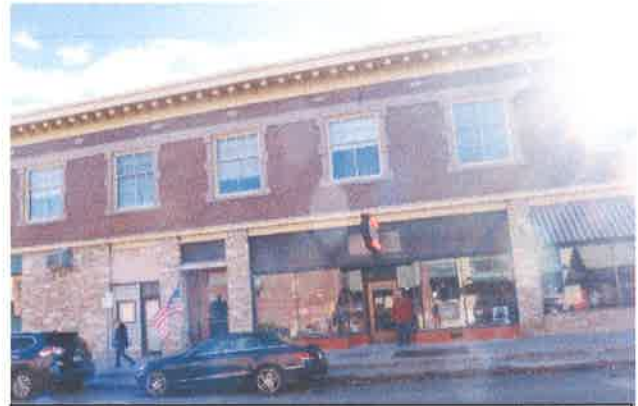
Photo #1: 109 West Callender

Vault Lid: The vault concrete lid is leaking and is in poor condition. The concrete slab is approximately 6". The slab is supported by concrete encased steel railroad rails. There is wood spanning between the encased steel beams. The wood and steel beams have been exposed to moisture and are corroding. Steel framing supporting the vault glass skylights are corroded and showing signs of distress. There is a steel sidewalk access in front of Sax & Fryer, however it appeared that it is no longer being used.

Conclusion: The vault lid is in poor condition and needs to be replaced. The Sax & Fryer and the Wild West Custom Clothing vaults could be upgraded to maintain storage. Sax & Fryer and the Wild West Custom Clothing vault street side walls will need to be upgraded and repointed. The section where the foundation wall failed will require upgrades. The Taylor-Levitt Insurance section is not being used and is a good candidate to be infilled.

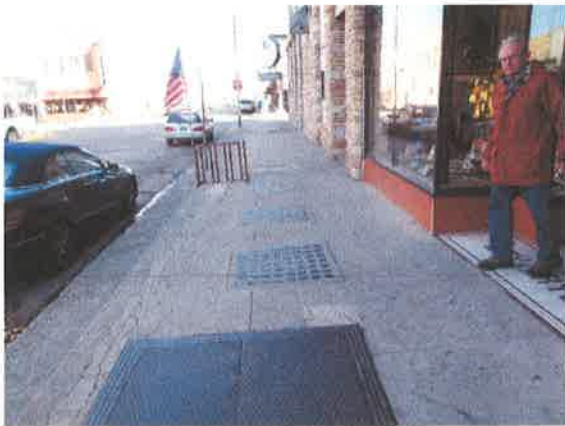
Sax & Fryer Metal access and Glass Skylights

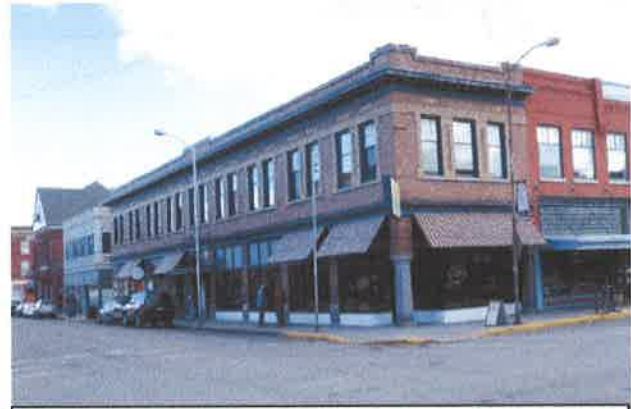
Photo #1: 101 S. Main & W. Callender St. Building

Vault Lid: The concrete vault lid is cracked and water infiltration is evident especially at the 9'-0" vault locations. The concrete lid looks to have #5 reinforcing steel at 5" on center each direction. Concrete encased steel beams support the larger 9'-0" vault areas. The steel

beams are rusted and the concrete around the beams is cracked and damaged. The concrete slab is approximately 6". The south portion of the main street vault is supported by recently installed wood joists and plywood sheathing. The reinforcement in the concrete slab is unknown.

Conclusion: The vault lid in the 4' sections is in good condition however the 9'-0" vaulted sections are in poor condition and should be replaced. The existing street side concrete foundation walls are in good condition. The vault area is used for storage including the wood framed storage units. The building line steel beams are in good condition however exposure to moisture infiltration will continue to damage the beams. This vault would be a good candidate to be maintained.

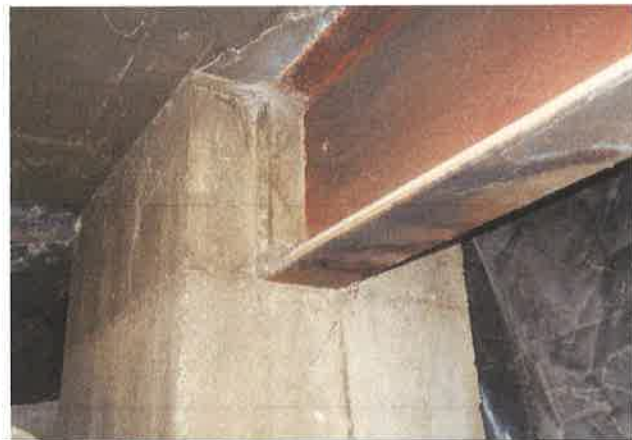
Photo #2: Building Line Steel Bm & Conc Column

Building Line Walls: The front of the building is supported by steel beams spanning between concrete columns, see photo #2. The 12" deep steel beams bear on 24" square concrete columns. The concrete columns are about 16'-0" on center. The steel beam is in good condition however corrosion was noted on the top flange. The building Line steel beam supports the concrete vault lid.

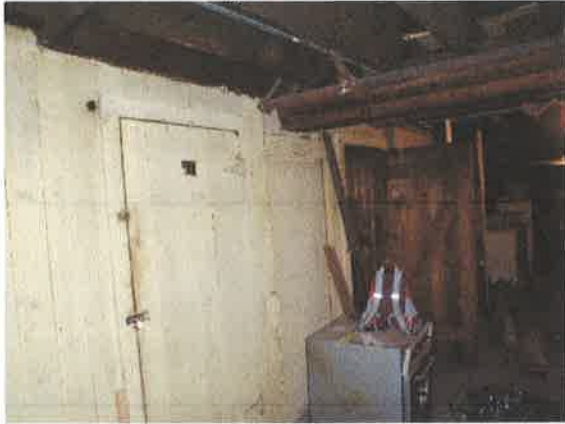
Front Storage Unit Wood Walls

Vault Miscellaneous: There are old wood storage units in the 4'-0" vaulted area. The owner will need to determine if the storage units will remain during construction. If the storage unit framing is to remain there is expected to be additional cost to save and work around.

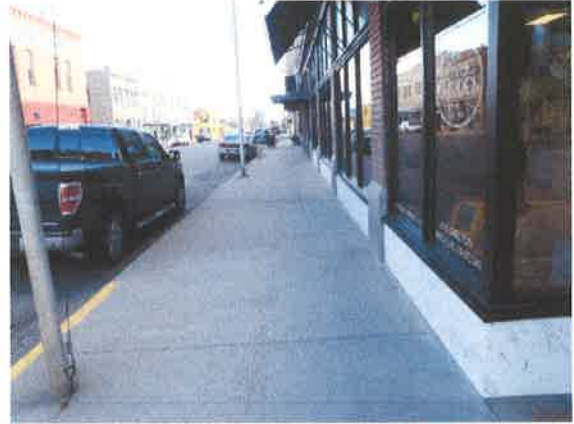
Marble Veneer @ the Slab

The buildings veneer bears directly on the concrete slab along building line. The Frame Garden has marble veneer that will need to be protected during construction.

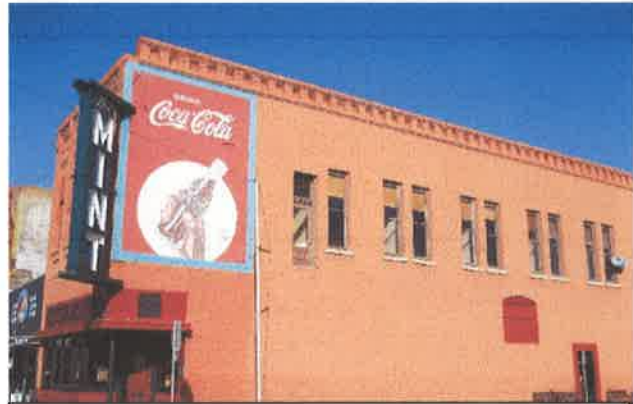
Photo #1: 102 N. Main & W. Callender St.

Street Side & End Walls: The vault street side and end walls along Callender Street are stone rubble foundation walls. The Stone rubble walls support the concrete vault lid. Portions of the vault walls are damaged, possibly from water infiltration. The mortar between the stones is crumbling away or not present. The foundation wall will need to be repointed if the vault is to be maintained.

Conclusion: The vault lid is in poor condition and should be replaced. The existing street side foundation walls is in fair condition, however the walls will need to be repointed. The vault area is being used for little to no storage. This vault could be maintained if desired by the owner. If the vault was to be infilled the building line windows and doors shall be infilled with reinforced CMU blocking.

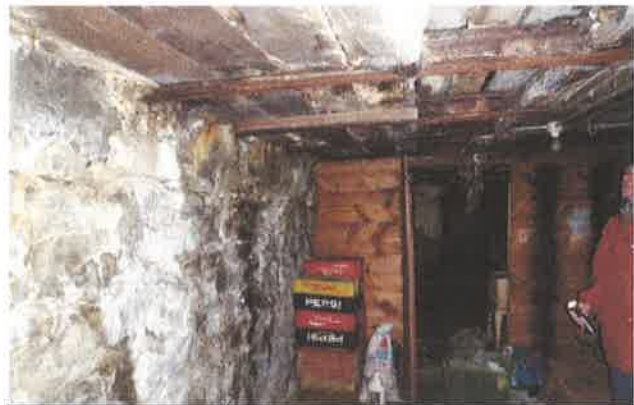
Photo #2: Callender St. Vault Wall and Lid

Vault Lid: The vault concrete lid has been patched several times and is leaking. The concrete slab is approximately 6". The slab is supported by concrete encased steel railroad rail beams. Wood planks span between the railroad rail beams. The railroad rail beams and the wood planking show significant corrosion from water infiltration.

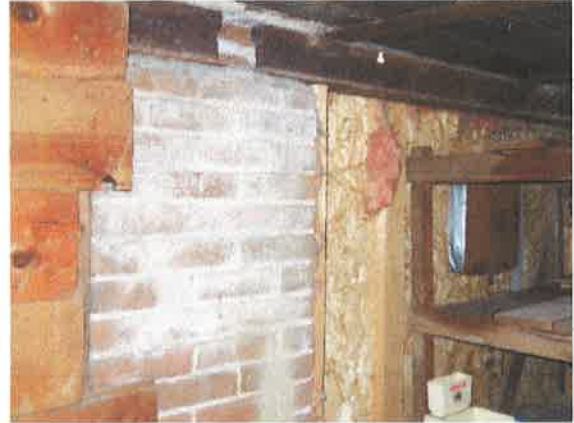
Building Line Wall with Steel Beams @ Lid

Building Line Walls: The front building line where there is no vault is supported by a stone rubble foundation wall. The building line with the vault section is supported by brick and concrete columns. There are several door and window openings in the basement building line at the vault section. Steel railroad tie headers are installed at the window openings to support the vault lid. Moisture infiltration is also damaging the mortar of the foundation walls.

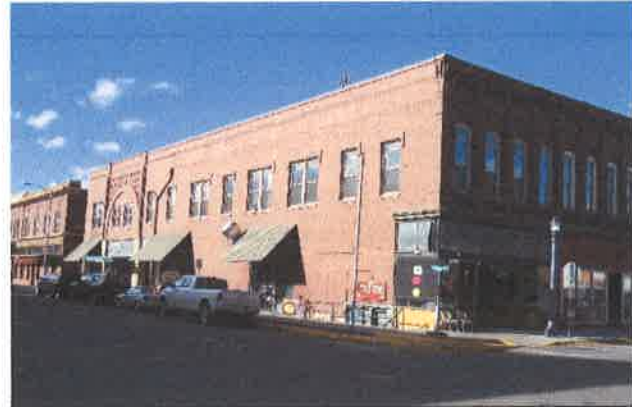
Photo #1: N. Main & W. Callender St. Building

Vault Lid: The vault concrete lid is leaking in a few locations. The vault lid was originally encased steel railroad rails. Wood planking spanned between the encased steel rail beams. More recently vault lid was replaced and light gauge delta rib metal decking was placed over the steel rail beams. The metal decking is non-structural decking. The slab is in good condition except where it transfers from vault to sidewalk. The concrete slab is approximately 6".

Conclusion: The vault lid is in poor to good condition and will be replaced. The existing street side foundation walls is in good condition, however the stone rubble foundation walls will required repointing. Vaults of the Reed Lehman Pottery and Curated Closet are used for storage and can be maintained. The vault area accessed through the bakery has minimal storage, this vault could be maintained. The brick veneer, concrete step, and roof down spout increase the complexity of the project.

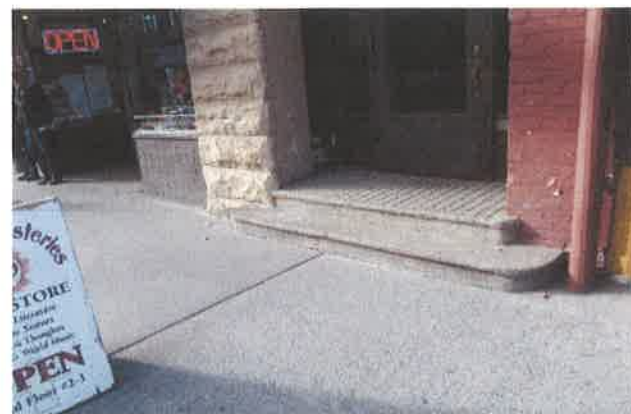
Photo #2: Stair at Callender St. Entry

Brick veneer bears directly on the concrete slab along building line. This was specifically noted at the column locations. There is also a concrete stair that bears directly on the sidewalk slab, see photo #2.

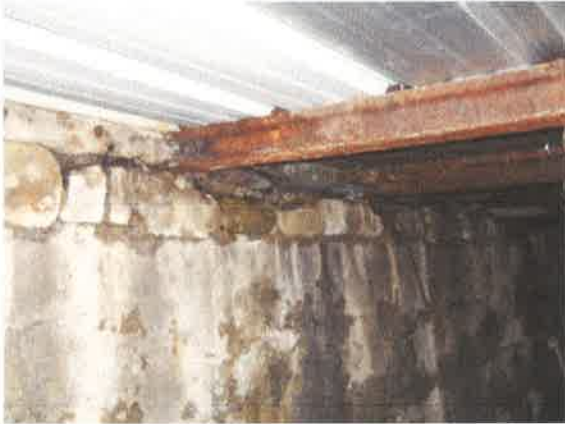
Street Side Foundation Wall & Vault Lid

Street Side & End Walls: The vault street side walls along Callender are stone rubble wall with a concrete parge coat along the Bakery and Salon vault sections. The street side and end walls of the Pottery and Curated Closet are stone rubble foundation walls. The stone rubble and concrete walls support a twostep concrete vault. The mortar between the stone foundation walls is crumbling away. The foundation wall will need to be repointed if the vault is to be maintained.

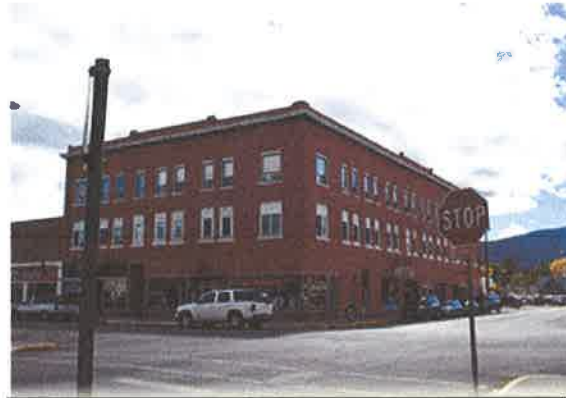
Photo #1: 206 Main & Lewis Street

Street Side & End Walls: The vault street side and end walls along Lewis Street are stone rubble foundation walls. The stone rubble walls support the concrete vault lid. Portions of the vault walls show signs of water infiltration and the mortar between the stones is crumbling away. The foundation wall will need to be repointed if the vault is to be maintained.

Building Line Walls: The building is supported by stone foundation walls. There are openings in the foundation wall. Wood has been placed in the opening to try retain the soil below the sidewalk slab along Lewis St. The wood shoring is susceptible to moisture and has failed creating voids under sidewalk slab. In the boiler room, CMU, wood framing supports the building line. The voids under the slab in the boiler room where the 2x support wall framing is located.

Vault Lid: The vault concrete lid is was not visible there is wood planking supporting the slab. The vault slab thickness is not known.

Conclusion: The vault lid/sidewalk slab is to be replaced. The vaults are not being used. It is suggested that the openings and the vault space along the building line be infilled with a concrete or CMU grouted blocks to replace the voids and wood shoring. Once the building line voids are infilled compacted soil or lean create can be placed to support the new sidewalk.
