CITY OF LIVINGSTON, MONTANA  
2014 INVENTORY REPORT OF MUNICIPAL PARK,  
BOULEVARD, AND CEMETERY TREES

Conducted, written, and photographed by:

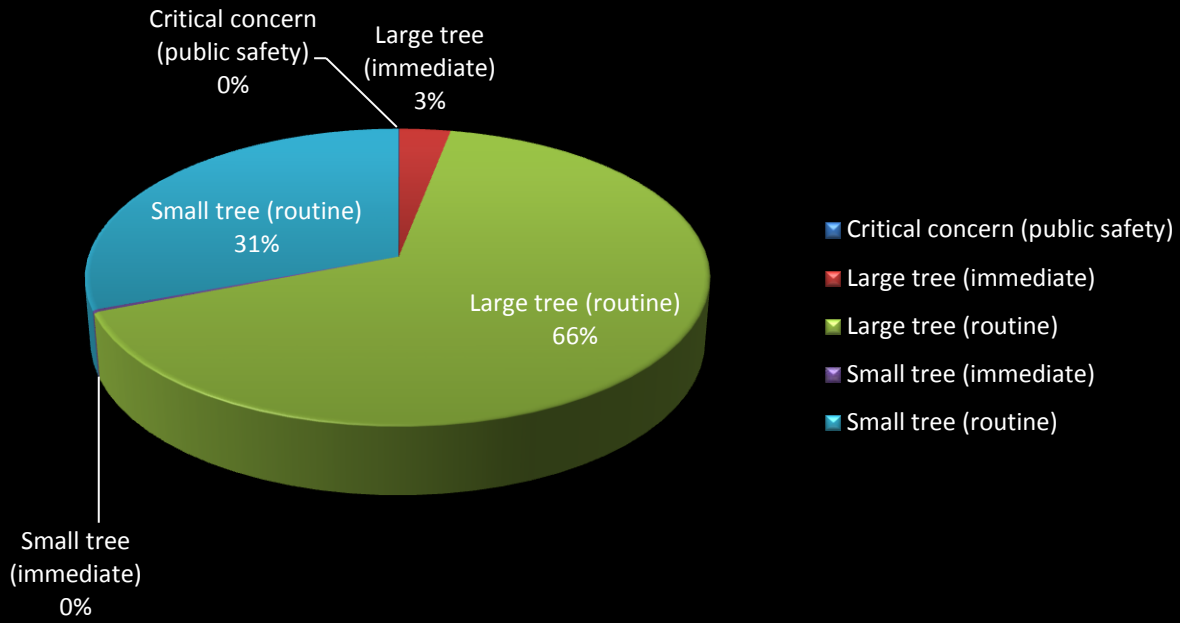
# Maintenance Recommendation

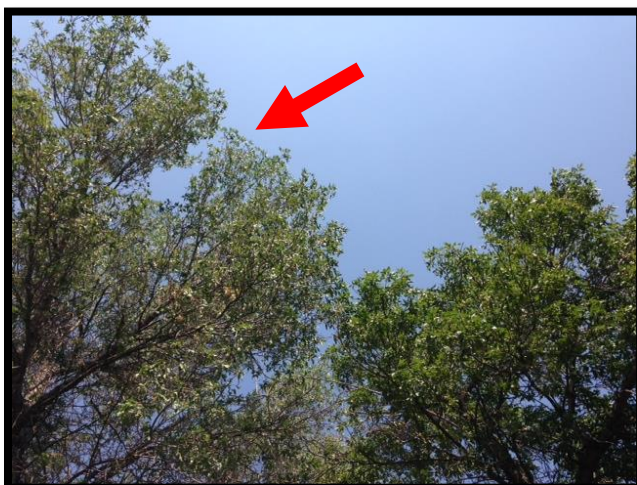
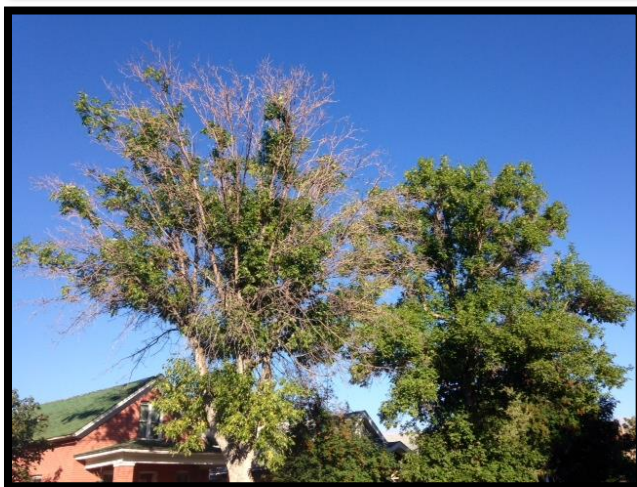
FADING AND DYING ASH TREES: TYPICAL THROUGHOUT LIVINGSTON. ARROWS POINT TO TREES RATED AS "REMOVALS"

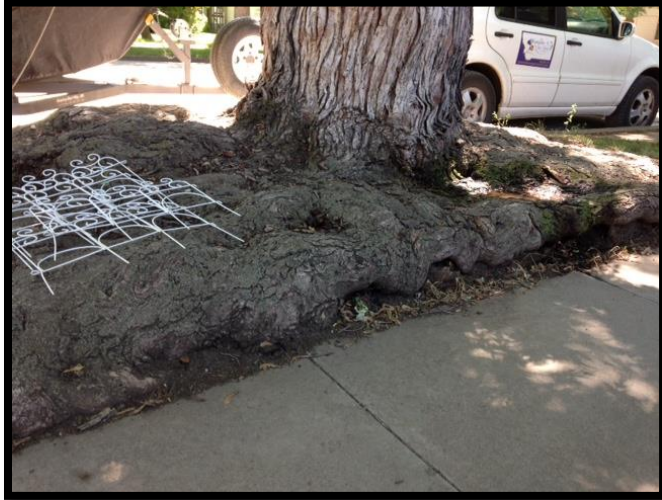
PHOTO SHOWS  
TYPICAL ROOT  
DAMAGE TO  
BOULEVARD TREES  
THAT HAVE RAISED  
OR EXPOSED  
SUPPORTING ROOTS

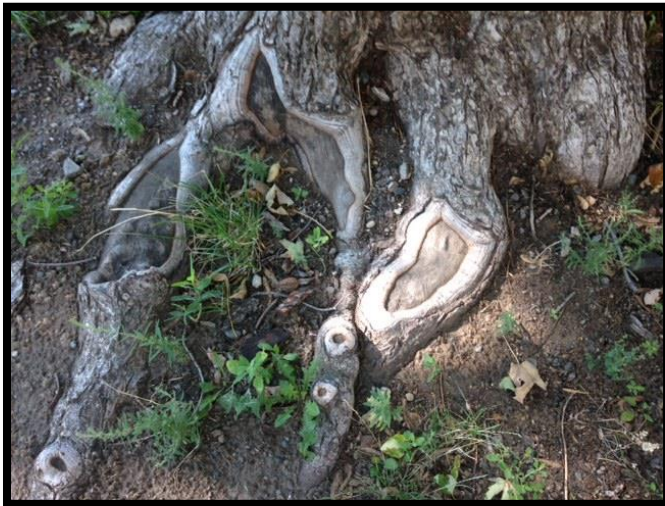
CONFLICTS WITH UTILITY LINES: HIGH RISK AND HIGH MAINTENANCE

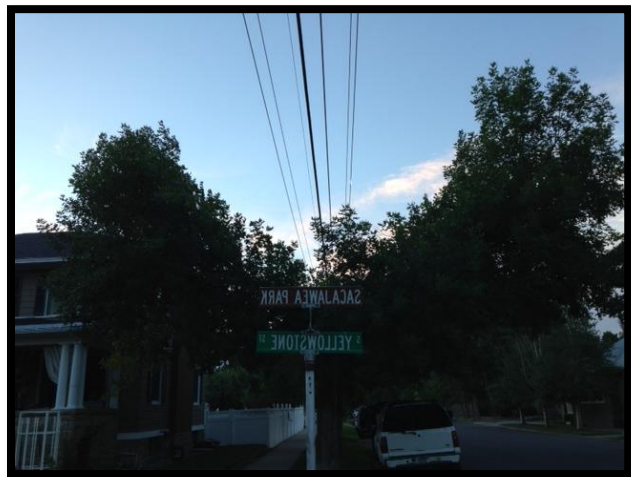
CONTACT WITH UTILITY LINES: HAZARDOUS AND RISKY

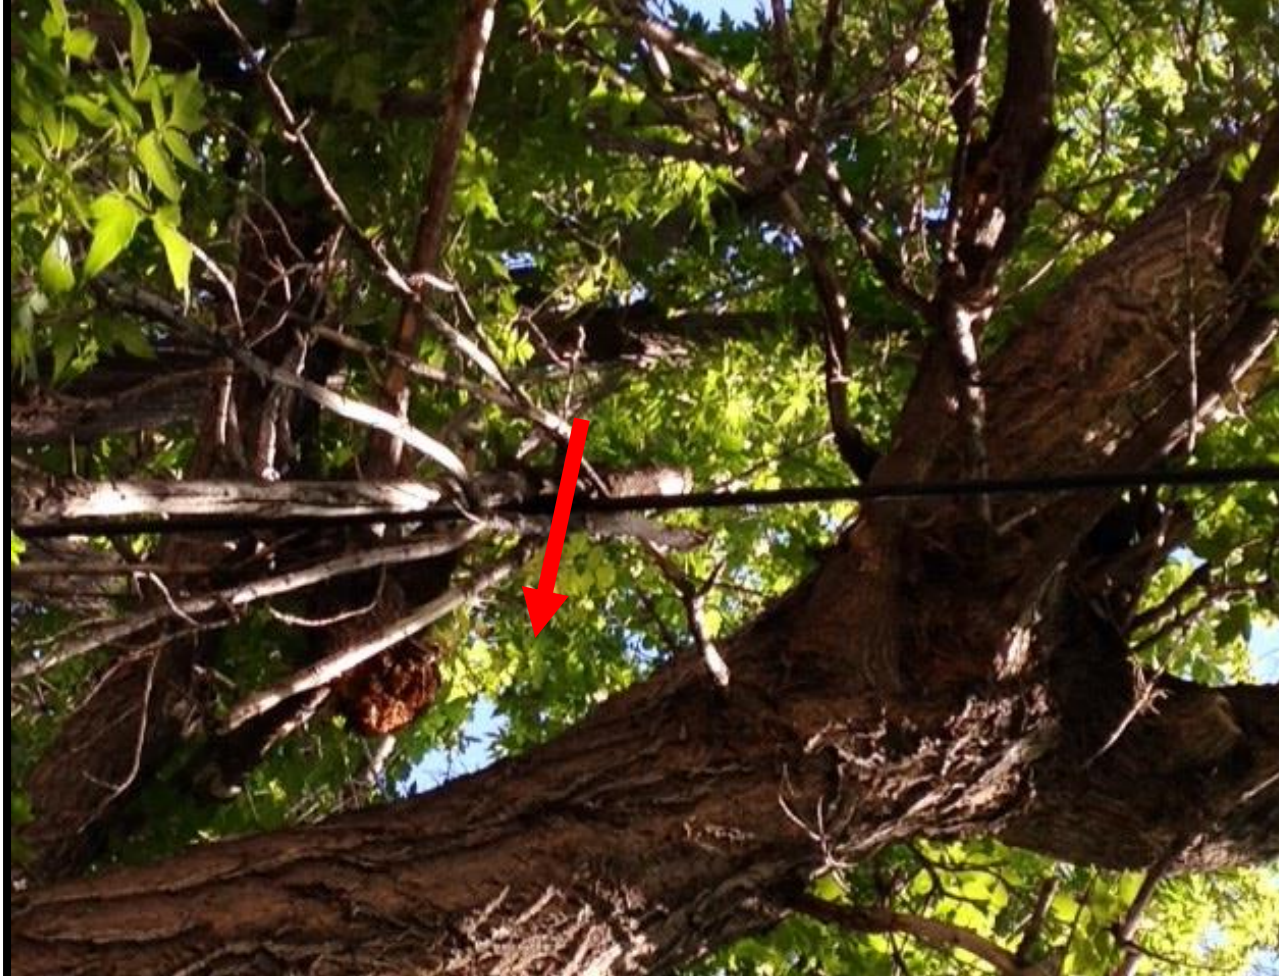
SIGNAGE CONFLICTS: HAZARDOUS AND RISKY

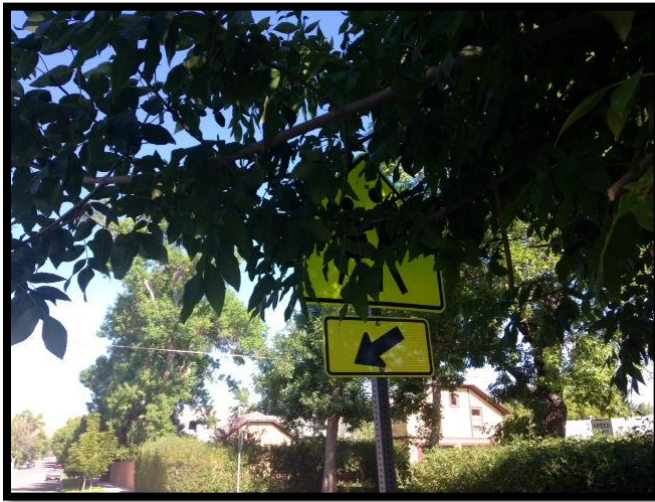
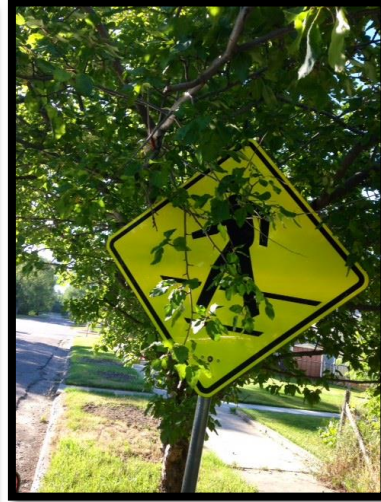
ARROW POINTS TO A  
STOP SIGN  
COMPLETELY  
COVERED BY FOILAGE

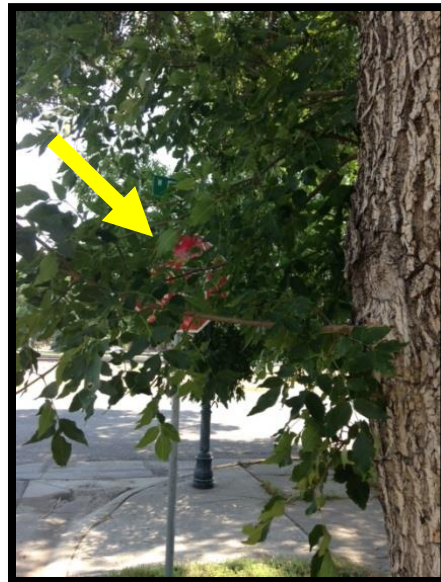
DEAD WOOD: CAN FAIL AT ANY TIME - UNPREDICTABLE & RISKY

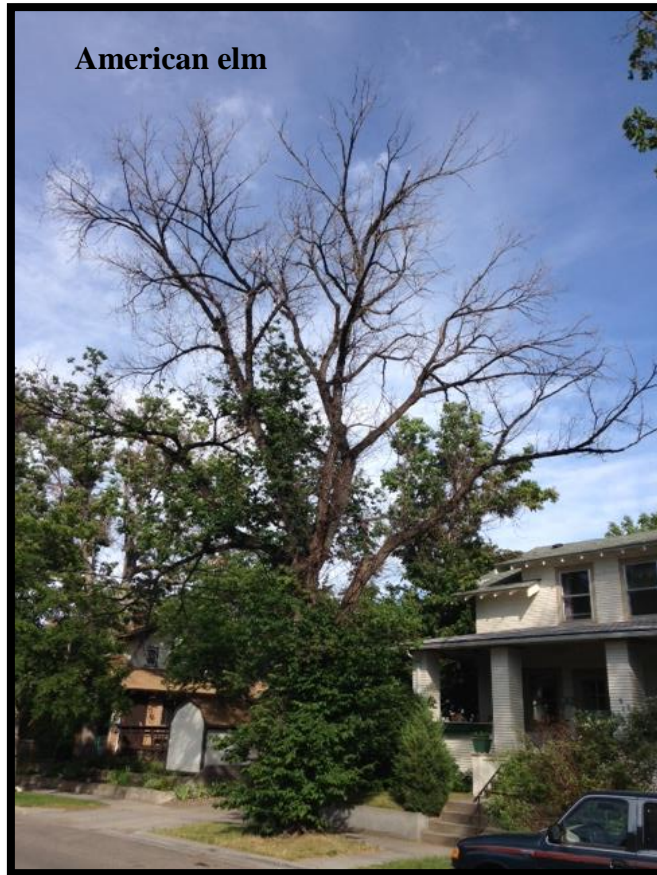
HANGERS: UNATTACHED BRANCHES ELEVATE RISKS. VERY COMMON IN LIVINGSTON'S BOULEVARD, PARK, AND CEMETERY TREES

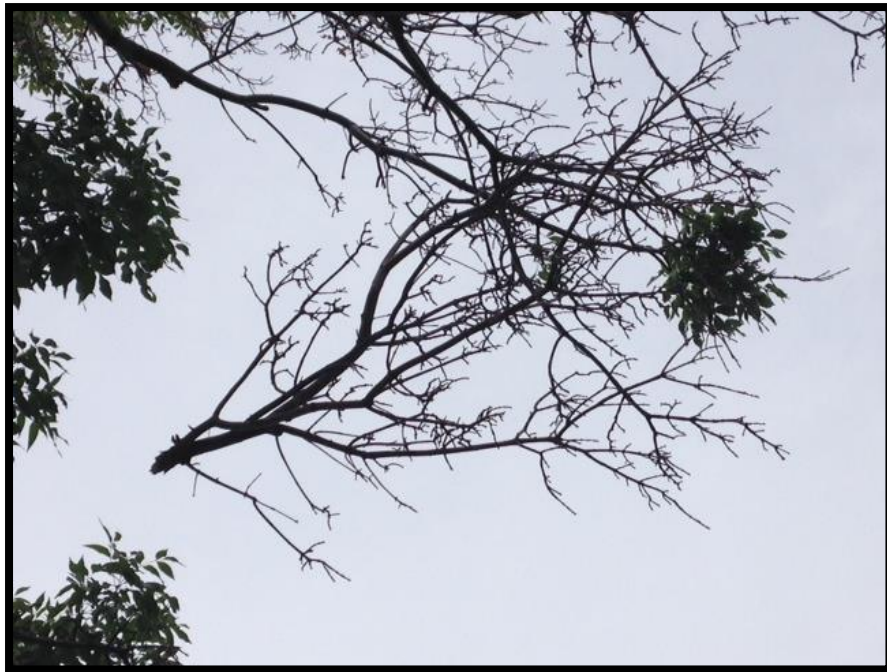
**HEALTHY LOOKING SILVER MAPLE WITH A DANGEROUS CAVITY ON THE MAIN STEM: TREES WITH HAZARDS AND HIGH RISKS CAN STILL LOOK HEALTHY**

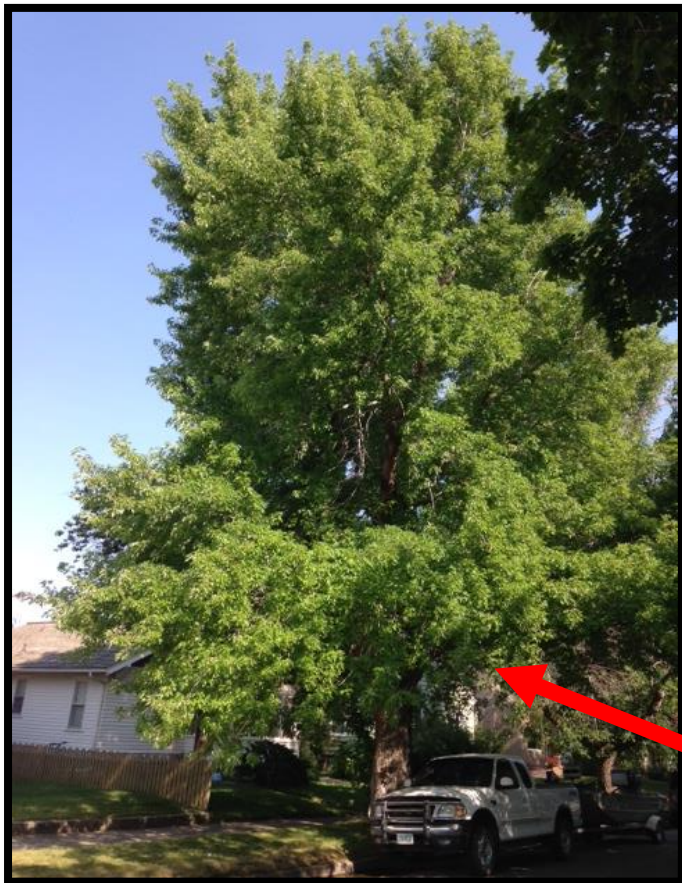
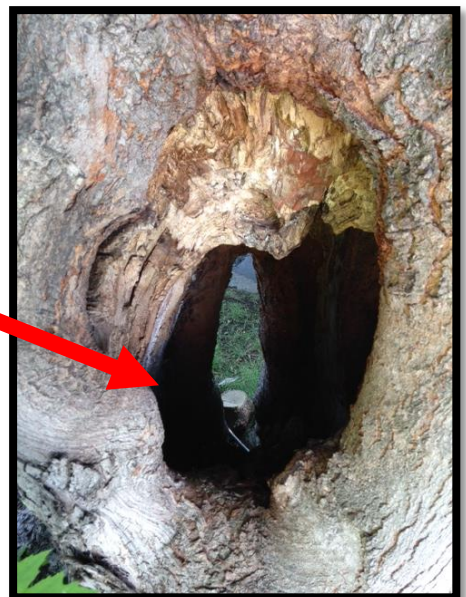
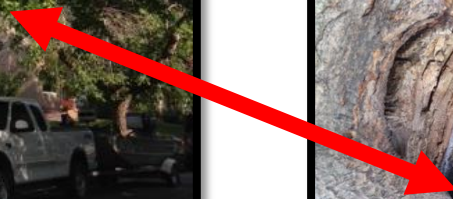
SPLIT MAIN STEMS: DANGEROUS HAZARDS AND HIGH RISKS

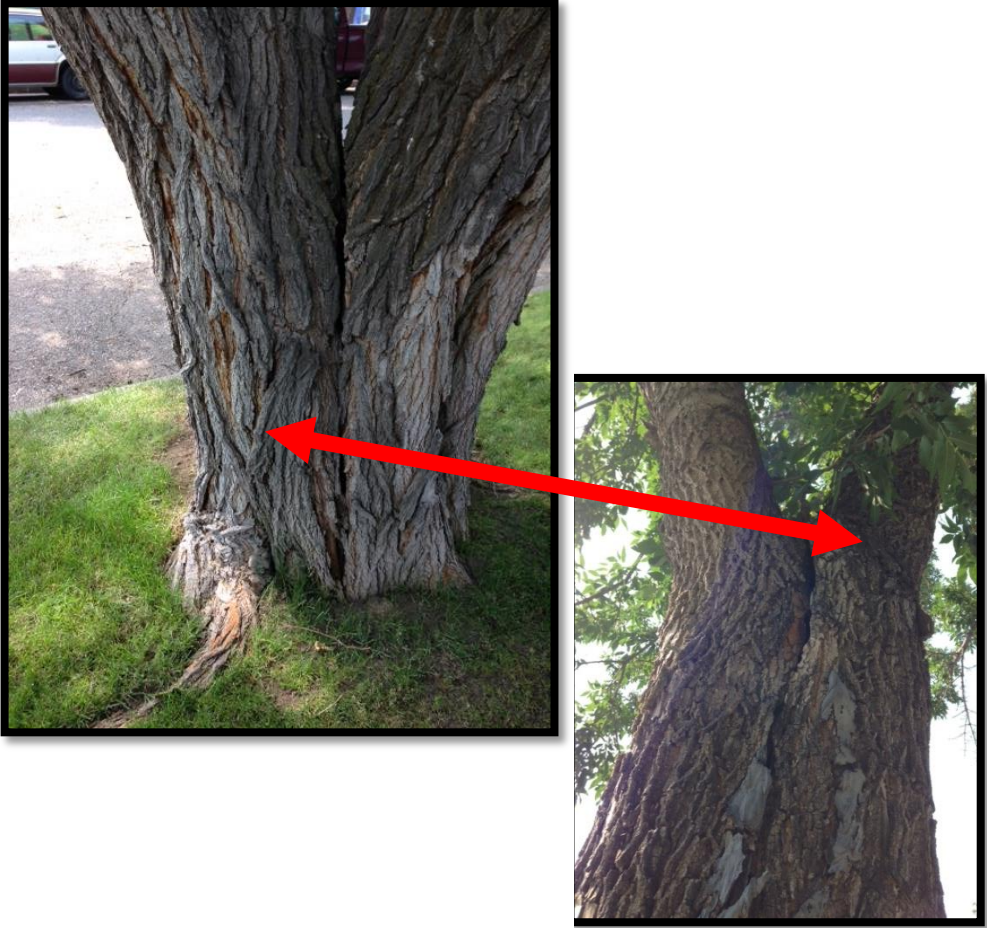
CO DOMINANT STEM WITH INCLUDED BARK:

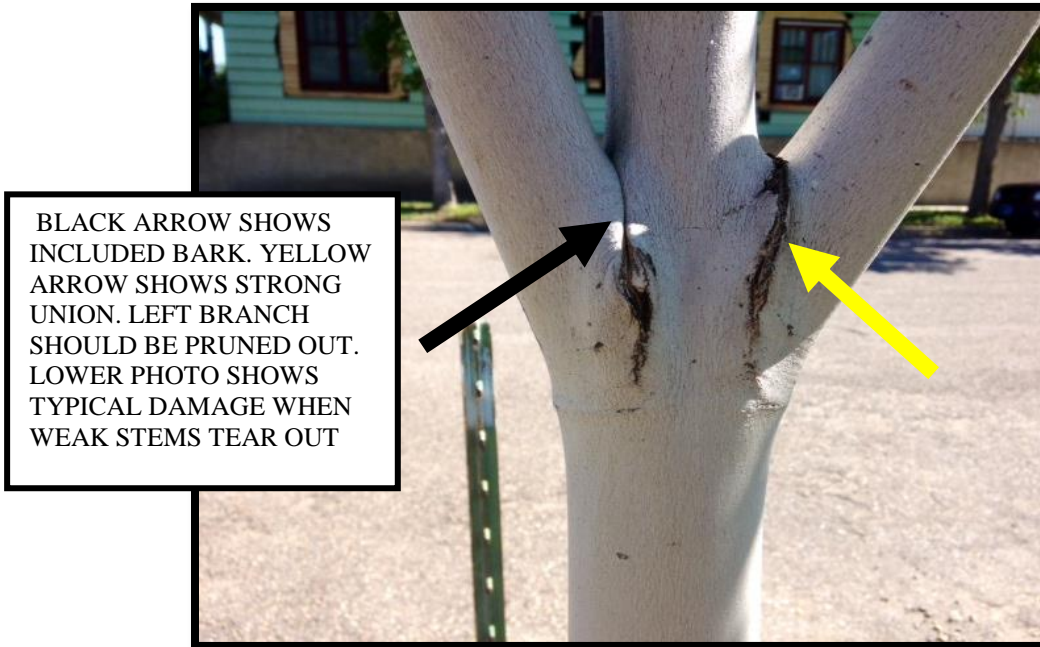
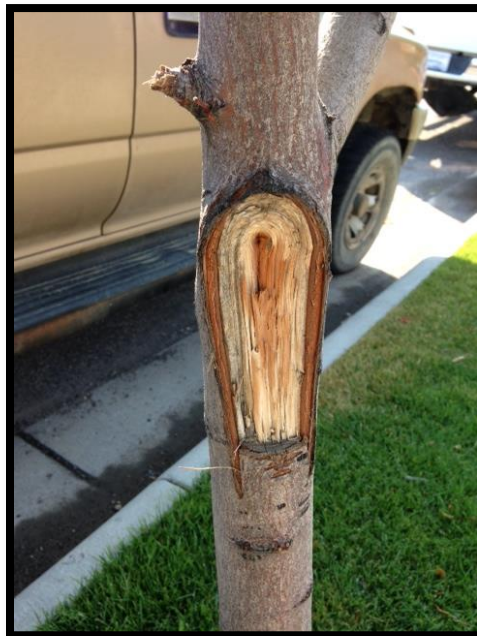
CO DOMINANT STEMS: WEAK STRUCTURAL UNIONS THAT TEND TO FAIL.  
COMMON DEFECT SEEN ON LIVINGSTON'S TREES

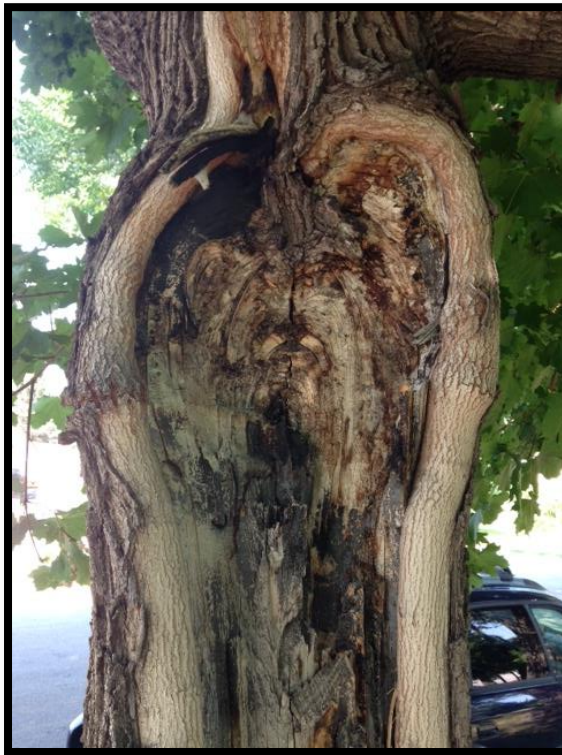
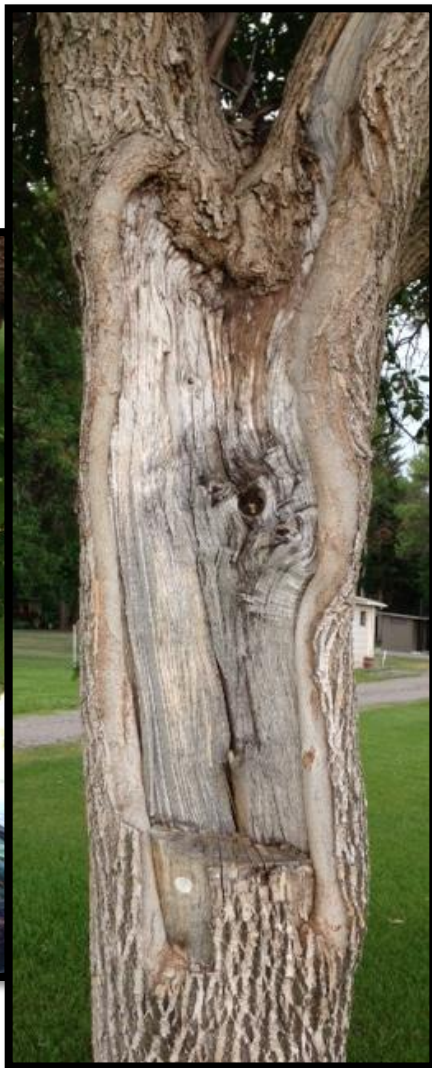
CAVITIES, HOLLOWNESS, AND DECAYING WOOD: DIFFICULT TO VISUALLY ASSESS EXTENT OF INNER DECAY

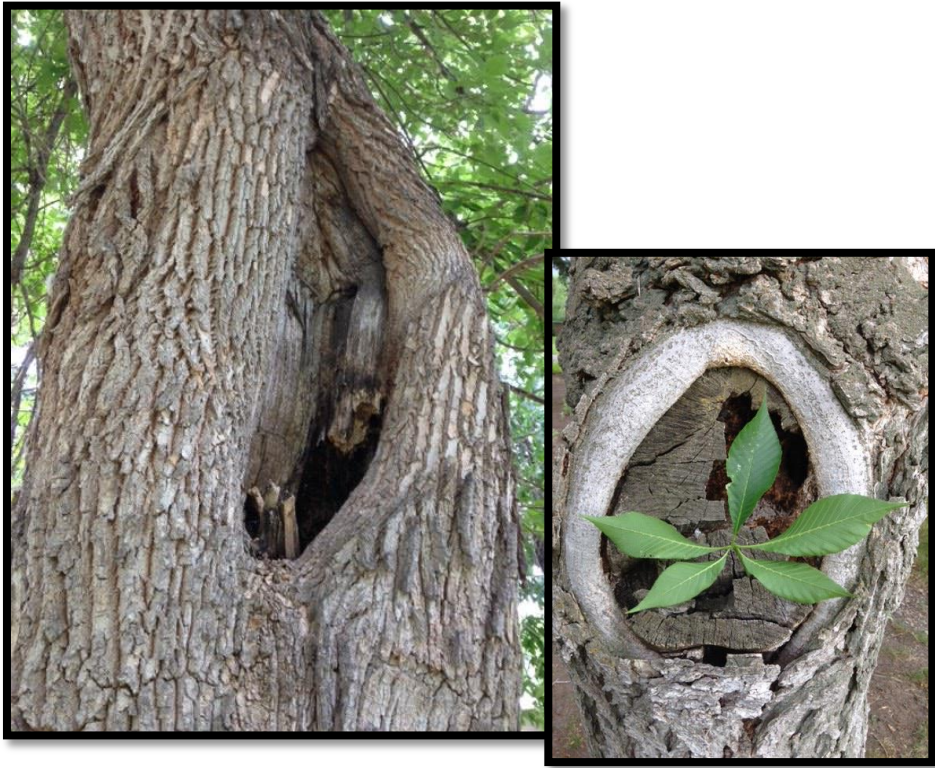
COMMON DAMAGE ON TREE STEMS: RIGHT PHOTO SHOWS MECHANICAL DAMAGE THAT IS STARTING TO DECAY. RIGHT PHOTO SHOWS A “SEAM” CAUSED BY A LIGHTENING STRIKE.

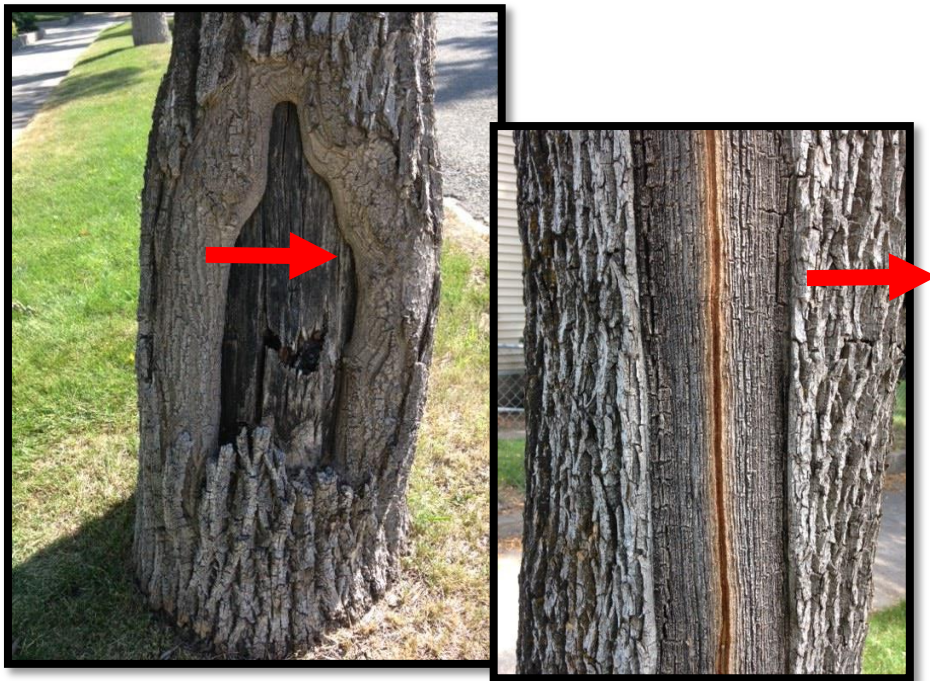
UNSKILLED TREE WORK: RIGID CABLES MAKE THE TREE UNABLE TO SWAY NATURALLY UNDER WIND LOADS AND ARE REDUCING UPTAKE OF WATER DUE TO CABLE GROWING INTO BARK & WOOD. LOWER ARROW POINTS TO DANGEROUS CRACK IN STEM-TREE SHOULD HAVE BEEN REMOVED

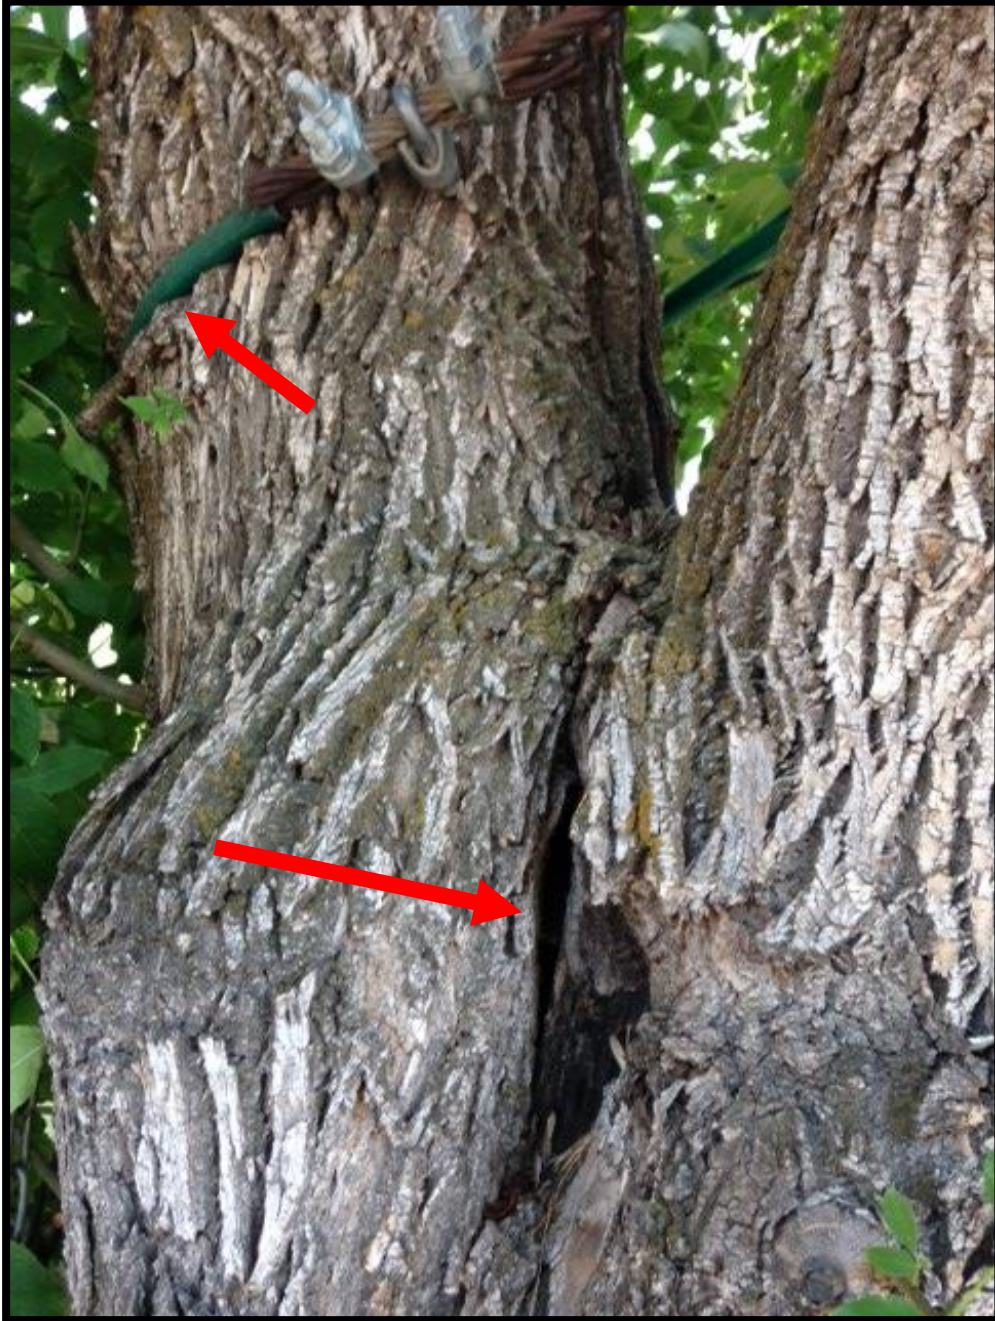
UNSKILLED TREE WORK: TOPPING CUTS: ALL BRANCHES IN THIS PHOTO ARE WEAKLY ATTACHED AND PRONE TO FAILURE

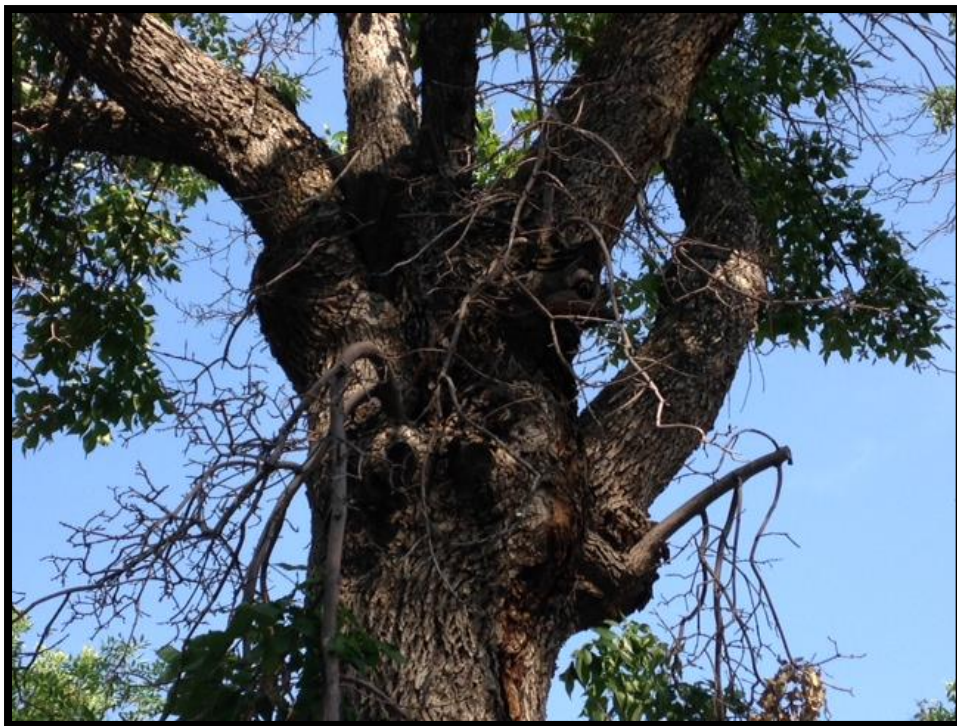
UNSKILLED TREE WORK: TOPPING CREATES HAZARDS & ELEVATES RISK

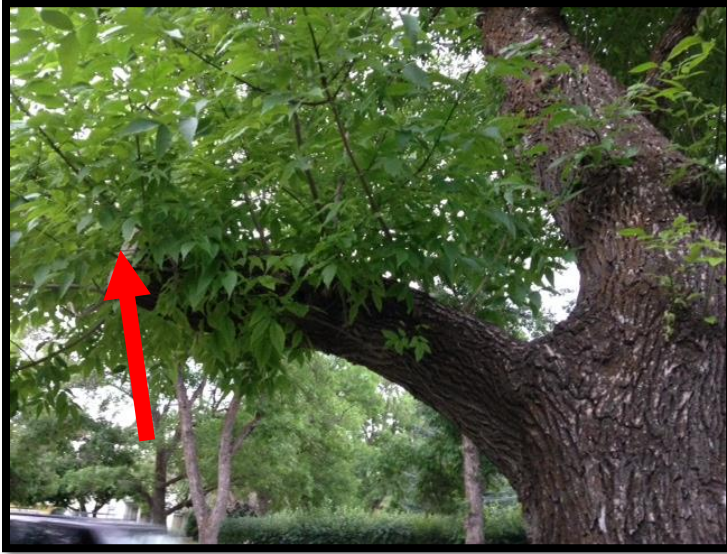
ARROWS POINT TO LIMBS THAT HAVE BEEN “TIPPED” OR “STUBBED”-ANOTHER FORM OF TOPPING THAT PRODUCES WEAKLY-ATTACHED NEW GROWTH.

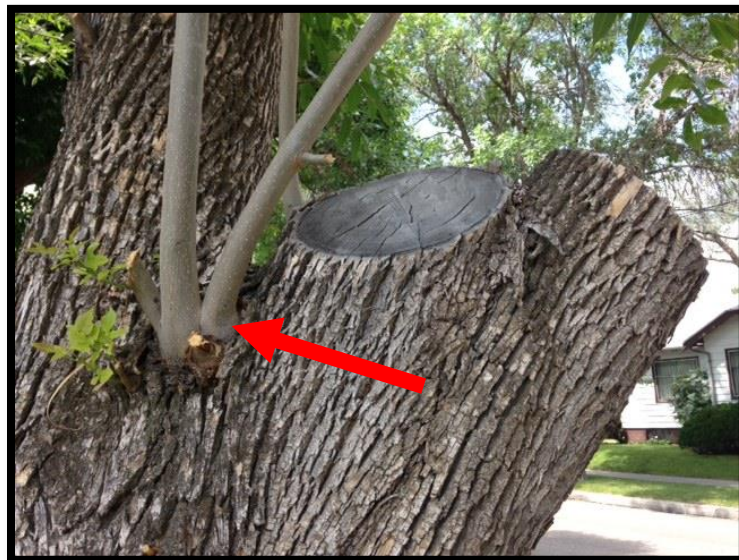
UNSKILLED TREE WORK: TOPPING CREATES HAZARDS & ELEVATES RISKS

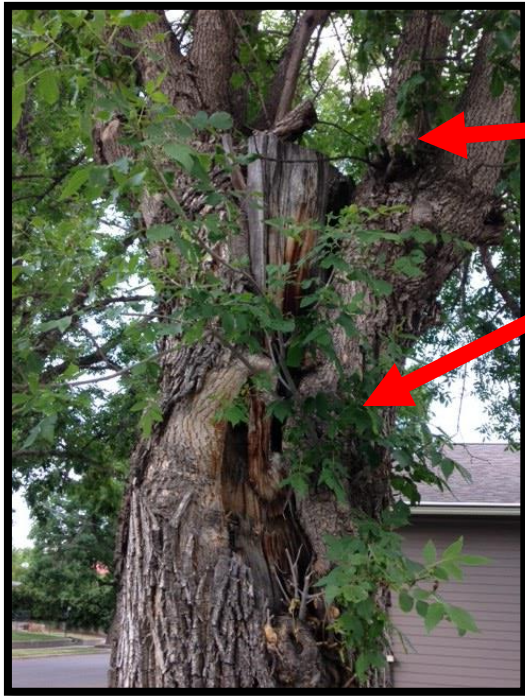
WEAK STRUCTURAL BRANCHES  
AND POCKETS OF DECAY

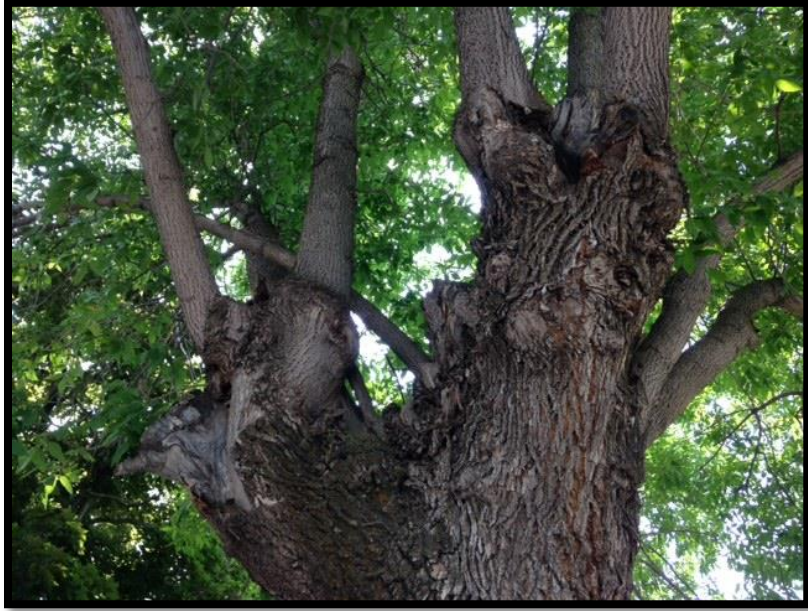
UNSKILLED TREE WORK: EXTREME CANOPY RAISING REDUCES STRUCTURAL STABILITY AND INCREASES CHANCE OF FAILURE

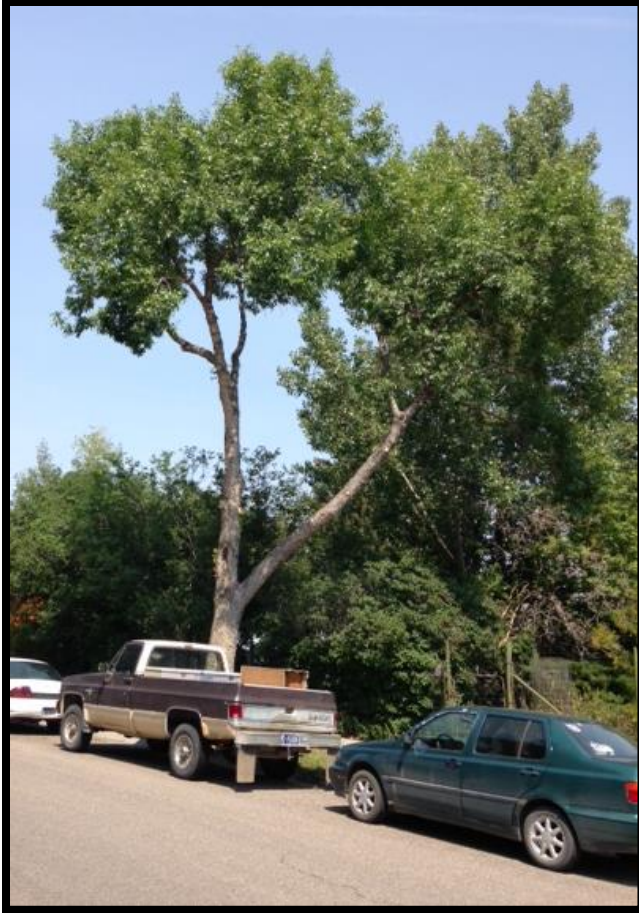
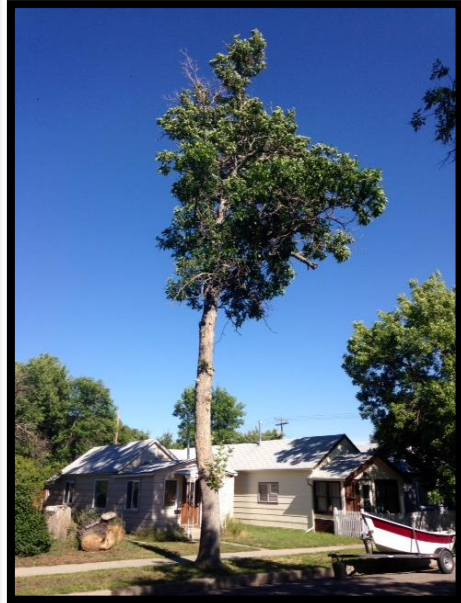
CONFLICTS, HAZARDS, AND RISKS ASSOCIATED WITH SIDEWALKS HEAVED BY TREE ROOTS. VERY COMMON ON LIVINGSTON'S BOULEVARDS

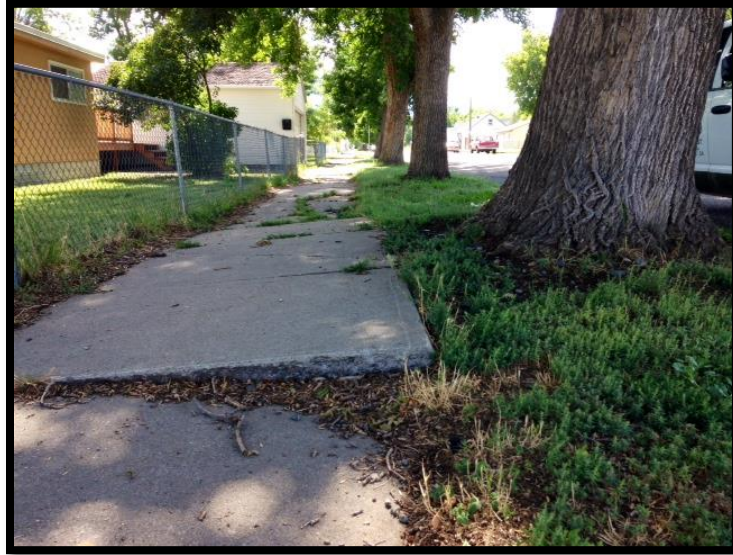
CONFLICTS: TREE ROOTS & CONCRETE - RISKY AND EXPENSIVE TO FIX

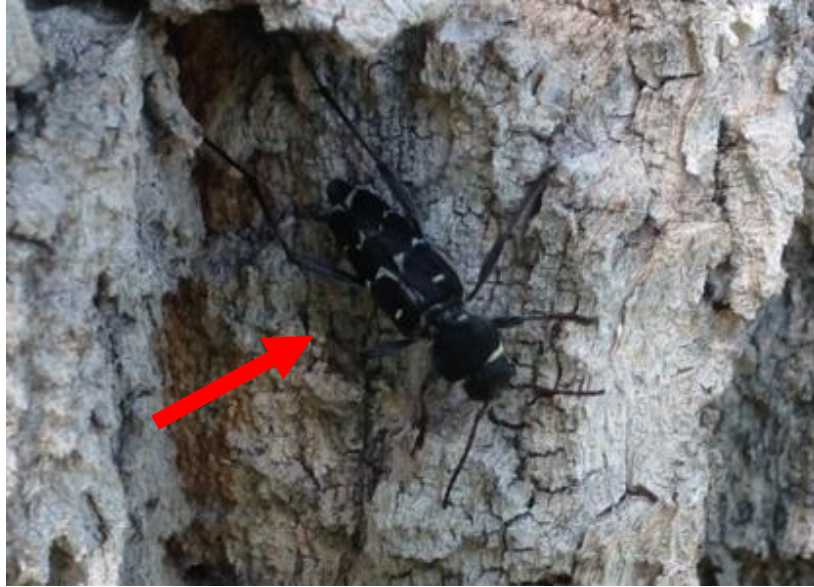
MUSHROOMS: SIGNS OF POTENTIAL DECAY AND ROT

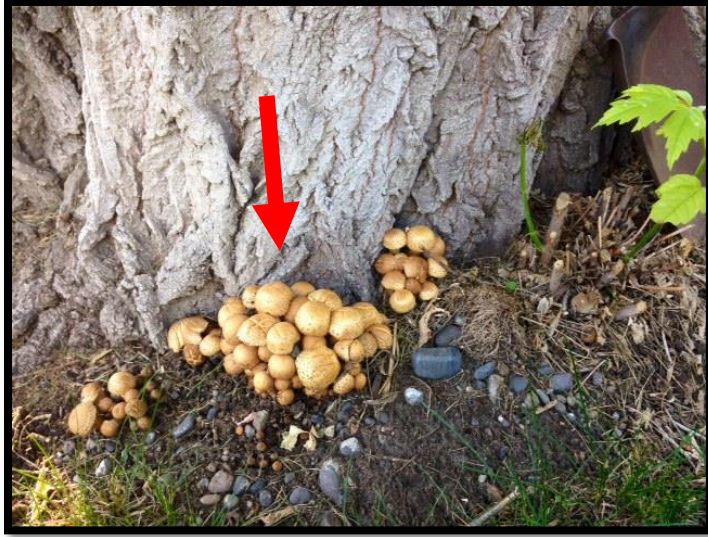
FOLIAR SYMPTOMS OF TREES IN DECLINING HEALTH & COLOR:  
LEAF SCORCH ON BUCKEYE & MAPLE TREES

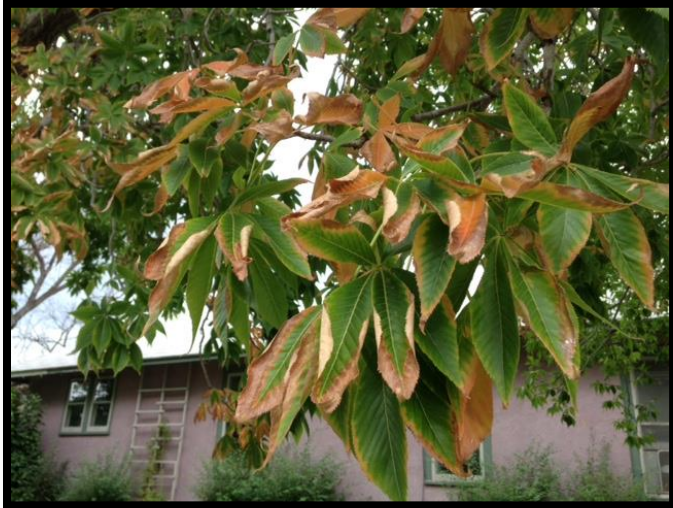
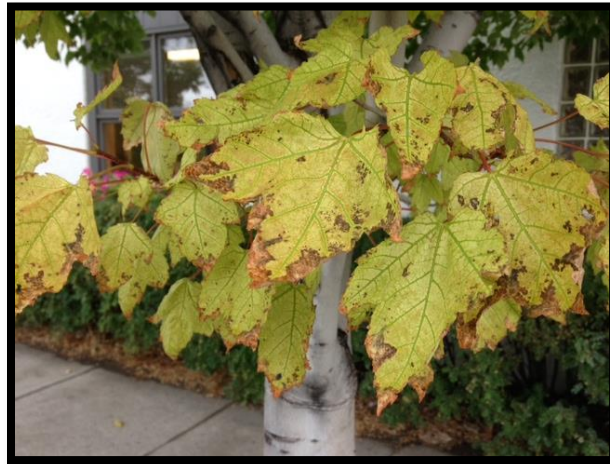
MIKE WEBB PARK: HUMAN- CAUSED TREE DEATH. ARROW POINTS TO MECHANICAL DAMAGE ON STEM. LACK OF WATER IS ALSO A PROBLEM

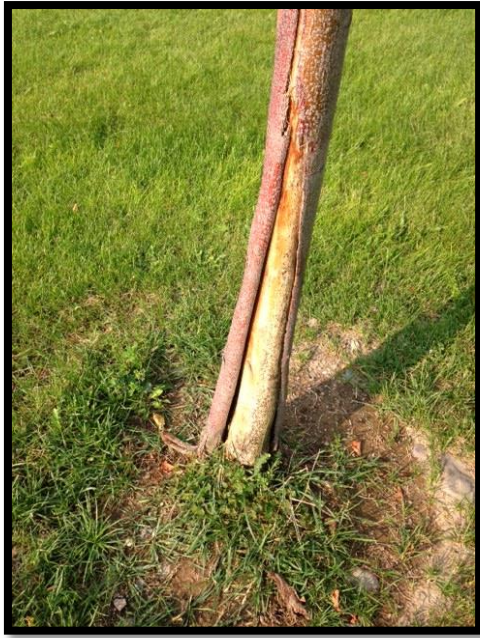
NORTH SIDE SOCCER PARK: DEAD & DYING TREES FROM LACK OF WATER

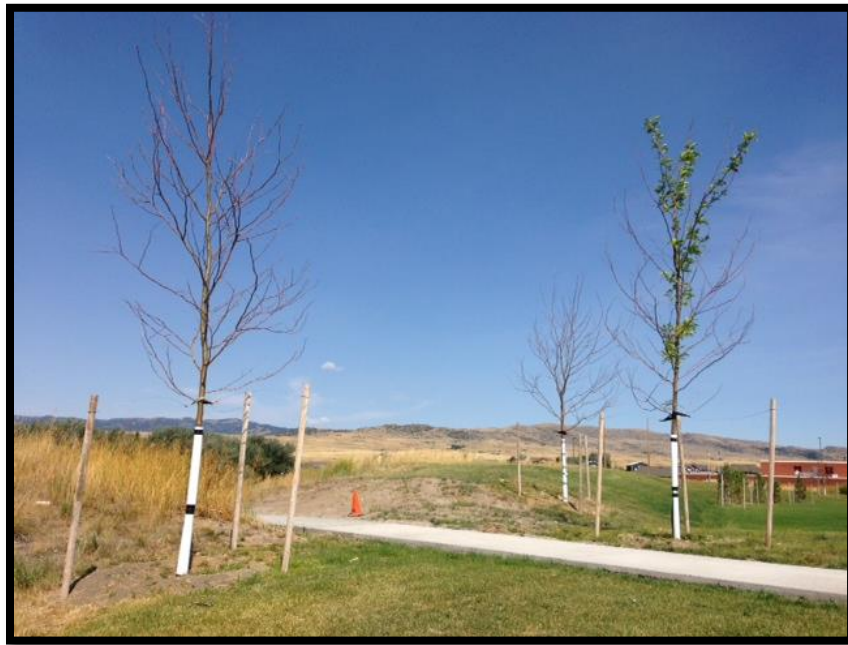
KATIE BONNELL PARK: DYING TREES CAUSED BY LACK OF WATER AND MECHANICAL DAMAGE ON STEMS

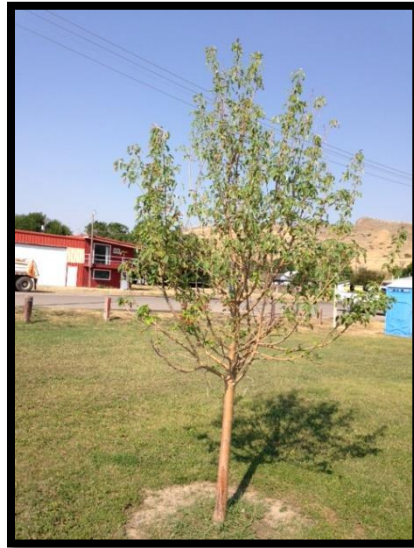
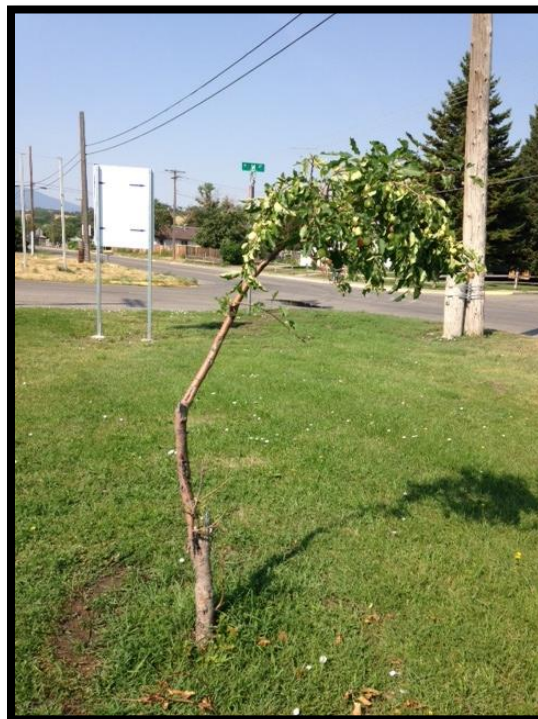
PROBLEMS WITH NEW TREE PLANTINGS: NO AFTERCARE MANAGEMENT

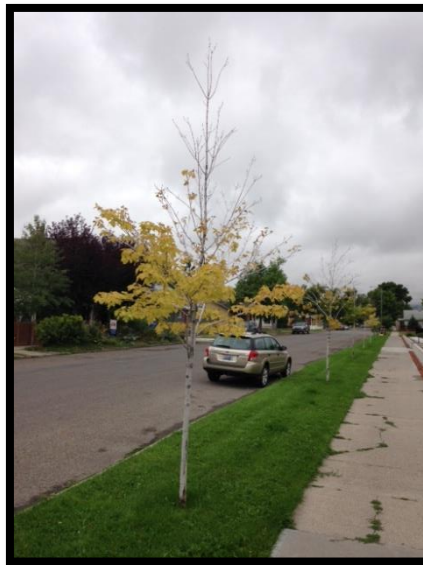
LEWIS AVENUE.  
SEVERAL MAPLES DEAD  
FROM LACK OF WATER

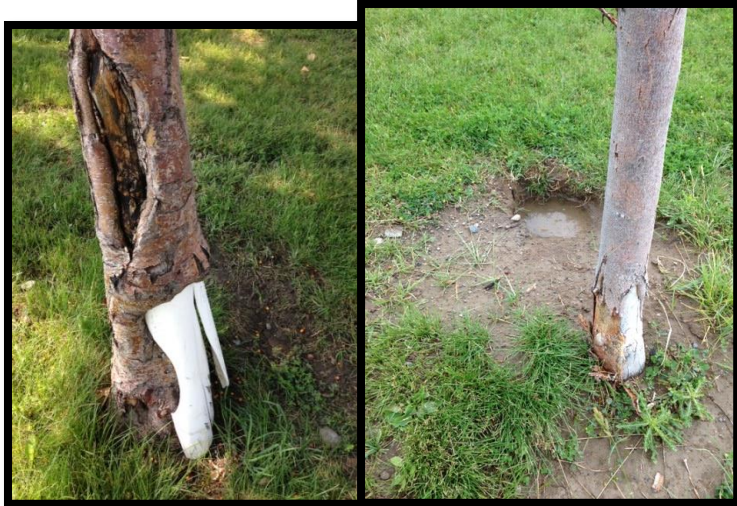
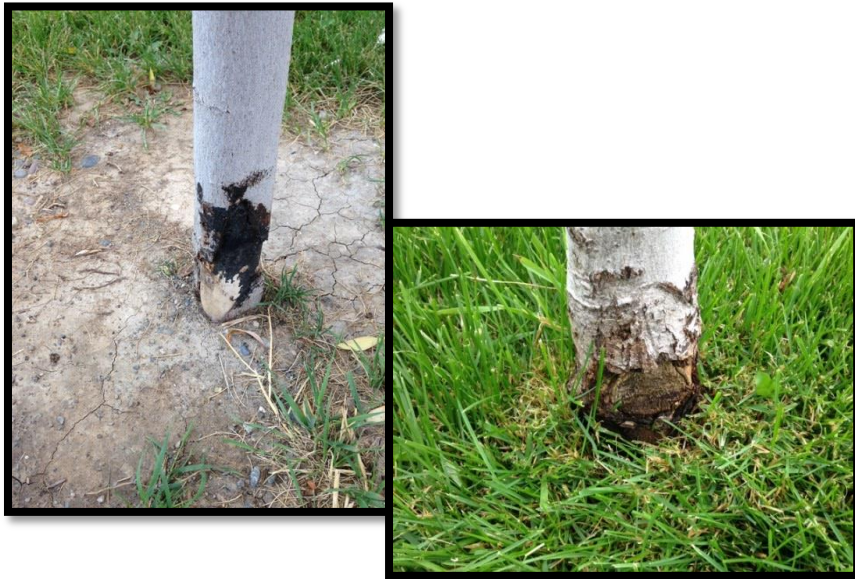
BOZEMAN PARK: ARROW POINTS TO BURROWING ANIMAL DAMAGE OF ROOTS  
MANY TREES IN THIS PARK HAVE EXTENSIVE ROOT DAMAGE CAUSED BY  
BURROWING

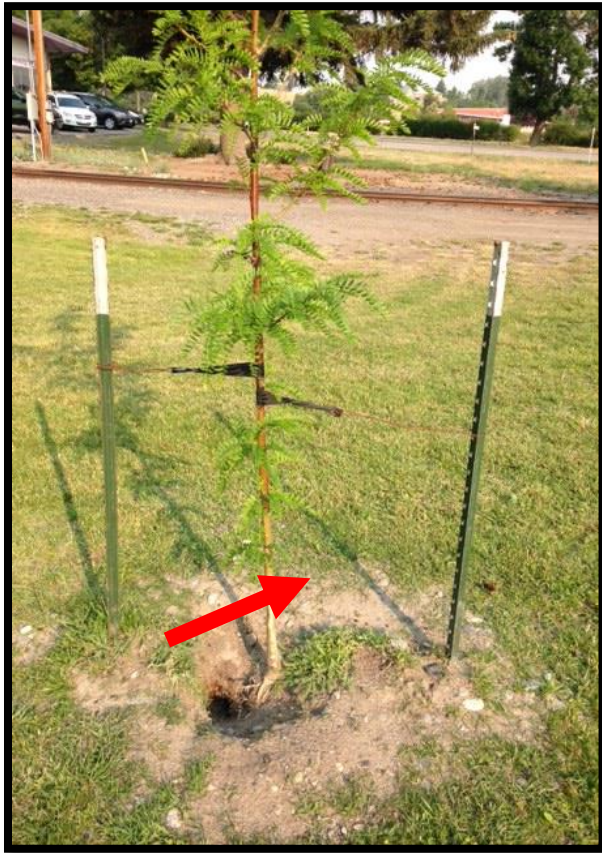
GOOD NEW TREE SPECIES: TOP LEFT PHOTO: AUTUMN BLAZE MAPLE. TOP RIGHT PHOTO-BUR OAK. BOTTOM PHOTOS: TATARIAN MAPLE “HOTWINGS”

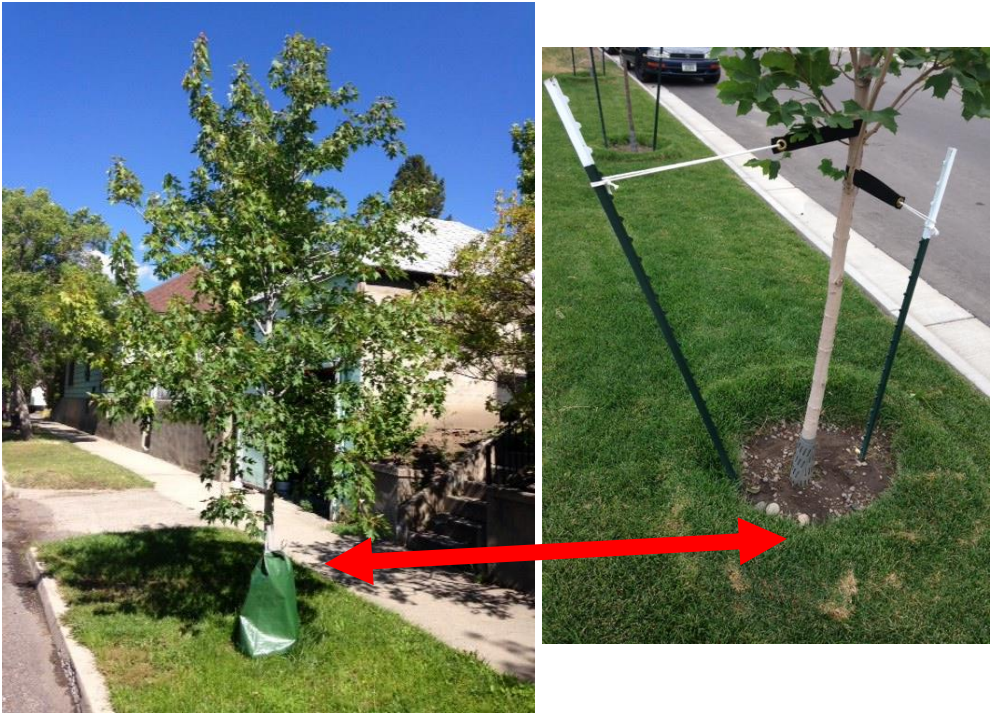
FACTORS THAT AFFECT RISK ASSESSMENT: BOTH TREES LEAN.  
THE LIKLIHOOD OF FAILURE AND THE POTENTIAL EXTENT OF DAMAGES TO  
HIGH VALUE TARGETS NEED TO BE EVALUATED

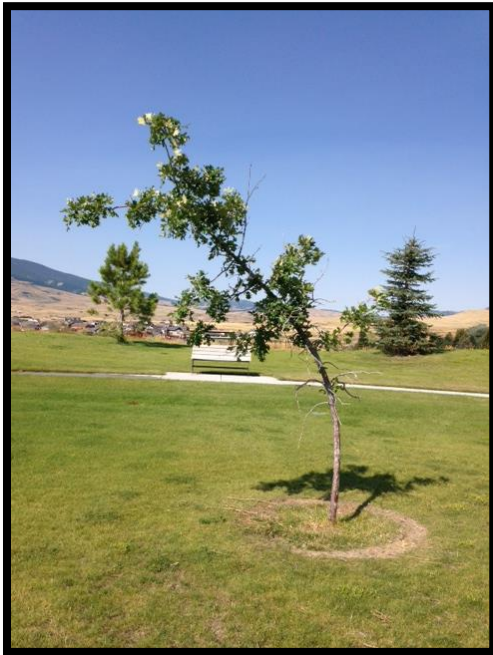
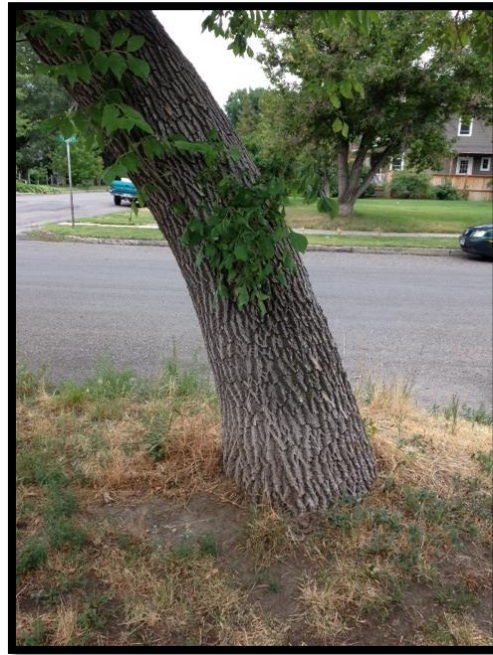
FACTORS AFFECTING RISK RATINGS: TARGET OCCUPANCY RATES

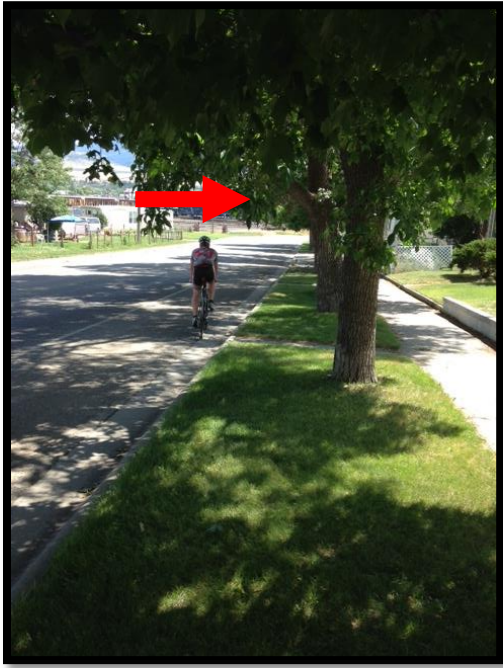
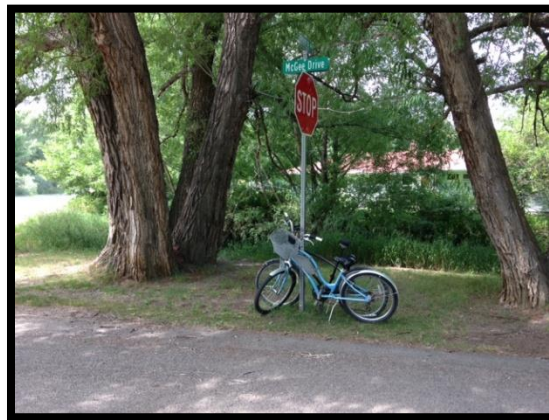
FACTORS ASSOCIATED WITH RISK: ***THE TIME OF SEASON.***  
MOVABLE AND NON-MOVABLE TARGETS
