CITY OF LIVINGSTON, MONTANA  
2014 INVENTORY REPORT OF MUNICIPAL PARK,  
BOULEVARD, AND CEMETERY TREES

Conducted, written, and photographed by:

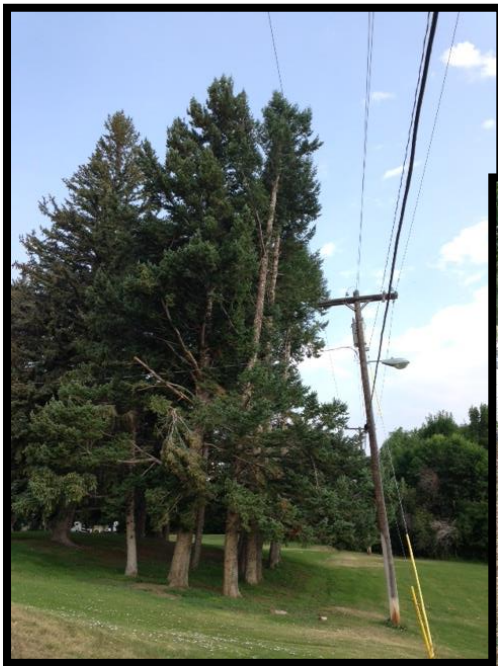
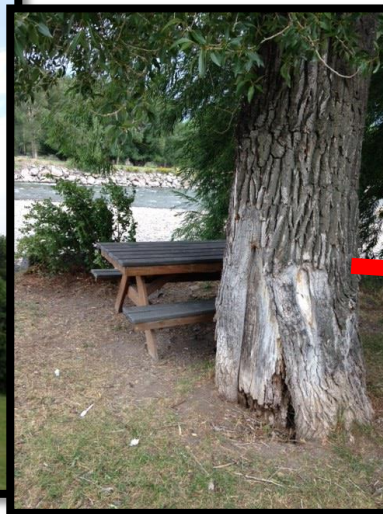
PROBLEMS CREATED BY HAZARD & RISK MITIGATION:  
NEW SIDEWALK INSTALLATION WORK ELIMINATES TRIPPING ON  
UPLIFTED WALKS BUT CONTRIBUTES TO TREE DECLINE BY REMOVING, OR  
DAMAGING TREE ROOT ANCHORAGE, ENERGY RESERVES, AND WATER  
TRANSPORT

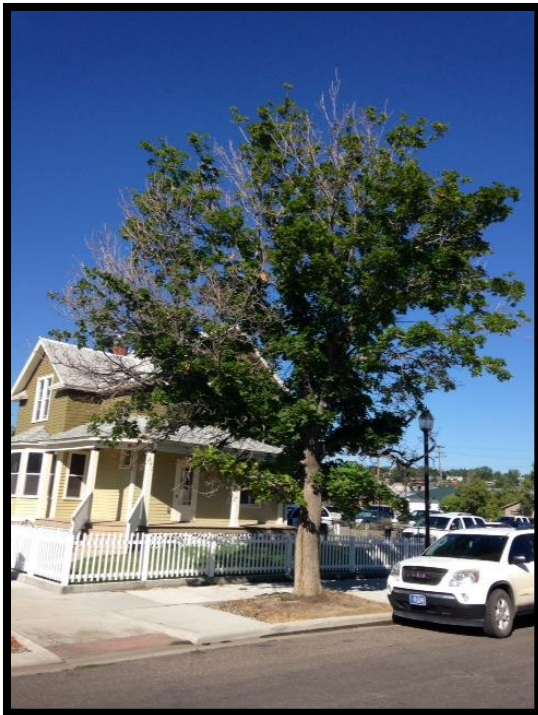
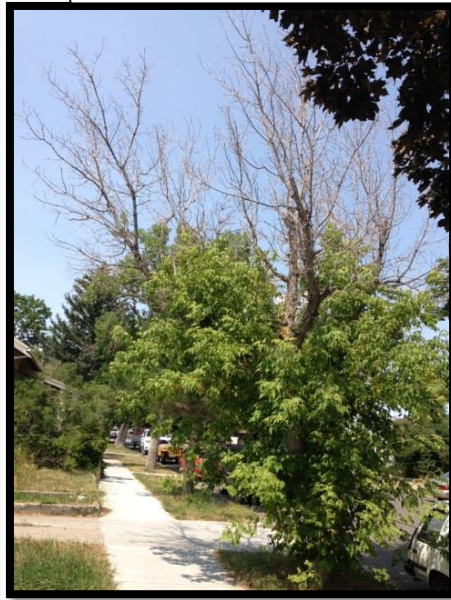
# ANY TREE CAN FAIL AT ANY TIME

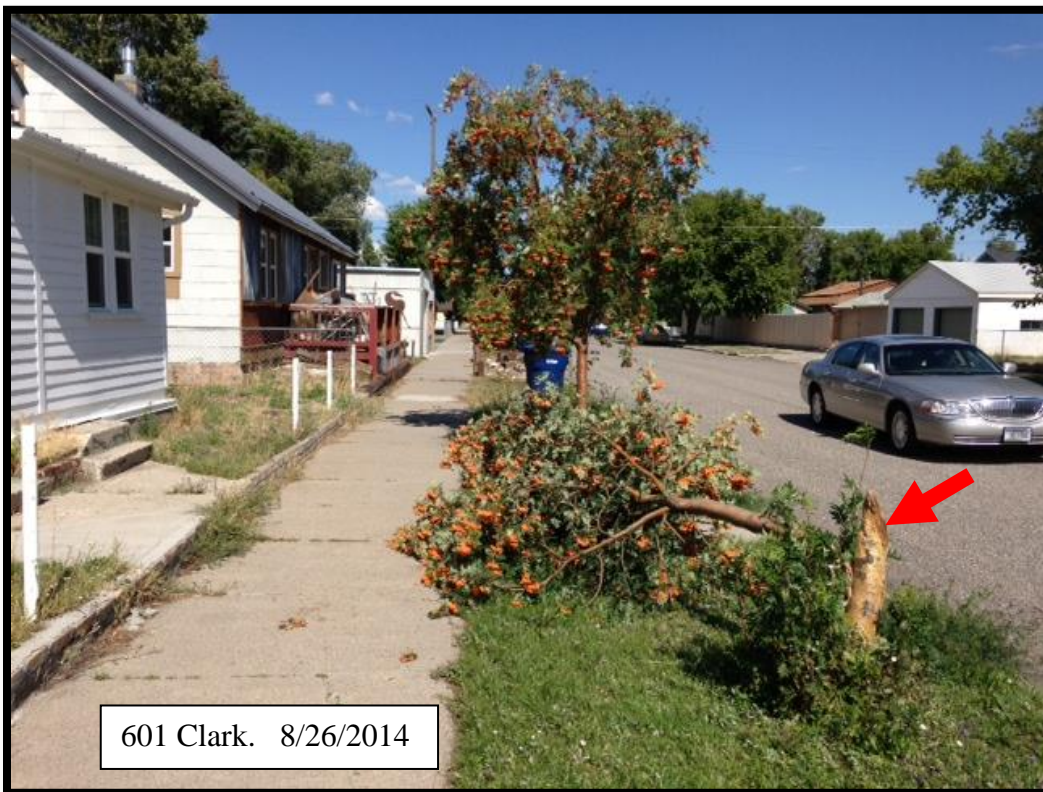
FUTURE BOULEVARD TREE ISSUES:  
CURRENT INSTALLATION OF UNDERGROUND UTILITY LINES HAS CAUSED  
HARM BY CRUSHING, GOUGING, DRYING, AND REMOVING ROOTS

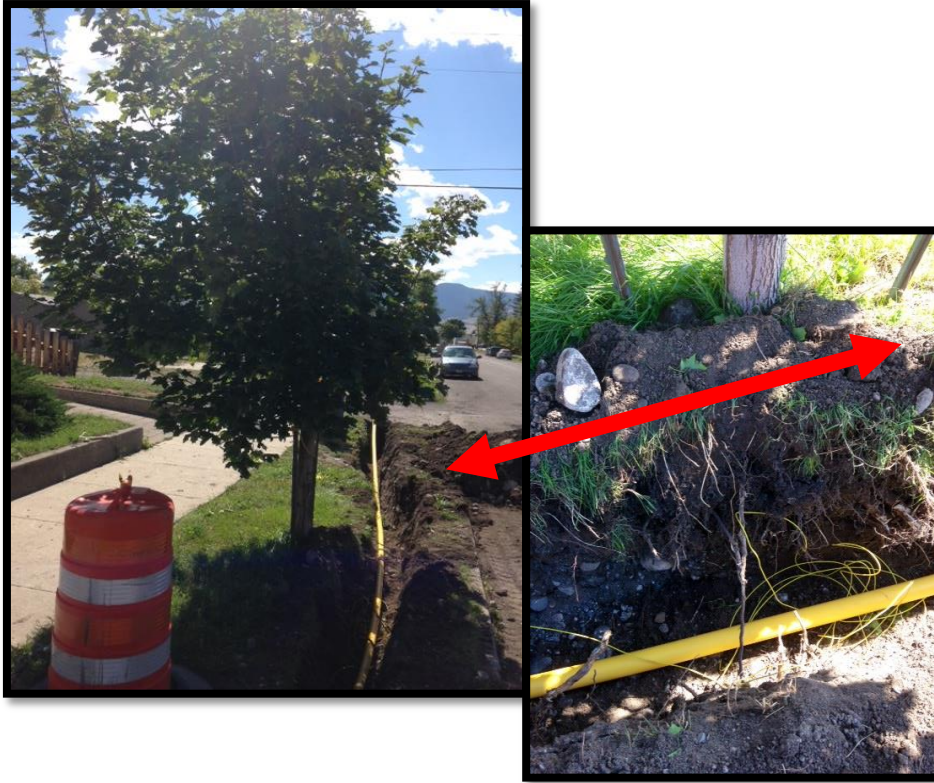
FUTURE RECOMMENDATIONS:  
INTRODUCE NEW TREE SPECIES THAT ARE APPROPRIATE FOR THE  
PLANTING SITE. KEEP OBSERVING EXISTING TREES IN RELATION TO THE MANY  
FACTORS THAT AFFECT THEIR STRENGTH, HEALTH, AND AMENITY VALUES

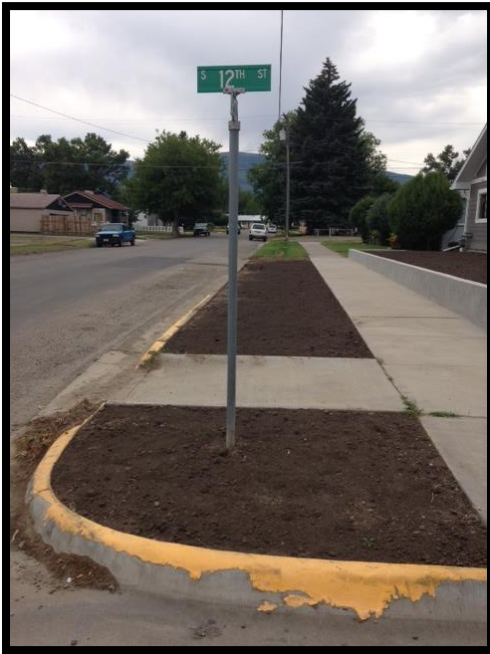
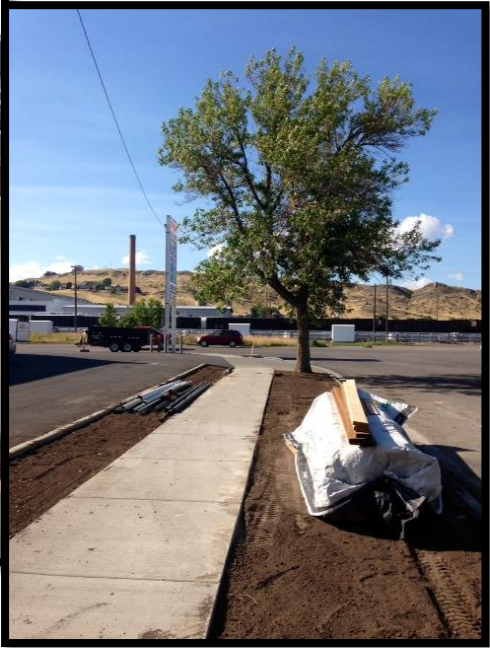
TREES ARE EXPENSIVE – TREES RETURN VALUABLE DIVIDENDS
