Park County Flood History

Upper Yellowstone Hydrology

Park County, Montana

April 29, 2024

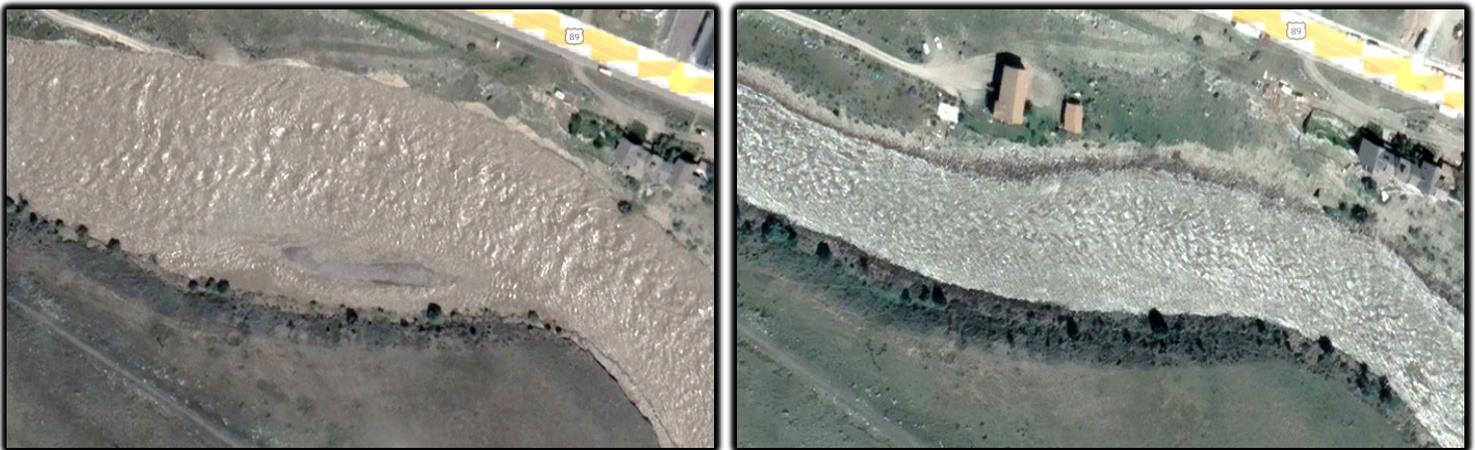
Photograph 3-1 Yellowstone River Flooding 2022 – Gardiner, MT

Caption: A house was undercut and fell into the Yellowstone River as the bank eroded away during the 2022 flood. Image on left is from June 14, 2022. Image on right is from 2019. Source: Google Earth Imagery.

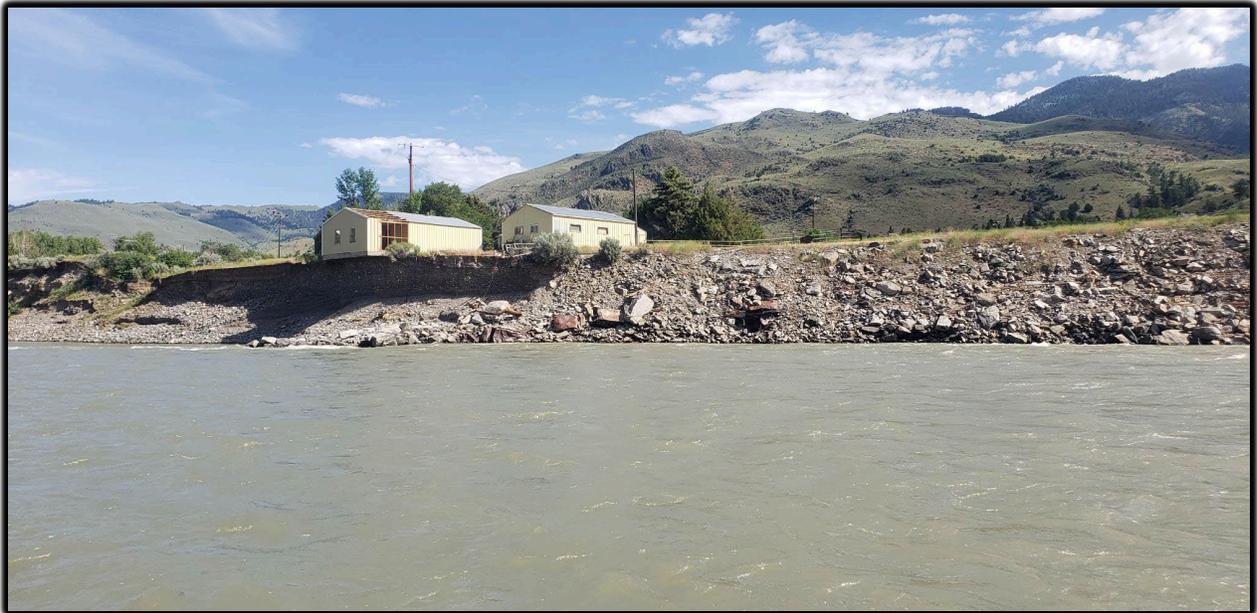
Photograph 3-2 Yellowstone River Flooding 2022 – 989 US Highway 89 South Gardiner, MT

Caption: The Yellowstone River undercut a structure along Highway 89 S near Gardiner, MT during the June 2022 flooding. The structure was still hanging over the edge when the photograph was taken one month after flood waters receded. Source: Pioneer.

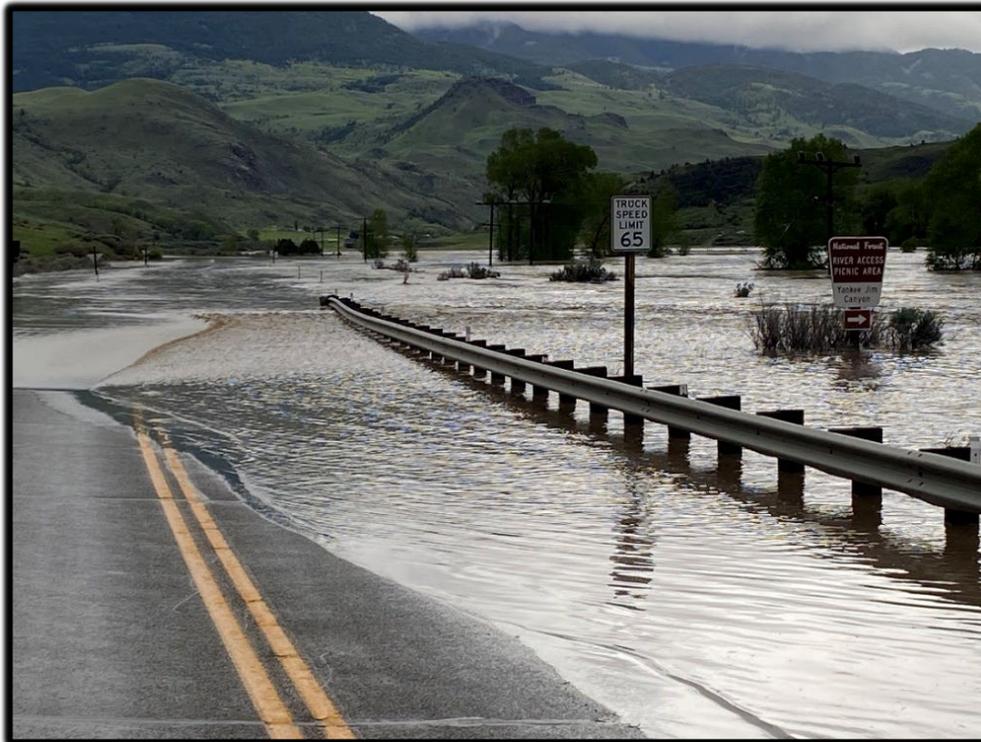
Photograph 3-3 Yellowstone River Flooding 2022 – Yankee Jim Canyon

Caption: Highway 89 South overtopped by the Yellowstone River at the Yankee Jim Canyon River Access site. Source: Park County.

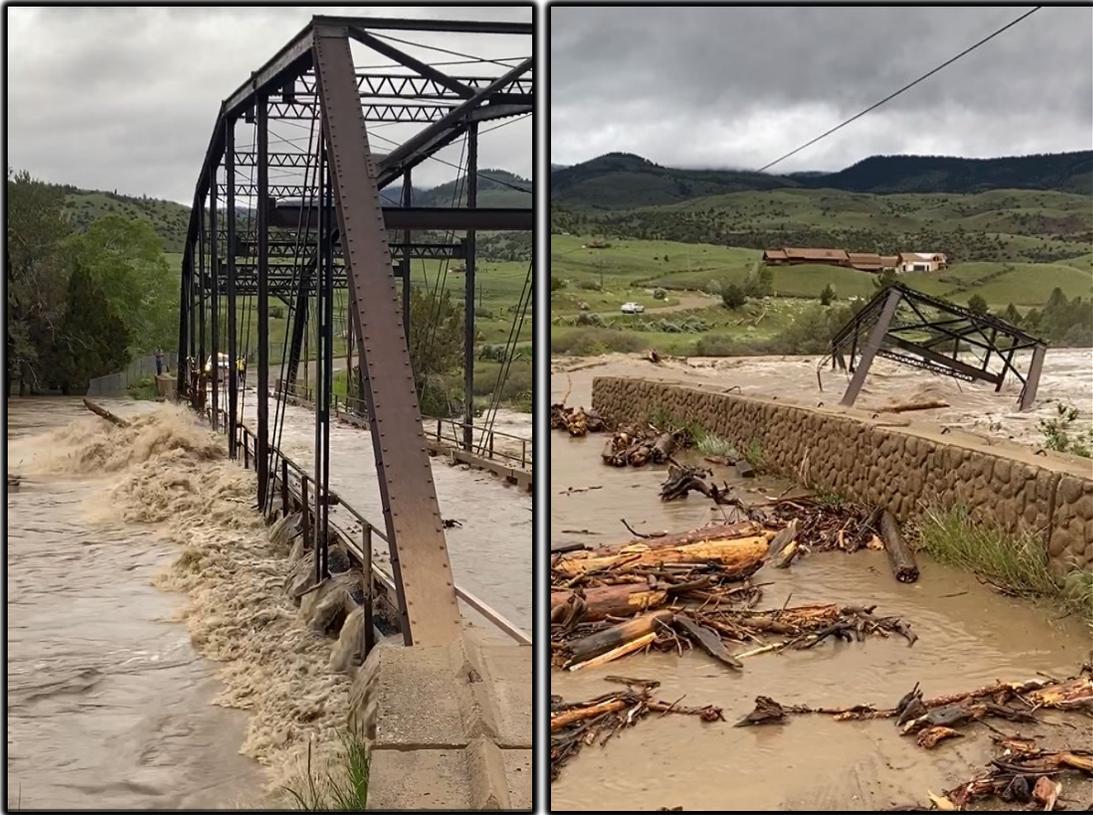
Photograph 3-4 Yellowstone River Flooding 2022 – Carbella Bridge

Caption: Carbella Bridge during the 2022 Yellowstone River flood before and during being washed away. Source: Park County.

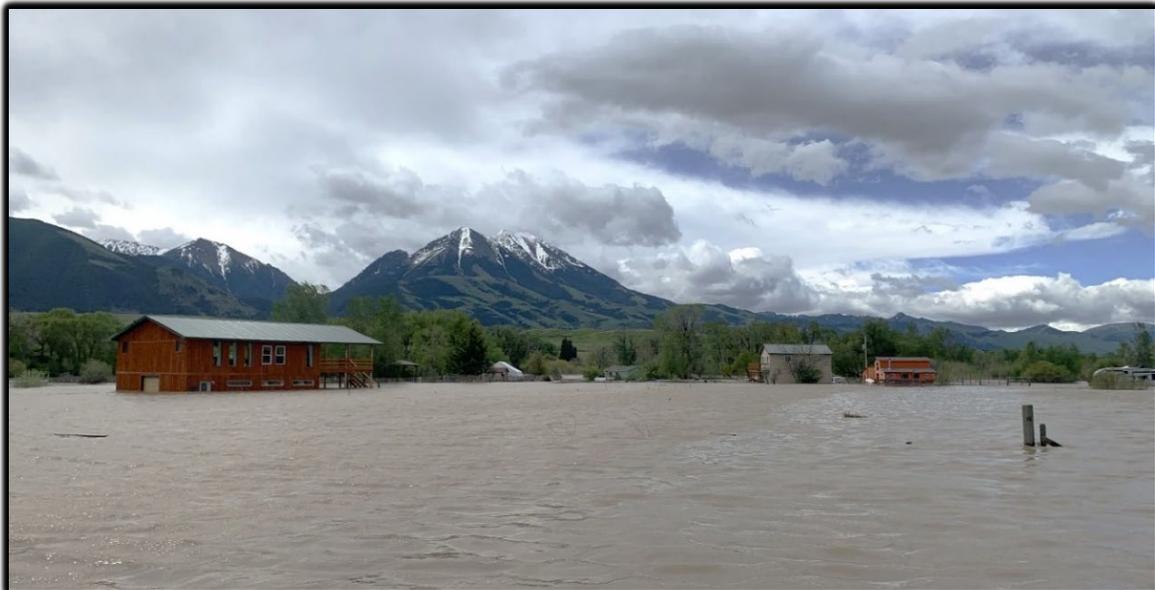
Photograph 3-5 Yellowstone River Flooding 2022 – Emigrant, MT

Caption: Residences and structures just east of the Emigrant Bridge crossing of the Yellowstone River are inundated. Source: Pioneer.

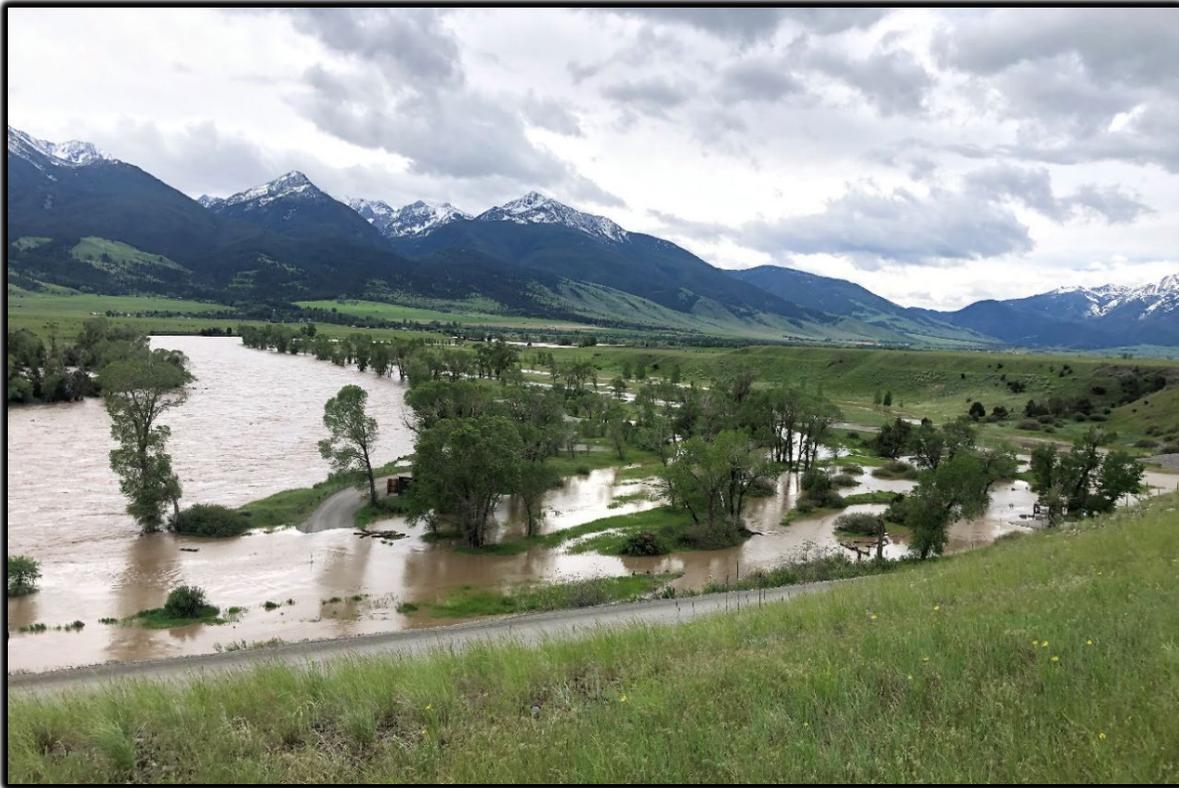
Photograph 3-6 Yellowstone River Flooding 2022 – Mallard’s Rest, Paradise Valley

Caption: Mallard’s Rest fishing access site and campground are inundated by the Yellowstone River. Much of the bank of the Yellowstone River sloughed off, leading to the closure of the site even after flood waters receded. Mallard’s Rest was photographed during the 1997 flood and is shown on Photograph 3-17. Source: Park County.

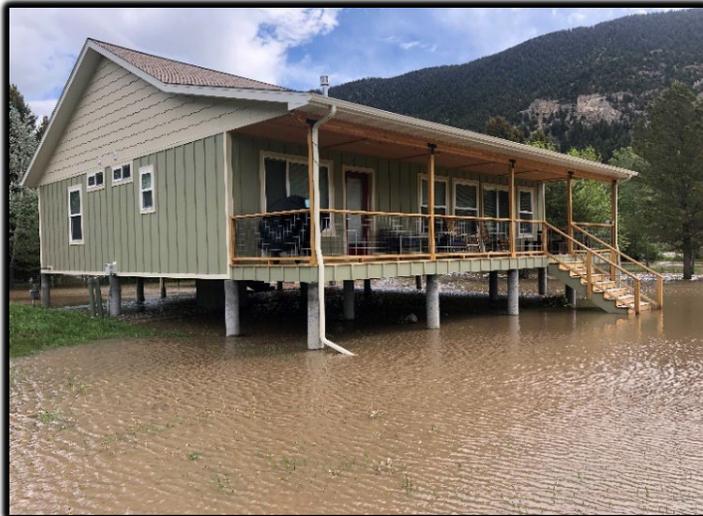
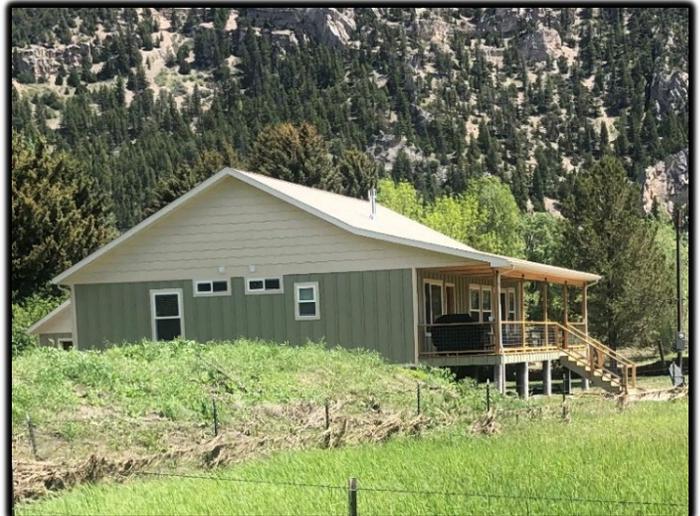
Photograph 3-7 Yellowstone River Flooding 2022 – Evergreen Lane near Carter Bridge

Caption: A residence built along Evergreen Lane off of Highway 89 South near Carter Bridge during and after the 2022 flooding. The residence is located on the banks of the Yellowstone River and avoided inundation due to being built on stilts. Source: Park County.

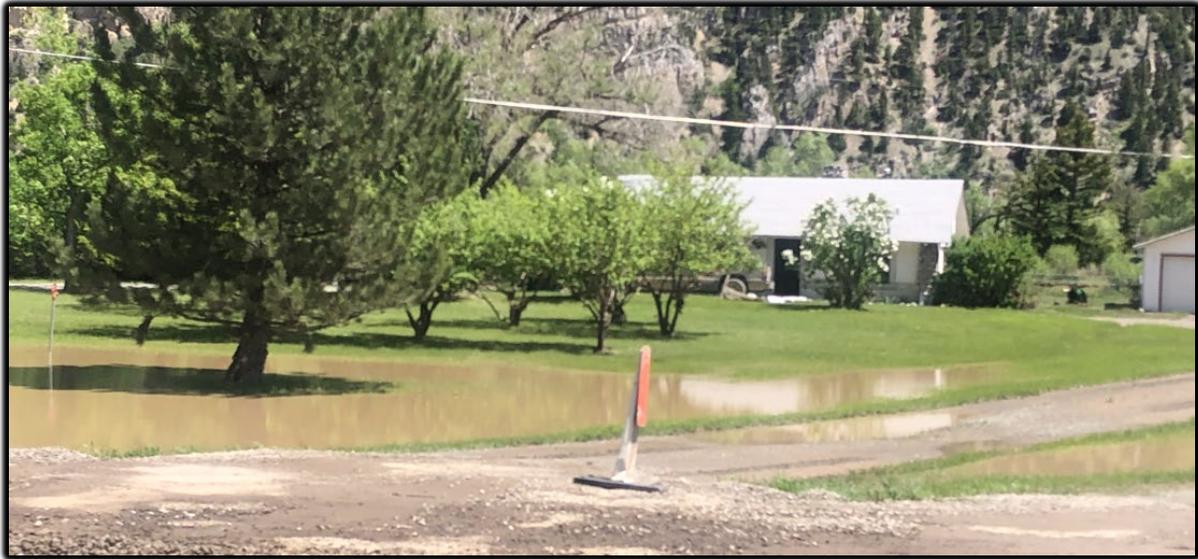
Photograph 3-8 Yellowstone River Flooding 2022 – 5024 Highway 89 South Livingston, MT

Caption: A house just north of Carter Bridge off Highway 89 South is shown after floodwaters receded from the 2022 flood events on June 15, 2022. This home was also photographed during the 1996 flood and is shown on Photograph 3-16. Source: Park County.

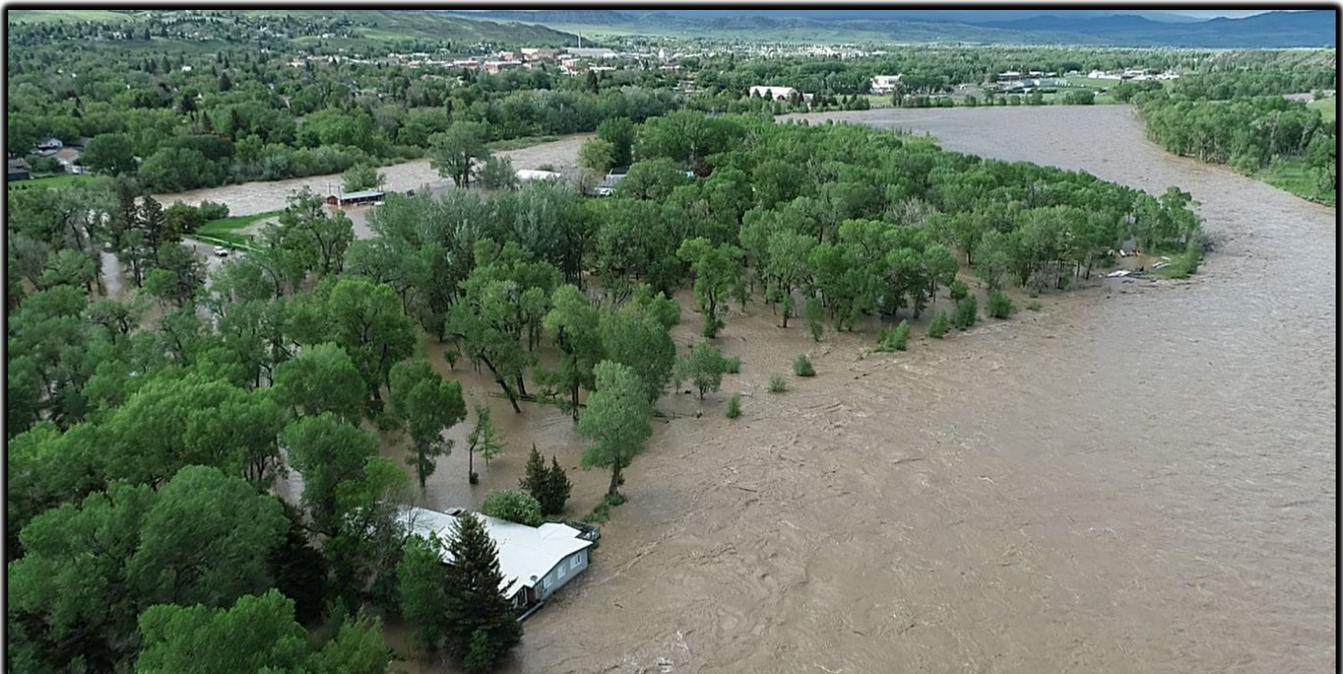
**Photograph 3-9 Yellowstone River Flooding 2022 –
Southern Portion of 9th Street Island Livingston, MT**

Caption: 9th Street Island floods residences on June 13, 2022. Source: DNRC – Still Taken from DNRC Sacagawea to Interstate Bridge video.

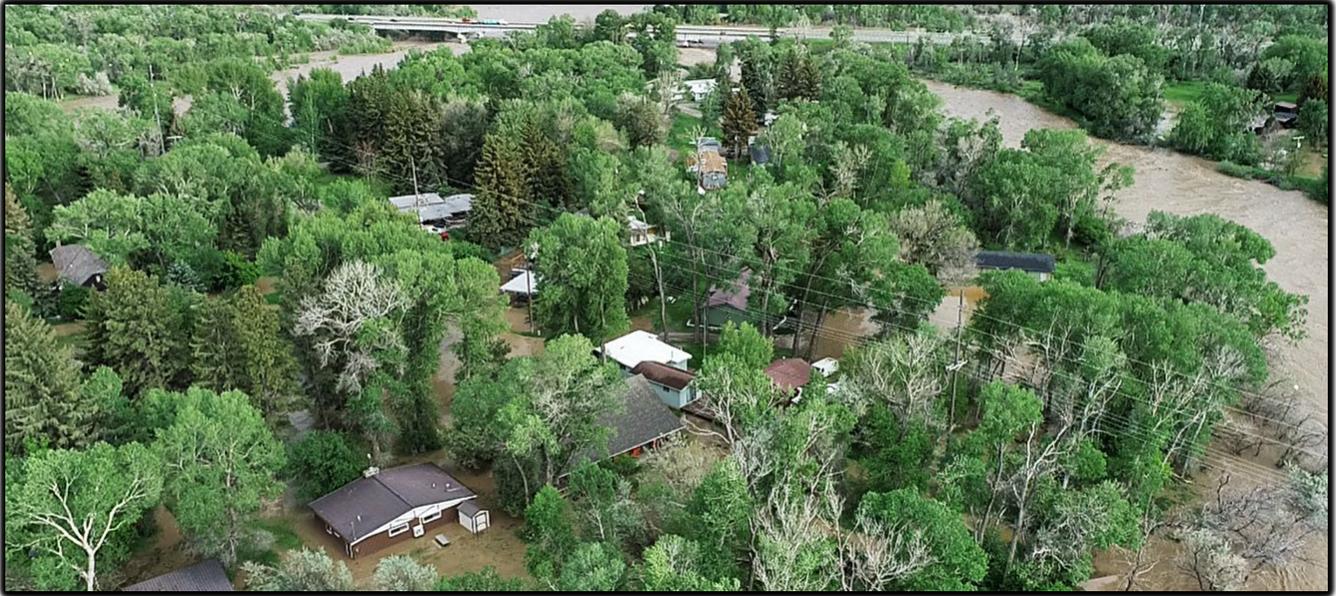
Photograph 3-10 Yellowstone River Flooding 2022 – East Side of 9th Street Island Livingston, MT

Caption: A residence on 9th Street Island is inundated and in direct path of the Yellowstone River on June 13, 2022. Source: DNRC – Still Taken from DNRC Sacagawea to Interstate Bridge video.

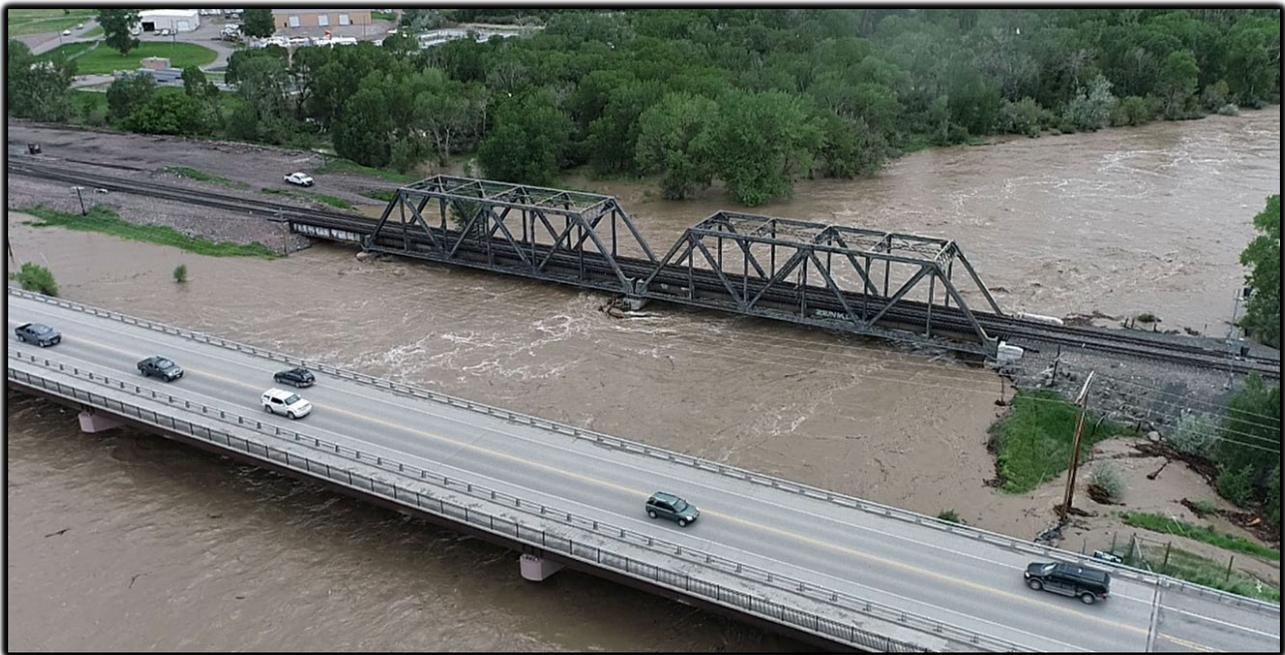
Photograph 3-11 Yellowstone River Flooding 2022 – Veterans Bridge Livingston, MT

Caption: Flood waters rise to almost low chord at Veterans Bridge in Livingston, MT. Source: DNRC's Veterans Bridge Video.

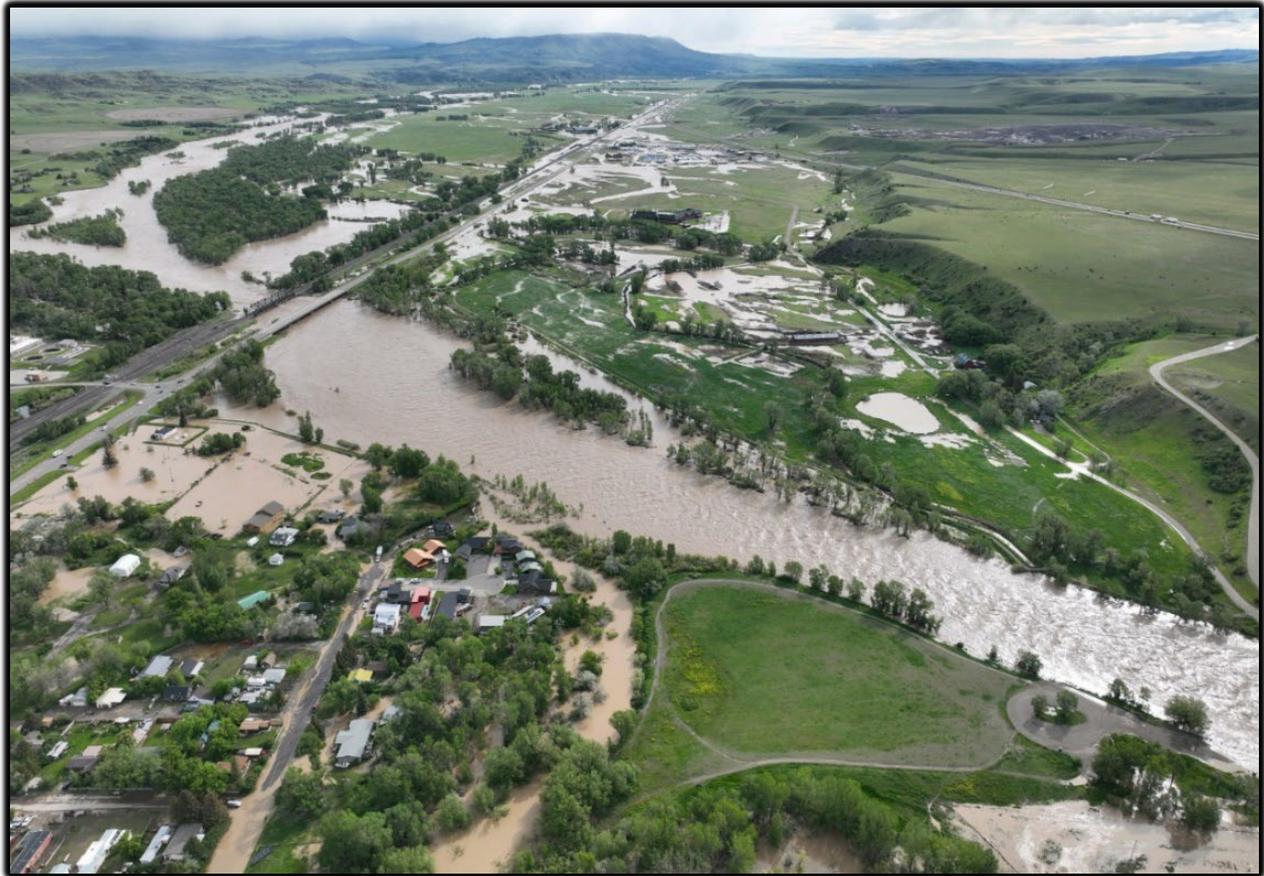
Photograph 3-12 Yellowstone River Flooding 2022 – Livingston, MT Aerial Image

Caption: The Yellowstone River inundates part of Livingston, Montana, on June 13, 2022. In the bottom right of the photograph, Mayor's Landing Fishing Access Site is under water. The hospital is shown near the top of the photograph with flood water surrounding the building. Residences and structures in the bottom left of the photograph between Highway 89 and East Lewis Street see flooding as well. Source: Park County.

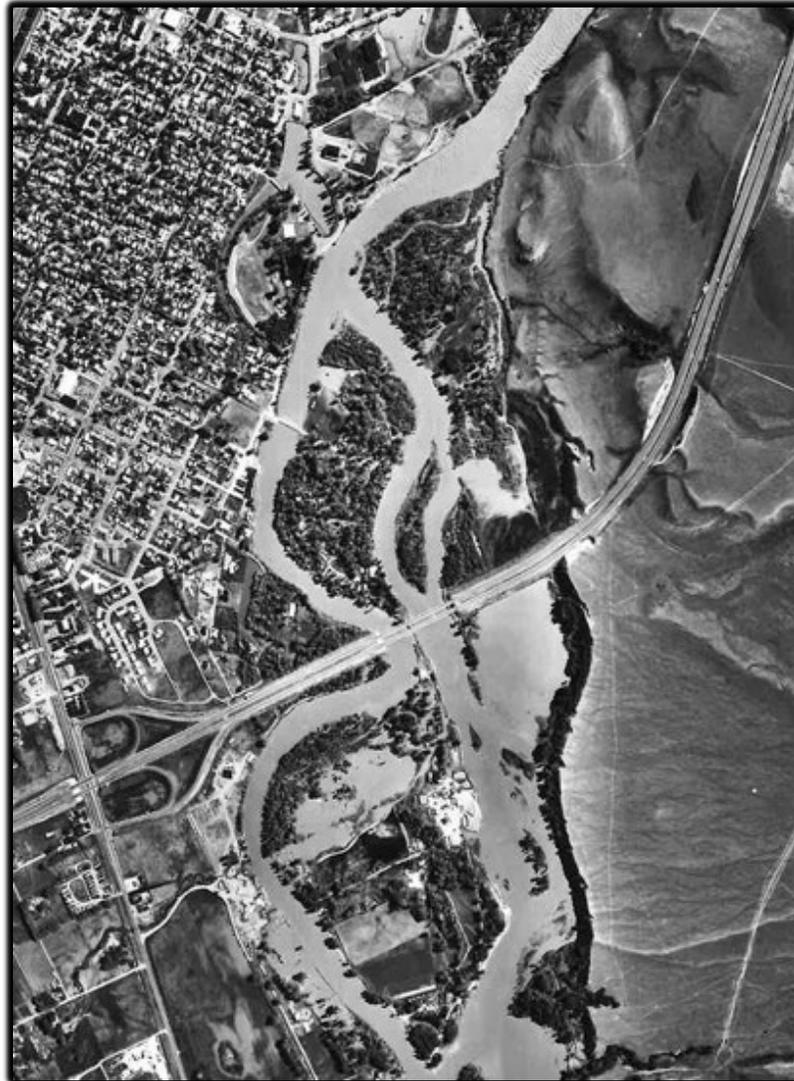
Photograph 3-15 Yellowstone River Flooding 1974 – Livingston, MT

Caption: The Yellowstone River inundated parts of Livingston, Montana, in 1974. Shown on the photograph are the interstate bridges and inundation of both 9th Street Island and Siebeck Island. Source: Park County.

In 1974, the peak flows at gage stations 06192500 Yellowstone River near Livingston, MT and 06191500 Yellowstone River at Corwin Springs, MT were 36,300 and 30,900 cfs, respectively. The peak flows exceeded the current estimated 10-year event at the Livingston gage location, and the 25-year event at the Corwin Springs gage location. The flooding in Livingston inundated much of 9th Street Island and the school football field and track; the 9th Street Island bridge and Vista View Road from the Main Street bridge to the golf course were closed (RESPEC, 2018). An aerial image taken one day after the peak of the 1974 flood event is shown on Photograph 3-15.

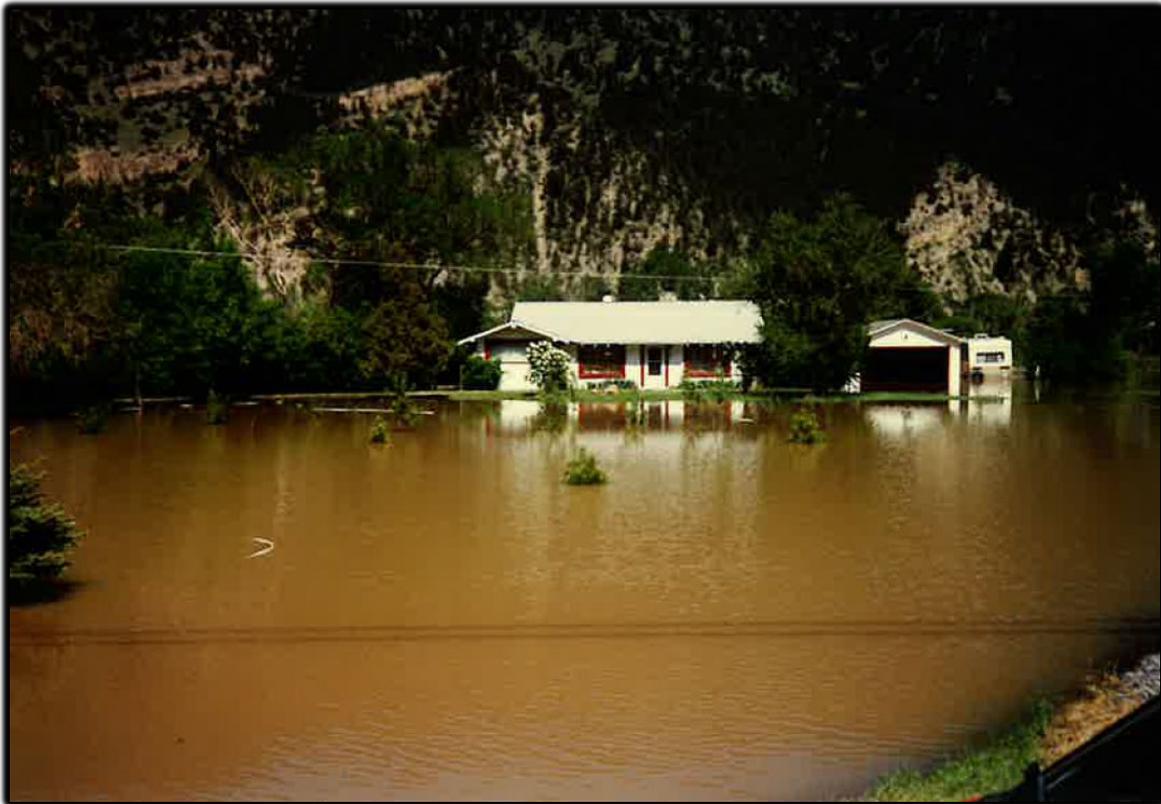
Photograph 3-16 Yellowstone River Flooding 1996 – 5024 Highway 89 South, Livingston, MT

Caption: A house just north of Carter Bridge off Highway 89 South is shown during the 1996 flood. This home was also inundated during the 2022 flood and is shown on Photograph 3-8. after the floodwaters receded. Source: Park County.

In 1996 and 1997, the peak flows at USGS gage 06191500 Yellowstone River near Livingston, MT were measured at 37,100 and 38,000 cfs, respectively. At the time, the floods were considered nearly 100-year events. However, when compared to current AEP peak flood event discharges, these floods were both between a 25-year and 50-year event. The 1996 flood event was the flood of record when it occurred; then a year later, the 1997 flood became the new flood of record. Although the 1997 flood was slightly higher than the 1996 flood, according to Bozeman Daily Chronicle, the 1997 flood led to less damage due to community members preparing for potential flood events. Some of the residents worked together to build temporary dikes to help keep water out of their homes or properties and others cleaned out ditches and filled sandbags (McMillion, 1997). Both floods, despite the flood preparation efforts, led to numerous homes being inundated with floodwater in consecutive years (FEMA, 2021). Flooding of a home during the 1996 flood is shown on Photograph 3-16 and flooding from the 1997 event is shown on Photograph 3-17 and Photograph 3-18.

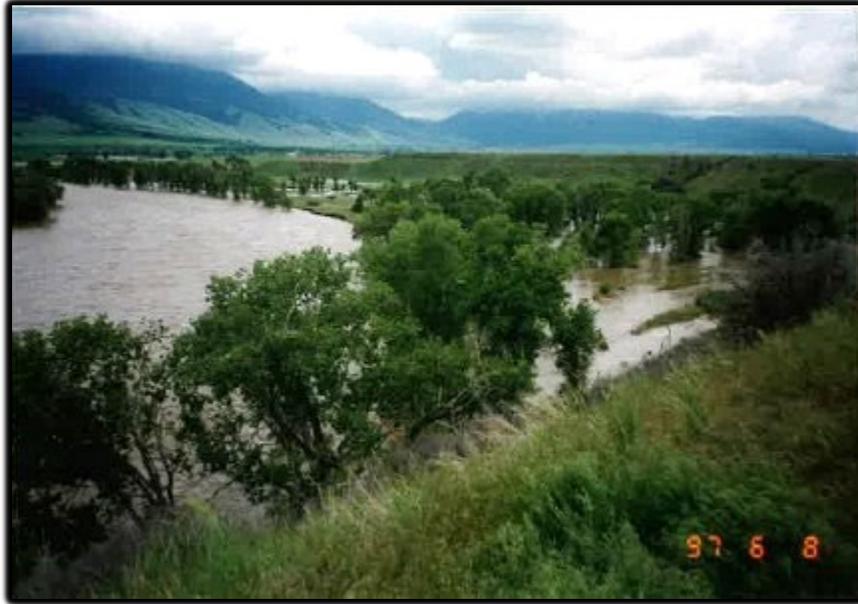
**Photograph 3-17 Yellowstone River Flooding 1997 –
Mallard’s Rest Fishing Access Site**

Caption: Mallard’s Rest Fishing Access Site is inundated with floodwaters during the 1997 Yellowstone River Flooding. A similar photograph was taken during the June 2022 flooding and is shown on Photograph 3-6. Source: Park County.

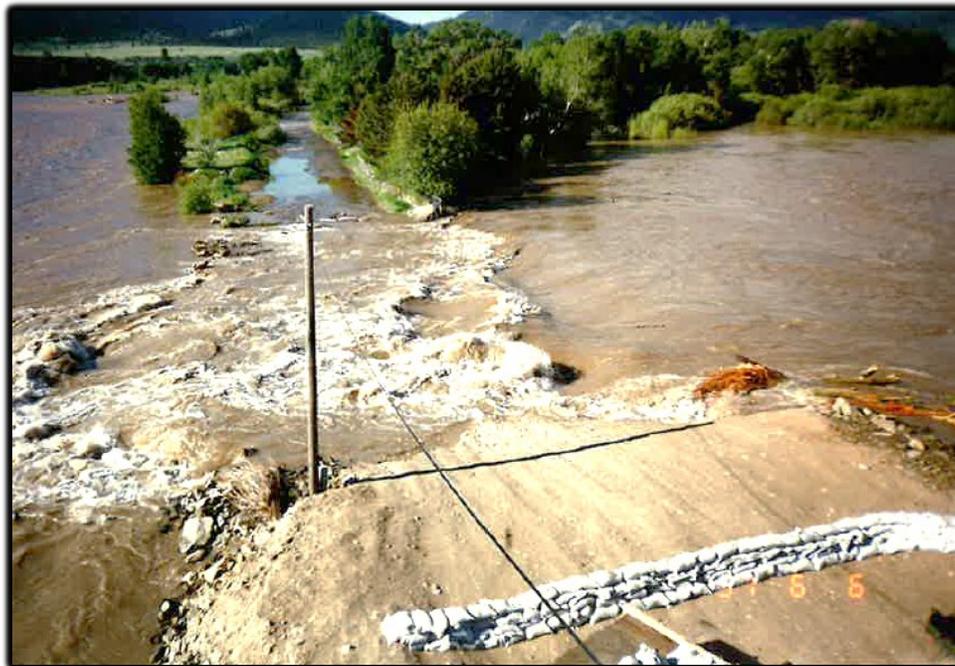
**Photograph 3-18 Yellowstone River Flooding 1997 –
9th Street Island Drive to Siebeck Island**

Caption: The road to Siebeck Island via 9th Street Island Drive was overtopped and washed out during the 1997 flood. Source: Park County.

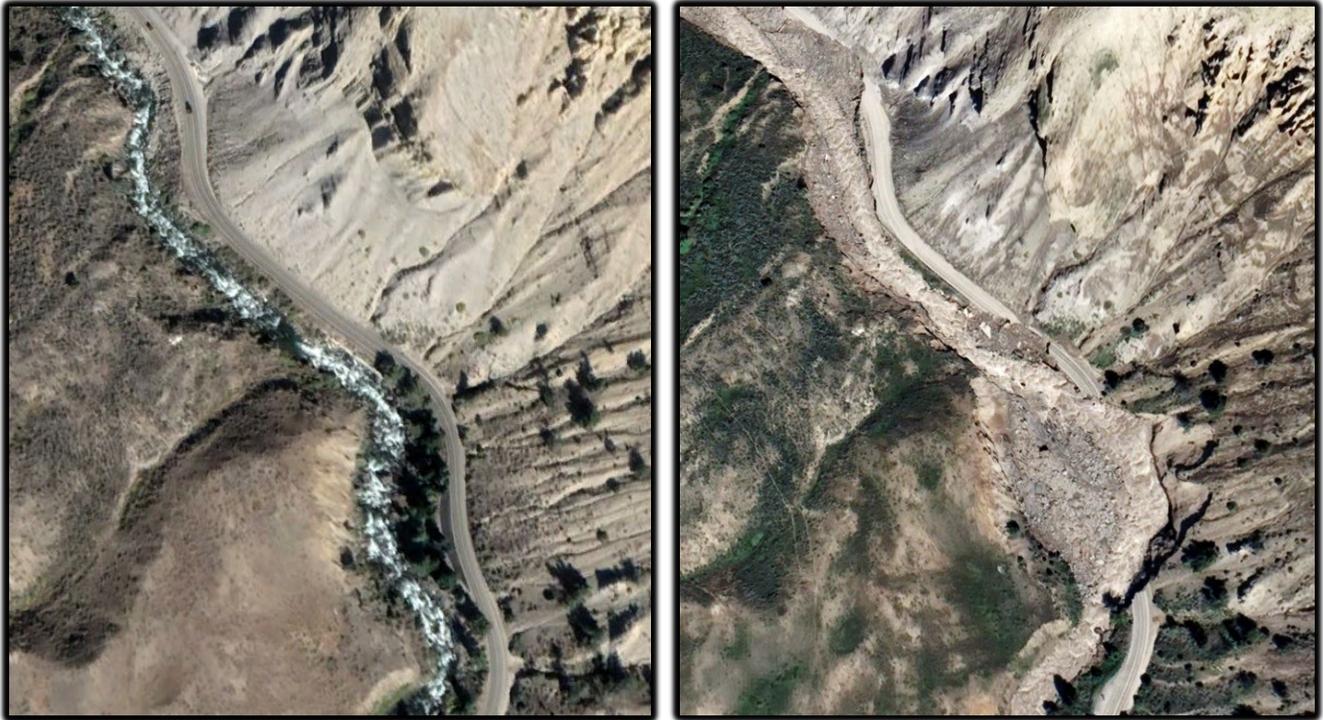
Photograph 3-19 Gardner River Flooding 2022 – Highway 89

Caption: Highway 89 South between Gardiner, Montana, and Mammoth, Yellowstone National Park, Wyoming, at the 45th parallel is washed away by the 2022 Gardner River flood. The image on the left is from 2019 and the image on the right is from 2022. Source: Google Earth Imagery.

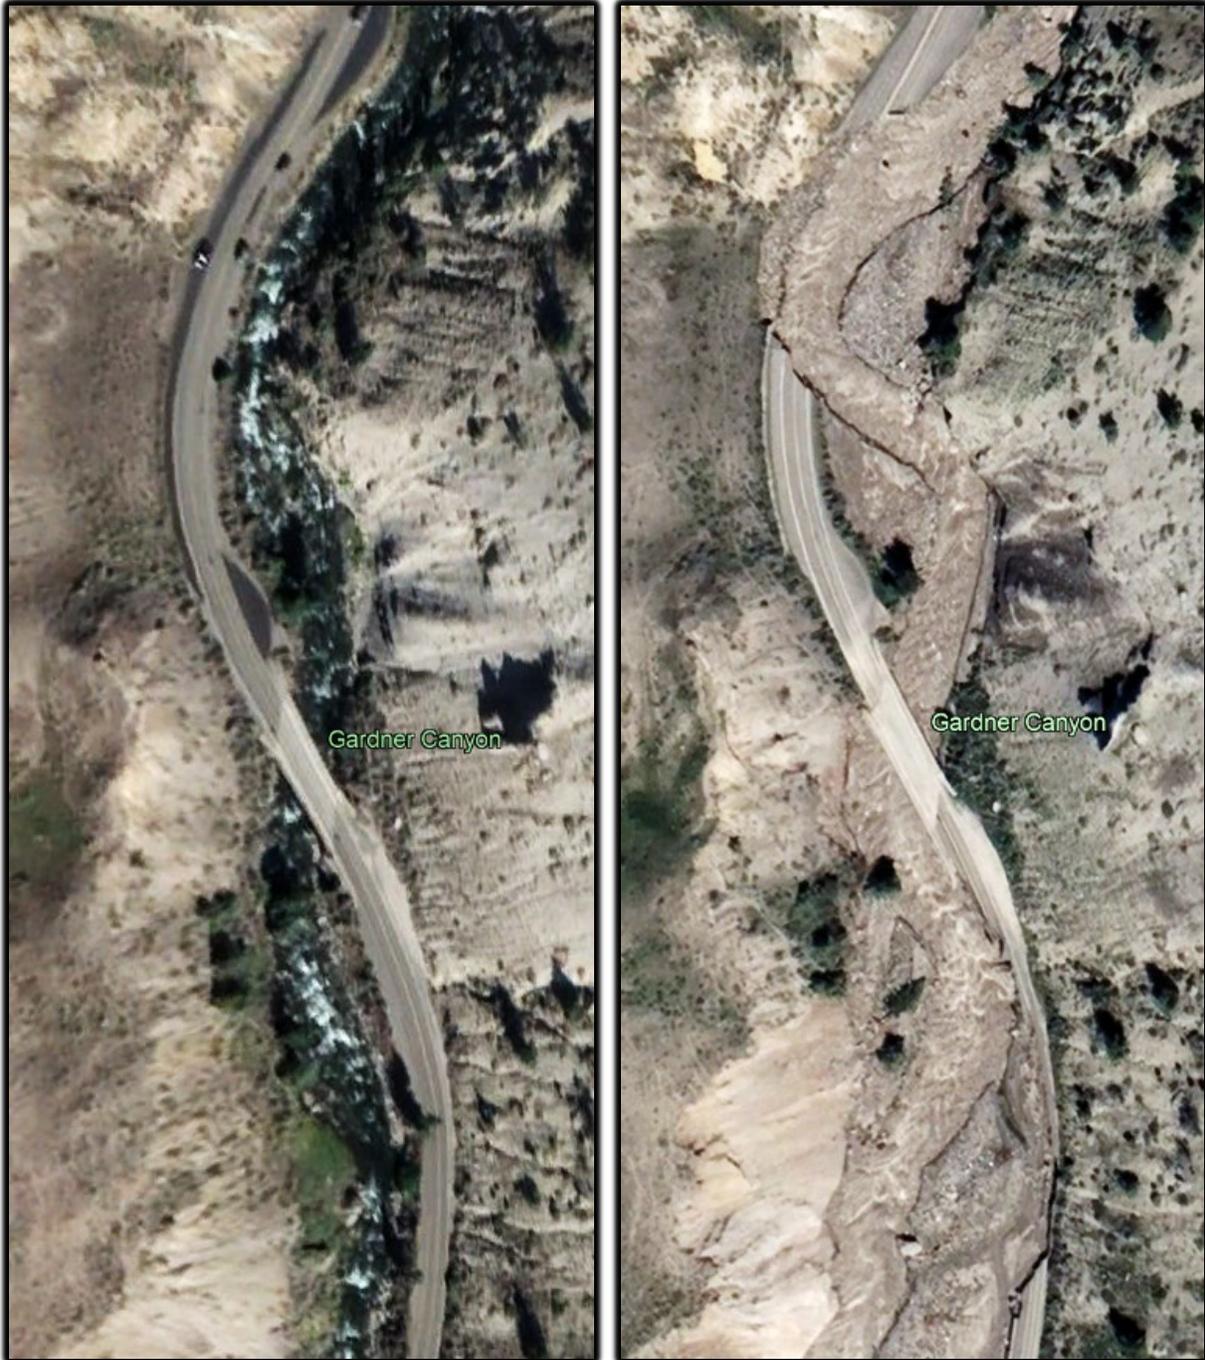
Caption: Highway 89 S between Gardiner, Montana, and Mammoth, Yellowstone National Park, Wyoming, south of Rescue Creek trailhead is washed away by the Gardner River 2022 flood. The image on the left is from 2019 while the image on the right is from 2022.

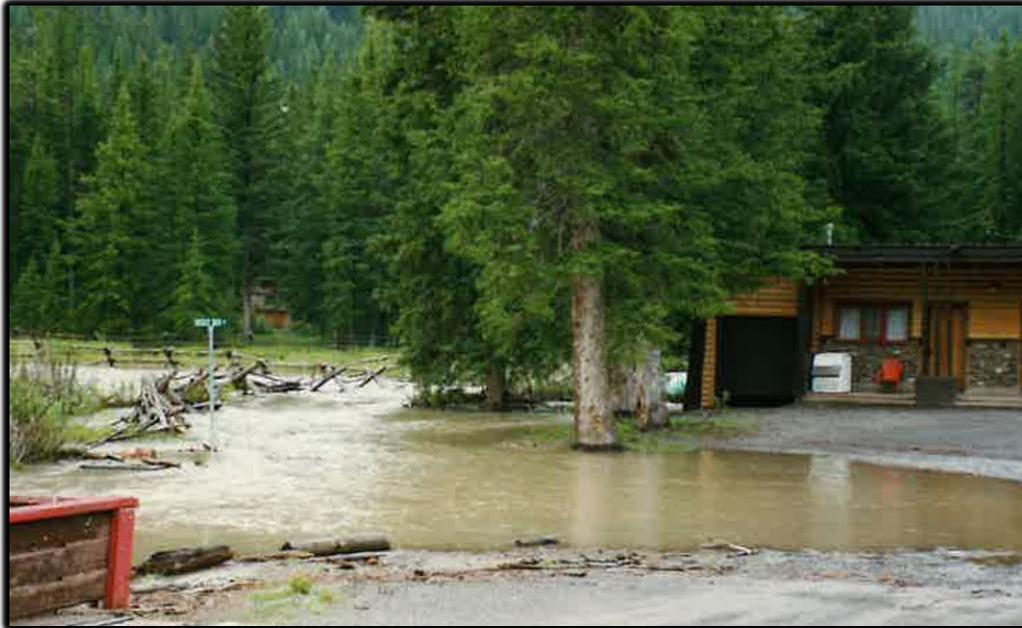
Photograph 3-21 Soda Butte Creek Flooding 1997 – Grizzly Lodge Silver Gate, MT

Caption: Grizzly Lodge surrounded by June 1997 floodwaters in Silver Gate, Montana. Source: Park County.

No historical or photographic documentation of the recorded 2010, 2011, or 2020 Soda Butte Creek flooding was found during the flood history investigation. Limited documentation of flooding occurring along Soda Butte Creek in Cooke City and Silver Gate, Montana, in both 1996 and 1997 was found; however, the Soda Butte Creek USGS gage station was not active during the floods. Therefore, a peak flow value is not associated with the flooding. Photographs from the 1997 flood event are shown on Photograph 3-21 through Photograph 3-24.

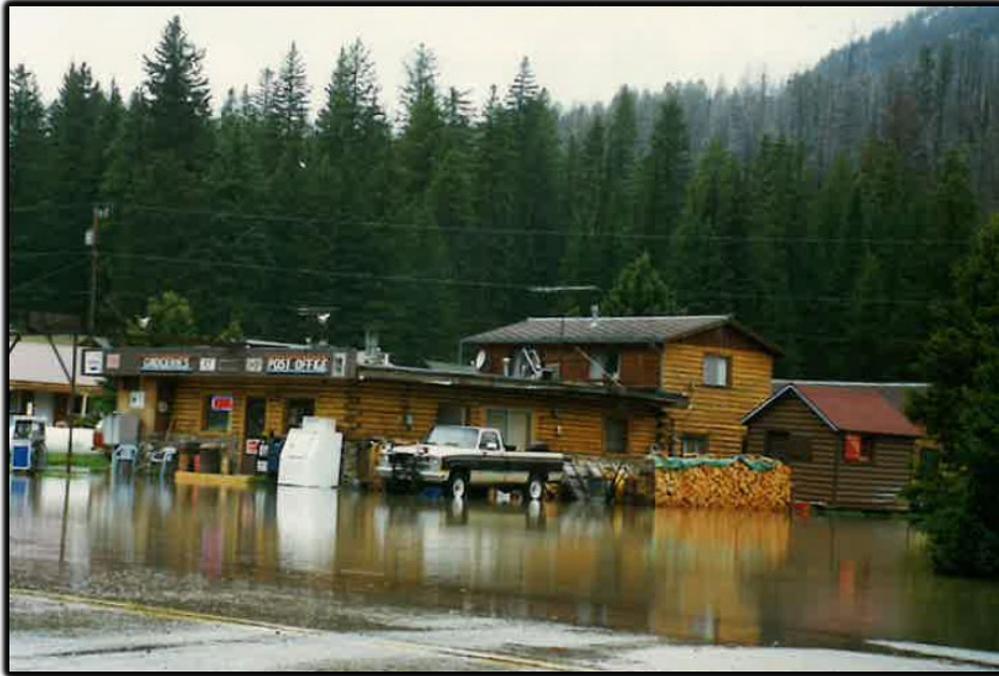
**Photograph 3-23 Soda Butte Creek Flooding 1997 –
Convenience Store Silver Gate, MT**

Caption: Convenience store in Silver Gate, Montana, is surrounded by 1997 floodwaters.
Source: Park County.

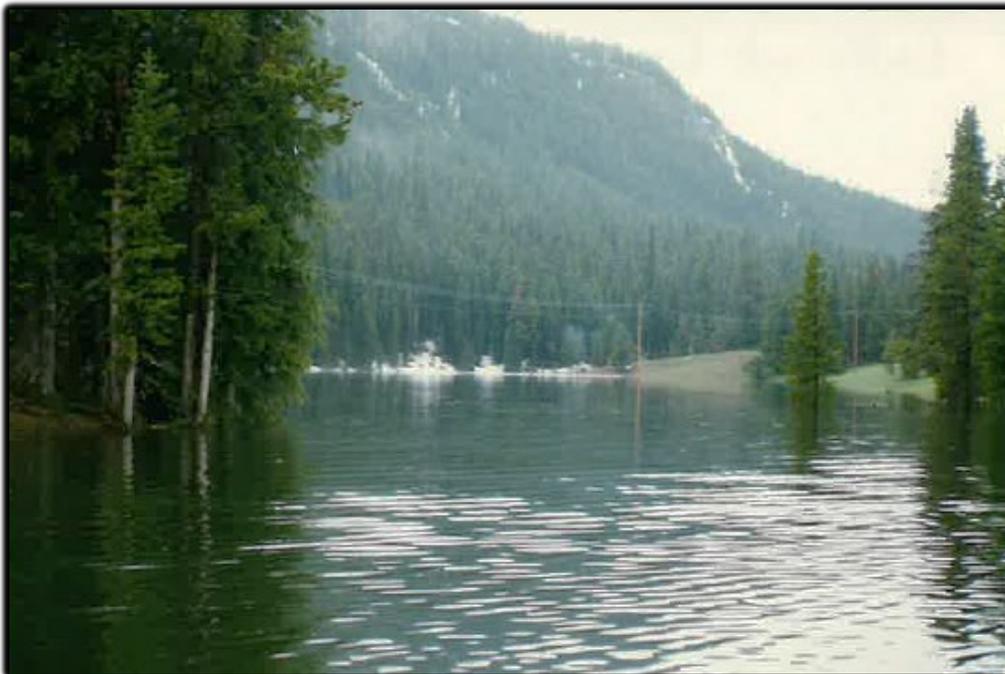
Photograph 3-24 Soda Butte Creek Flooding 1997 – Cooke City, MT

Caption: Flooding near Colter Pass outside of Cooke City in 1997. Source: Park County.

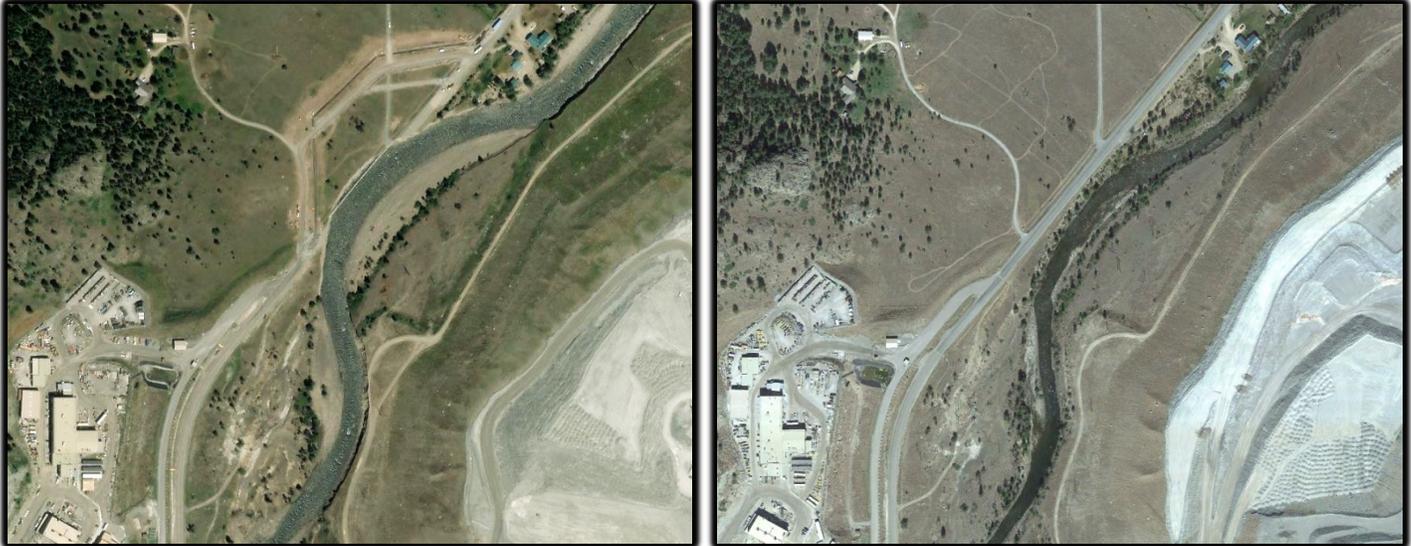
Caption: Nye Road at the Sibanye – Stillwater Mine was washed away by the Stillwater River in June 2022.
Sources: Left: Esri Imagery post 2022 flooding. Right: 2015 Google Earth.

There was limited to no damage from the Stillwater River flooding in Park County. However, downstream on the Stillwater River in Stillwater County, severe damage was reported and is

shown on Photograph 3-25. No flood photographs of the Stillwater River in Park County were found corresponding to flood events.

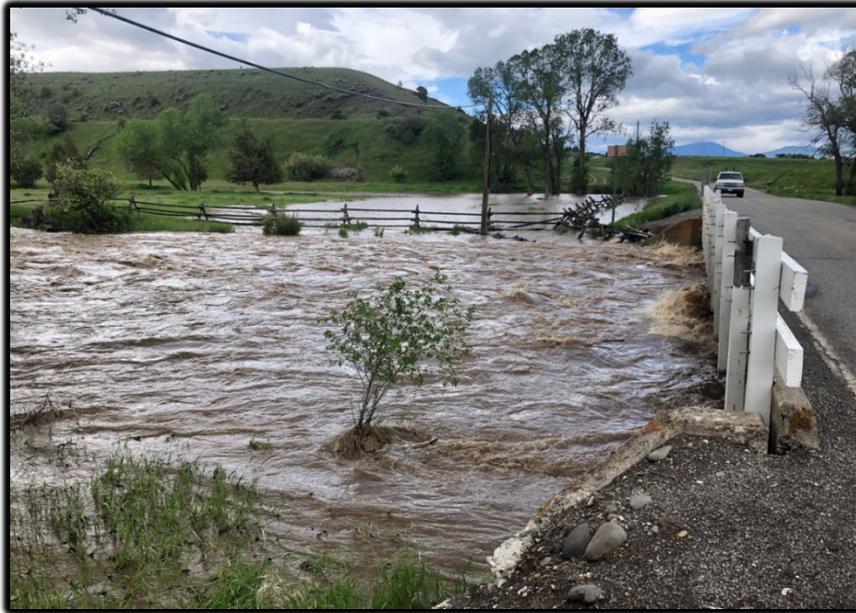
Photograph 3-26 Mill Creek Flooding 2022 – East River Road

Caption: Mill Creek spills over its banks on June 13, 2022, but does not overtop East River Road. Source: Park County.

Mill Creek, like many of the streams and rivers in southwest Montana, flooded during June 2022. Near the Mill Creek - Yellowstone River confluence, the Park County Sheriff's Office reported flooding of Burnside [Lane] along Mill Creek the day of the flooding (Park County Sheriff's Office, 2022). In the foothills, Mill Creek overflowed its banks upstream of East River Road, but it was not reported to have overtopped East River Road. Mill Creek at East River Road is shown on Photograph 3-26. Higher in the mountains, the bridge connecting Snowbank Campground in the Absaroka Mountains to Mill Creek Road was washed out, and damage to Mill Creek Road West Fork was reported due to West Fork Mill Creek flooding (Miller & Rosenbaum, 2023). West Fork Mill Creek is a major tributary to Mill Creek.
