Park County Flood History

Upper Yellowstone Hydrology

Park County, Montana

April 29, 2024

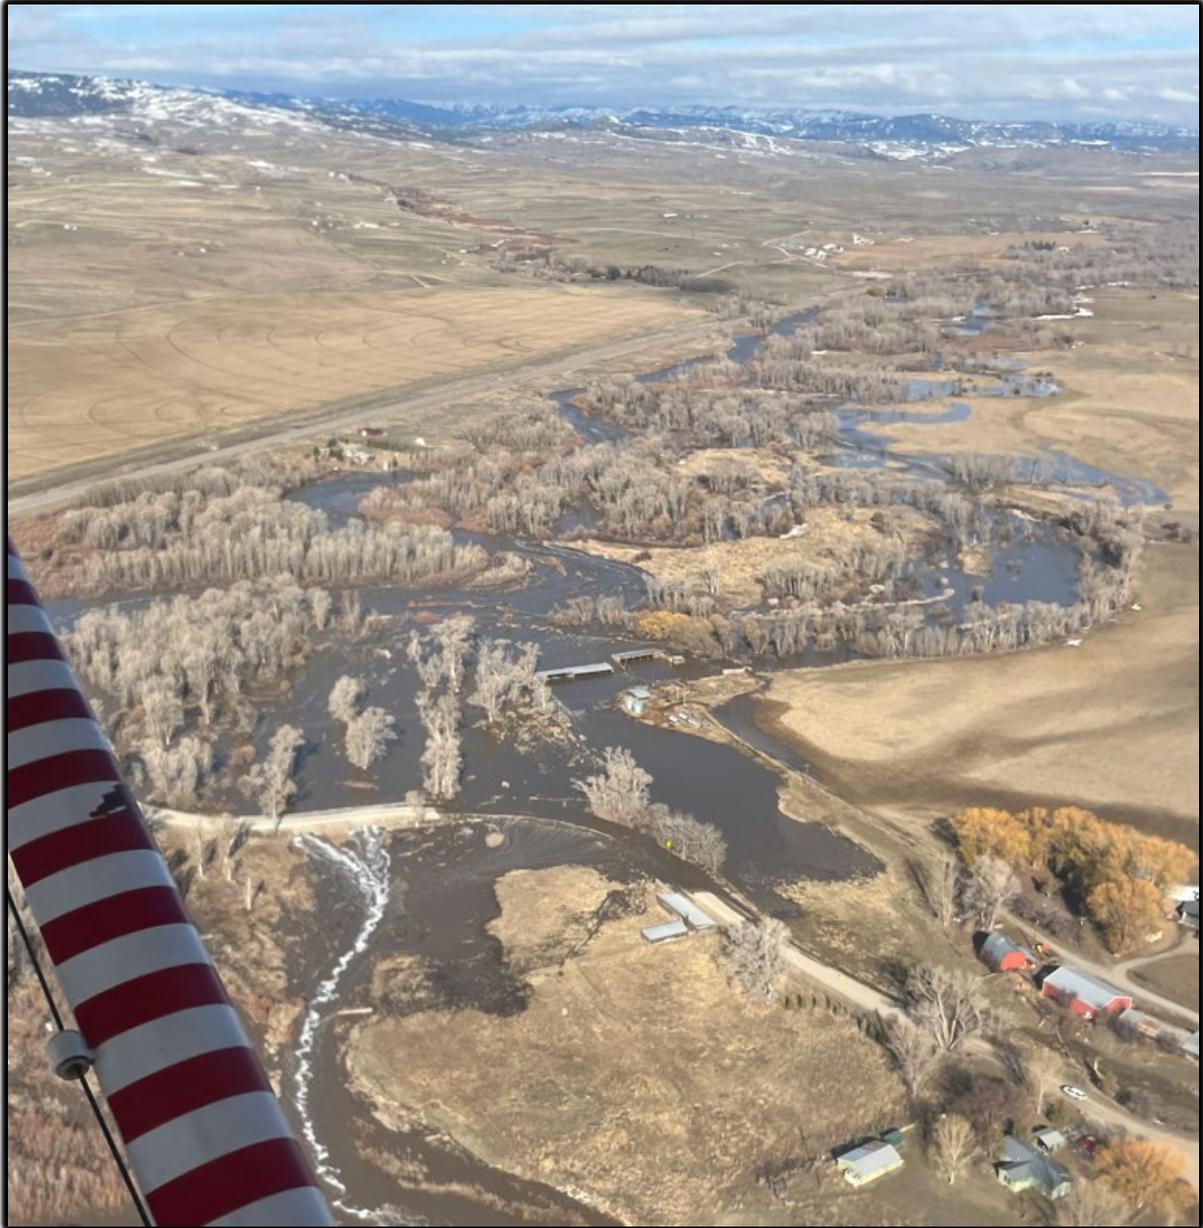
Photograph 3-27 Shields River Flood 2023 – Fiddle Creek Road

Caption: Shields River overtops Fiddle Creek Road in 2023 and inundated structures. Source: Lawson Moorman, Park County.

The 2023 flooding of the Shields River and its tributaries overtopped roads, inundated and damaged homes, bridges, and agricultural lands as a result of low elevation rapid snow melt. The Park County Public Works Director, Matt Whitman, estimated the cost of damages near \$240,000 (Batura, 2023). Although extreme flooding occurred in the Shields River Valley in 2023, the only active USGS gage, the Shields River near Livingston, MT gage station on the Shields River was damaged or malfunctioned, and discharge at the time of the flooding was not able to be measured. However, according to the Park County, Montana, Facebook page, the Shields River peaked at 6.02 feet on April 12, 2023 (Park County, 2023a) and the USGS has a provisional estimated daily mean average of 3,830 cfs at the Shields River near Livingston gage station listed for April 12, 2023. When comparing the peak height of 6.02 feet and the estimated daily average mean of 3,830 cfs, the 2023 flood peak discharge was likely around 4,000 cfs. An estimated peak discharge of 4,000 cfs would put the 2023 Shields River flooding event between a 10-year and a 25-year event, below the flood of record, which was recorded in 1979 and had a peak gage height of 6.8 feet and peak discharge of 5,600 cfs. Three aerial photographs from the 2023 Shields River flood are shown on Photograph 3-27 through Photograph 3-29.

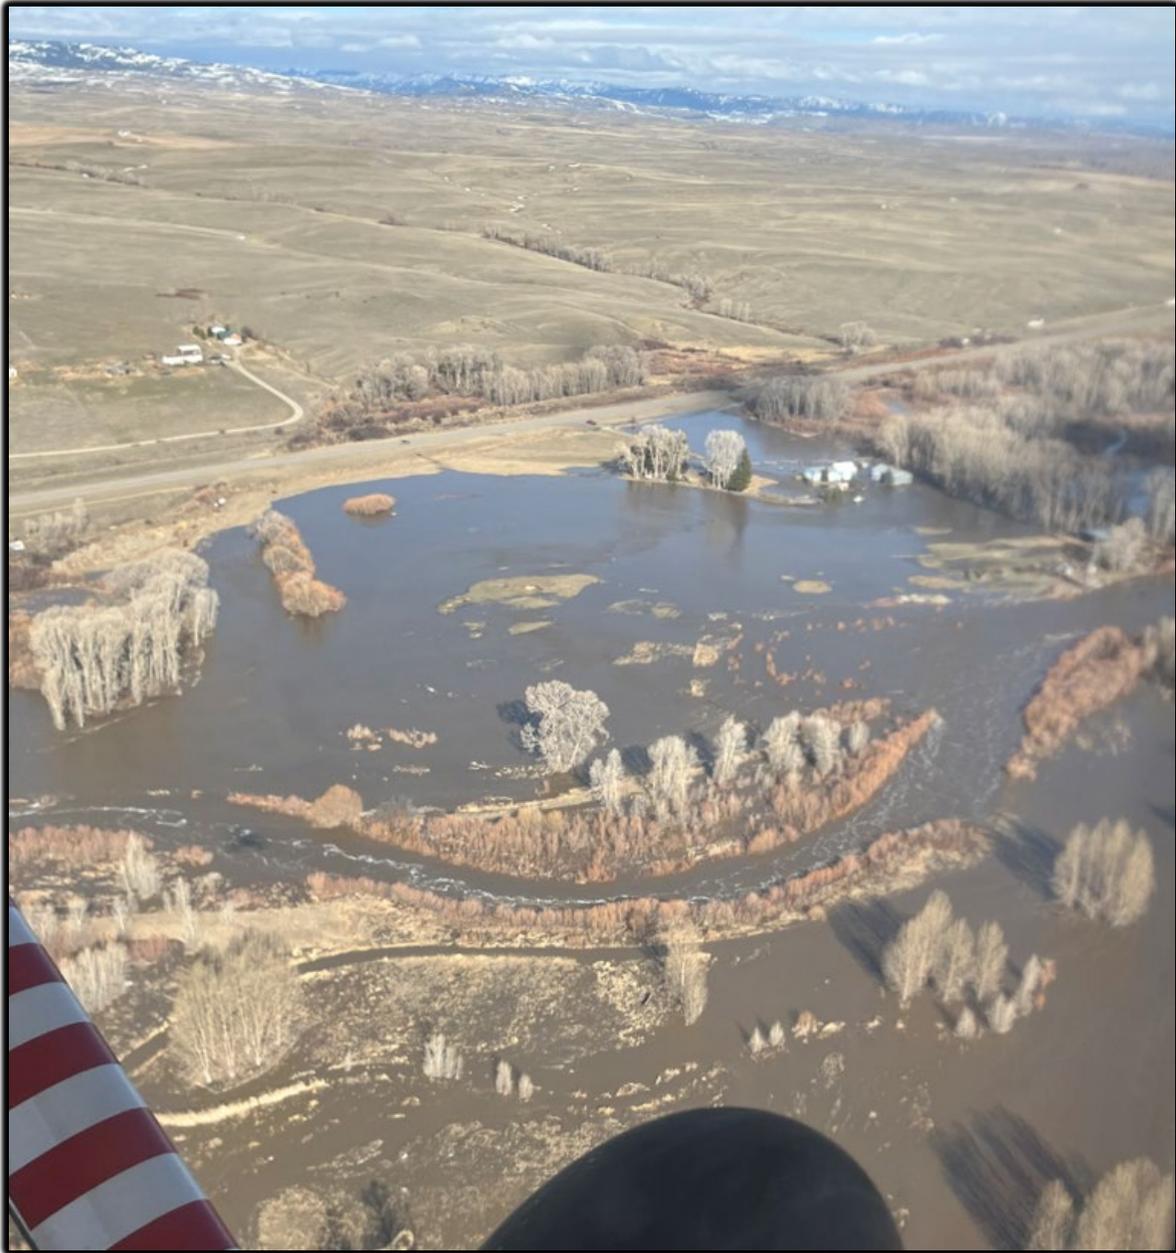
Photograph 3-28 Shields River Flood 2023 – 618 US Highway 89 North Livingston, MT

Caption: Shields River 2023 flooding inundates structures and agricultural land. Source: Lawson Moorman, Park County.

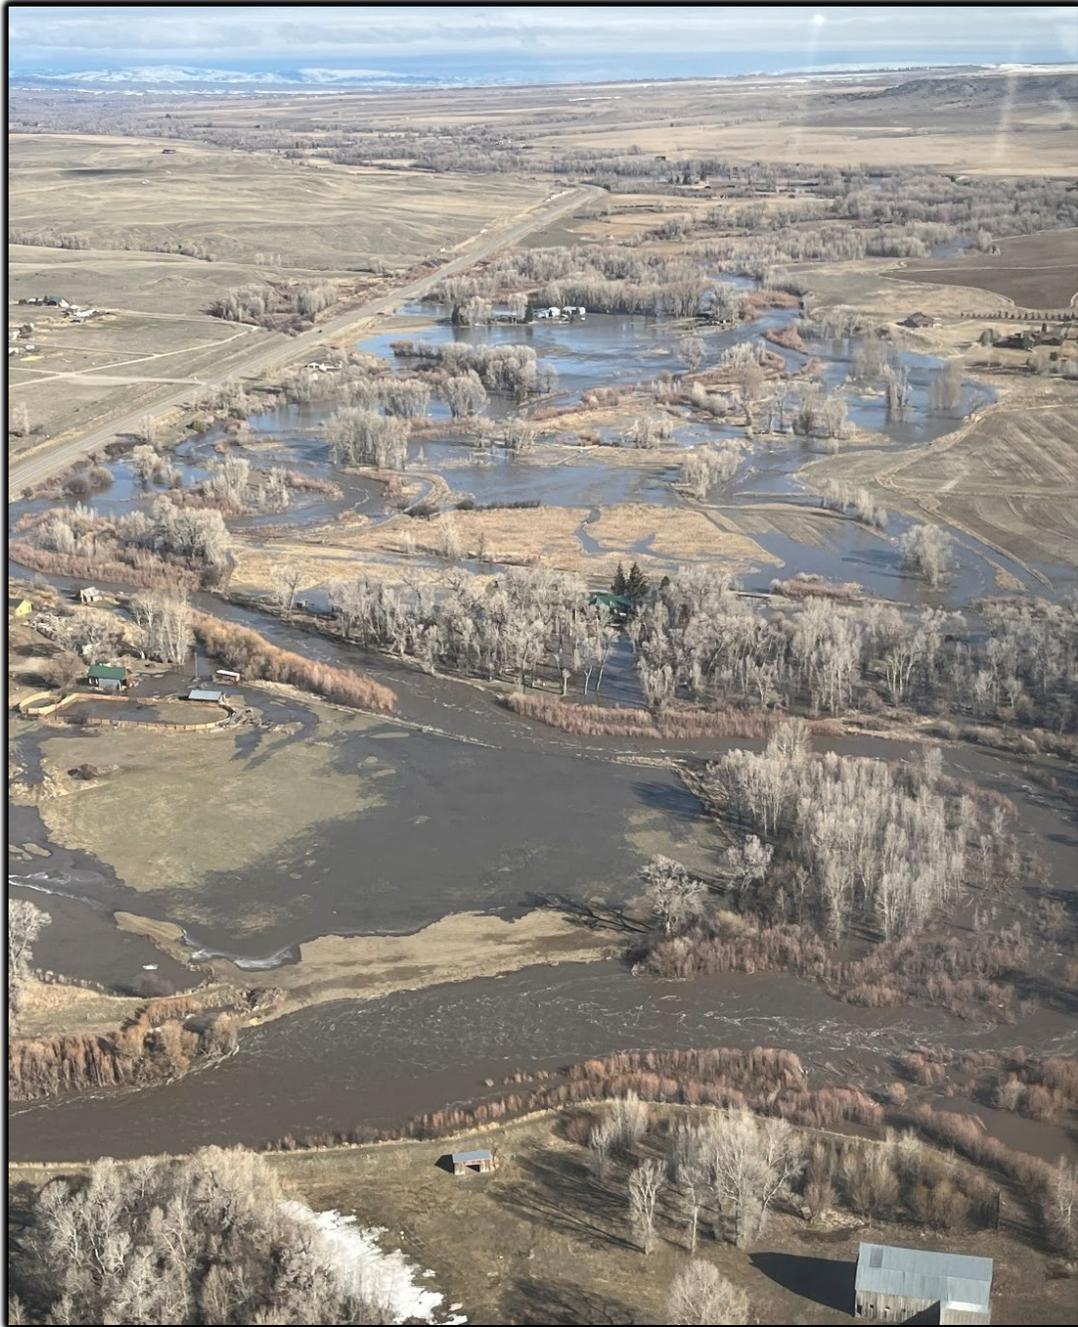
Photograph 3-29 Shields River Flood 2023 – 548 US Highway 89 North Livingston, MT

Caption: Shields River 2023 flooding inundates land and structures. Source: Lawson Moorman, Park County.

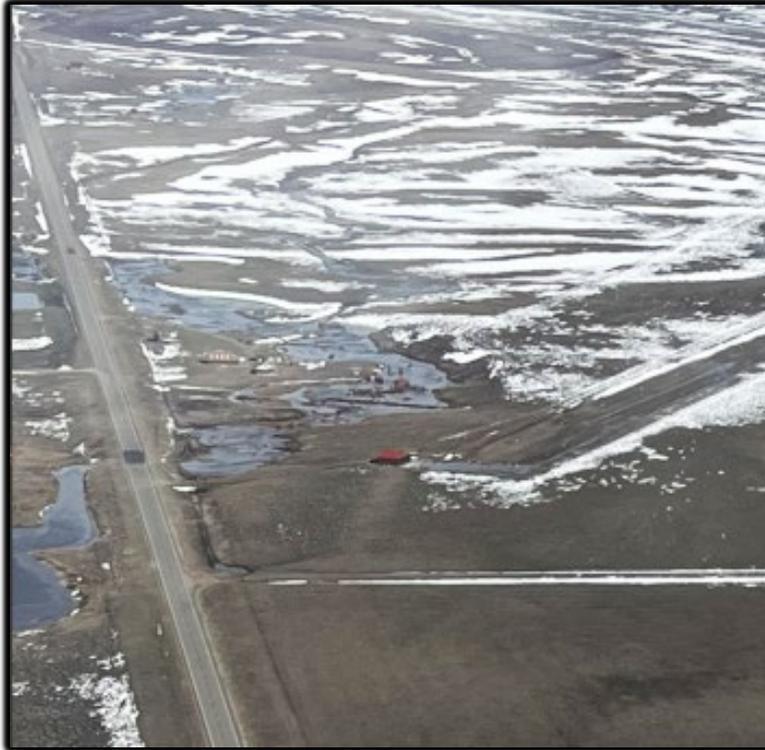
**Photograph 3-34 Cottonwood Creek B Flooding 2023 –
West of Wilsall Airport along US Highway 89**

Caption: Cottonwood Creek B floods in April 2023 along US Highway 89 near the Wilsall Airport. The upper portion of Cottonwood Reservoir is shown in the bottom left of photograph. Source: Lawson Moorman, Park County/ DNRC.

[- YouTube](#). Photograph 3-34 shows the inundation of Cottonwood Creek B near the Wilsall Airport upstream of Cottonwood Dam.

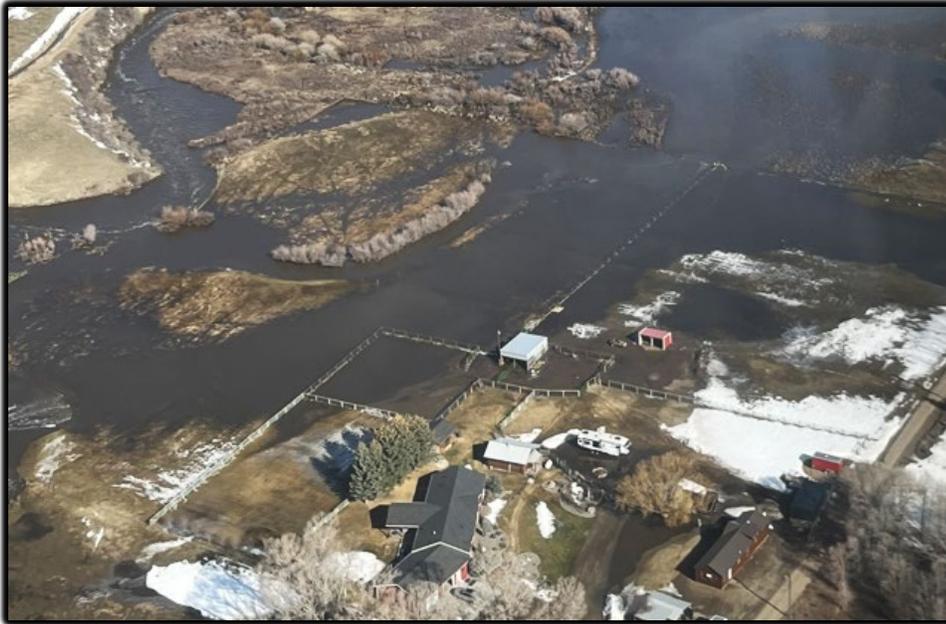
Photograph 3-35 Flathead Creek Flooding 2023 – North of Horse Creek Road

Caption: Flood waters from Flathead Creek in April 2023 inundate farmland and structures north of Horse Creek Road. Source: Lawson Moorman, Park County/ DNRC.

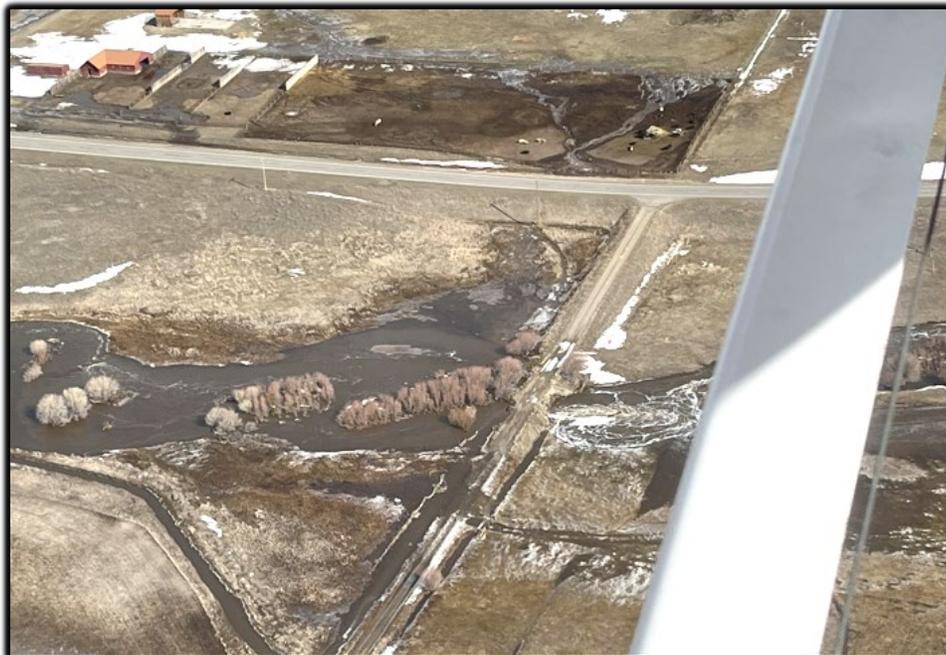
Caption: An unnamed road off Flathead Creek Road is overtopped and the culvert is at capacity during the April 2023 flooding. Source: Lawson Moorman, Park County/ DNRC.

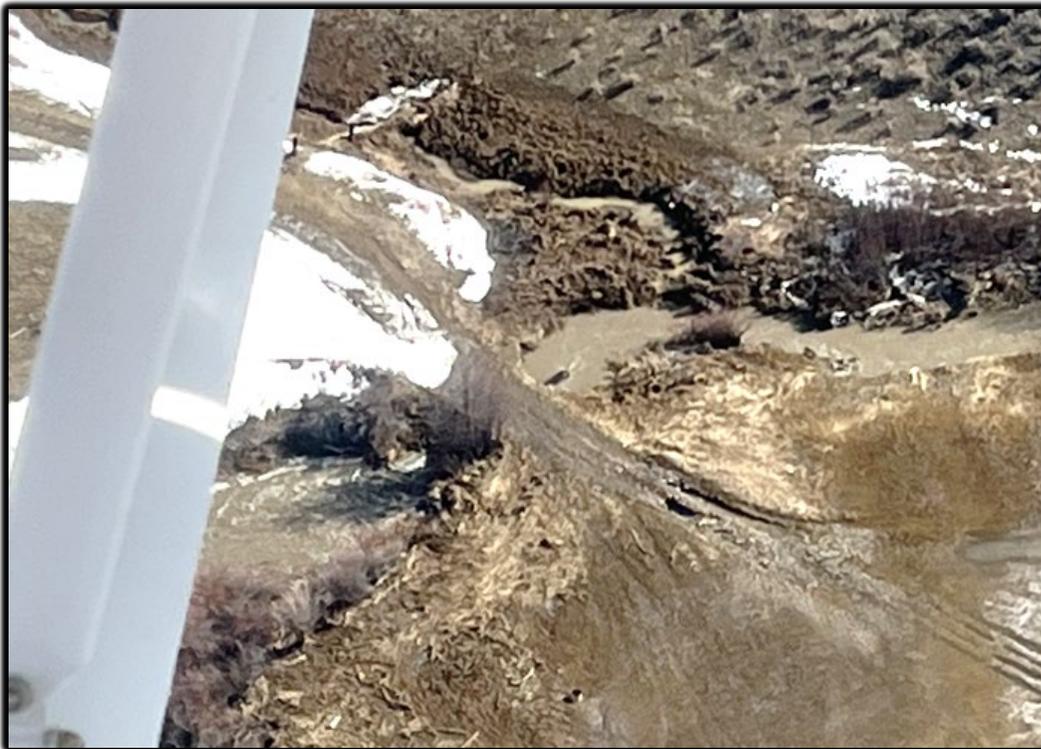
Photograph 3-37 Horse Creek B Flooding 2023 – Indian Creek Road

Caption: Rapid snowmelt in the Horse Creek B drainage resulted in high water in April 2023.
Source: Lawson Moorman, Park County/ DNRC.

Although there is limited documented flooding history on Horse Creek B, there is photographic documentation of Horse Creek B flooding in April 2023 when the Shields River Valley saw rapid snowmelt in the valley. Two photographs, Photograph 3-37 and Photograph 3-38, are shown below.

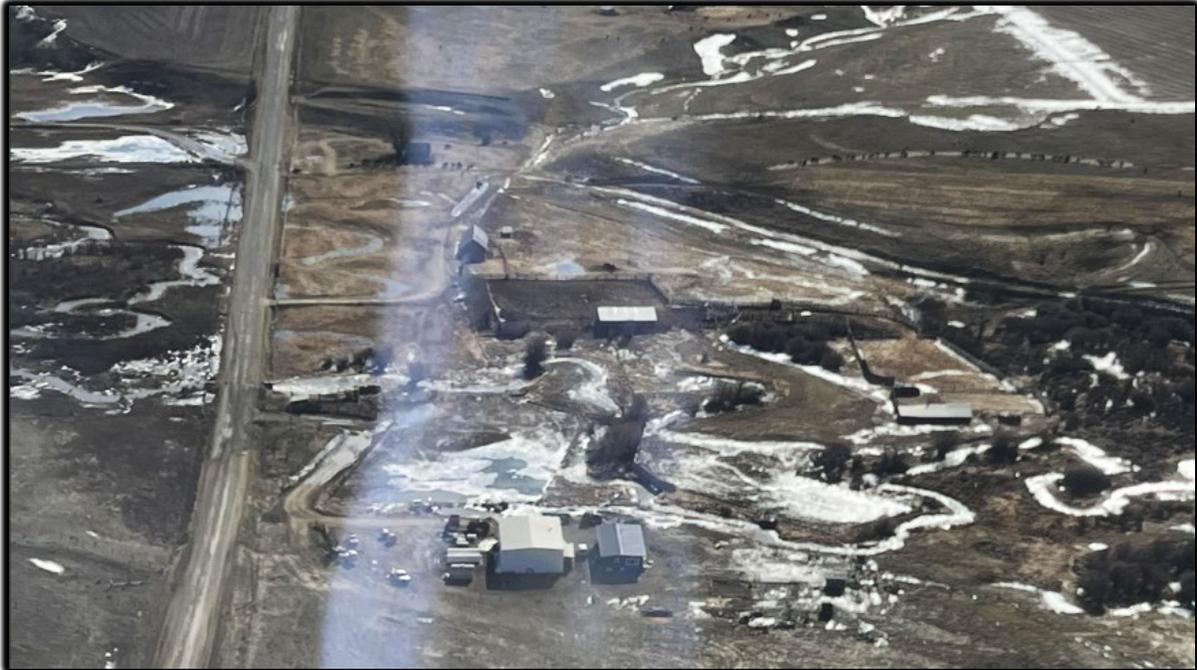
Photograph 3-38 Horse Creek B Flooding 2023 – Horse Creek Road

Caption: Rapid snowmelt in the Horse Creek B drainage resulted in high water in April 2023 and in some locations the water overflowed the Horse Creek B banks. Source: Lawson Moorman, Park County/ DNRC.

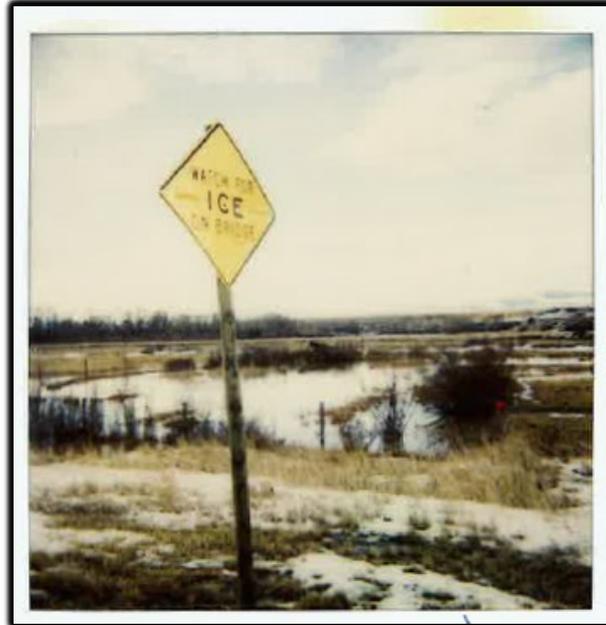
**Photograph 3-39 Looking Glass Creek Flooding in Early 1990s –
Near O’Halloran Road**

Caption: Water ponds on Looking Glass Creek near O’Halloran Road. Source: Park County.

There is limited flood history documentation of flooding on Looking Glass Creek and O’Halloran dams. However, the DNRC provided photographs from the early 1990s where Looking Glass Creek near the O’Halloran dams was out of banks. These photographs, where the exact location is unknown, are provided on Photograph 3-39 through Photograph 3-41.

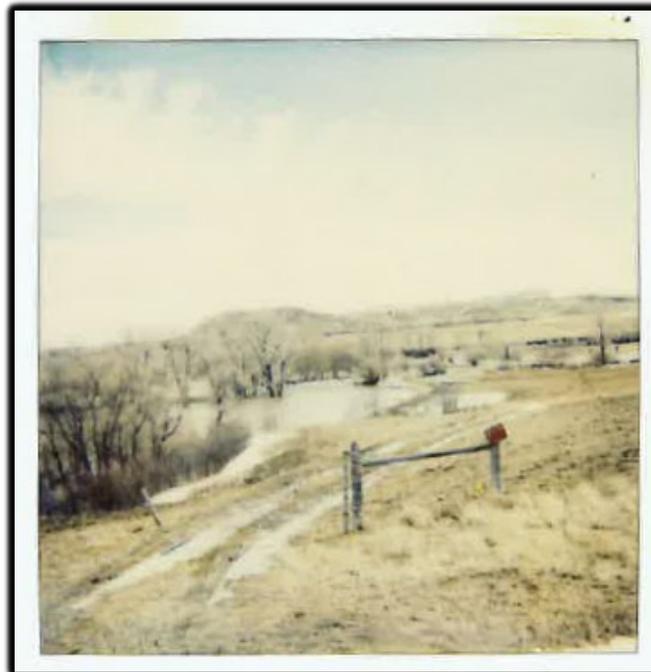
**Photograph 3-40 Looking Glass Creek Flooding Early 1990s –
Ponding**

Caption: Looking Glass Creek overflows its banks. Source: Park County.

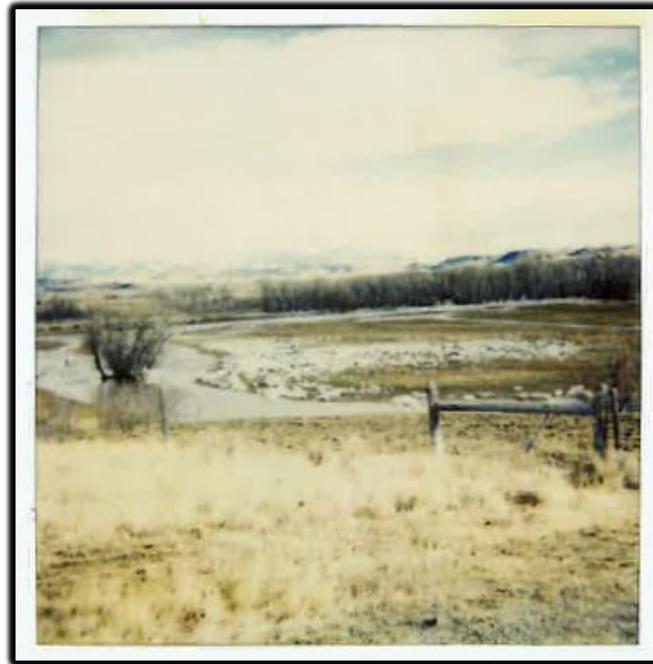
**Photograph 3-41 Looking Glass Creek Flooding Early 1990s –
Creek Swelling**

Caption: Looking Glass Creek overflows its banks. Source: Park County.

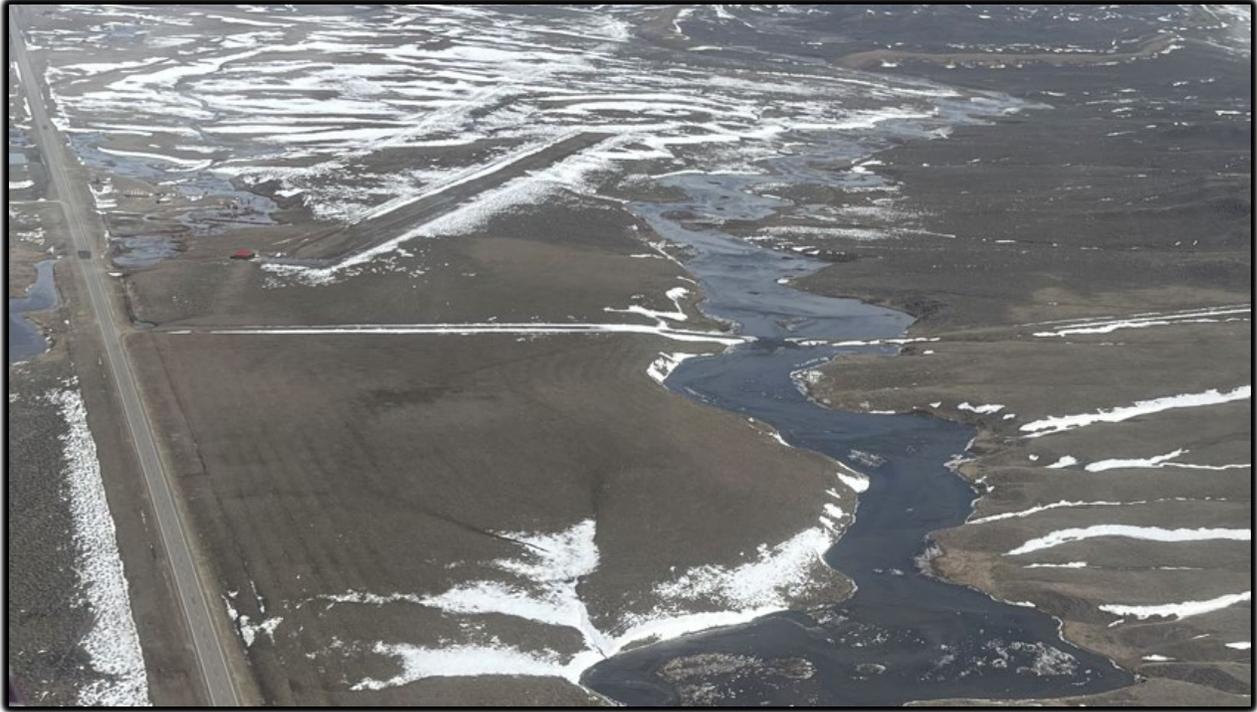
Caption: In April 2023, flooding of Potter Creek overtopped and unnamed road near the Wilsall Airport. On the left side of the photograph flooding of Cottonwood Creek B is also shown. Source: Lawson Moorman, Park County/DNRC.
