City of Livingston Planning Board Agenda

**MOUNTAIN VIEW
MAJOR SUBDIVISION
PRELIMINARY PLAT APPLICATION
TABLE OF CONTENTS**

MOUNTAIN VIEW SUBDIVISION

PRELIMINARY PLAT OF
MOUNTAIN VIEW SUBDIVISION, PHASES 1, 2, & 3

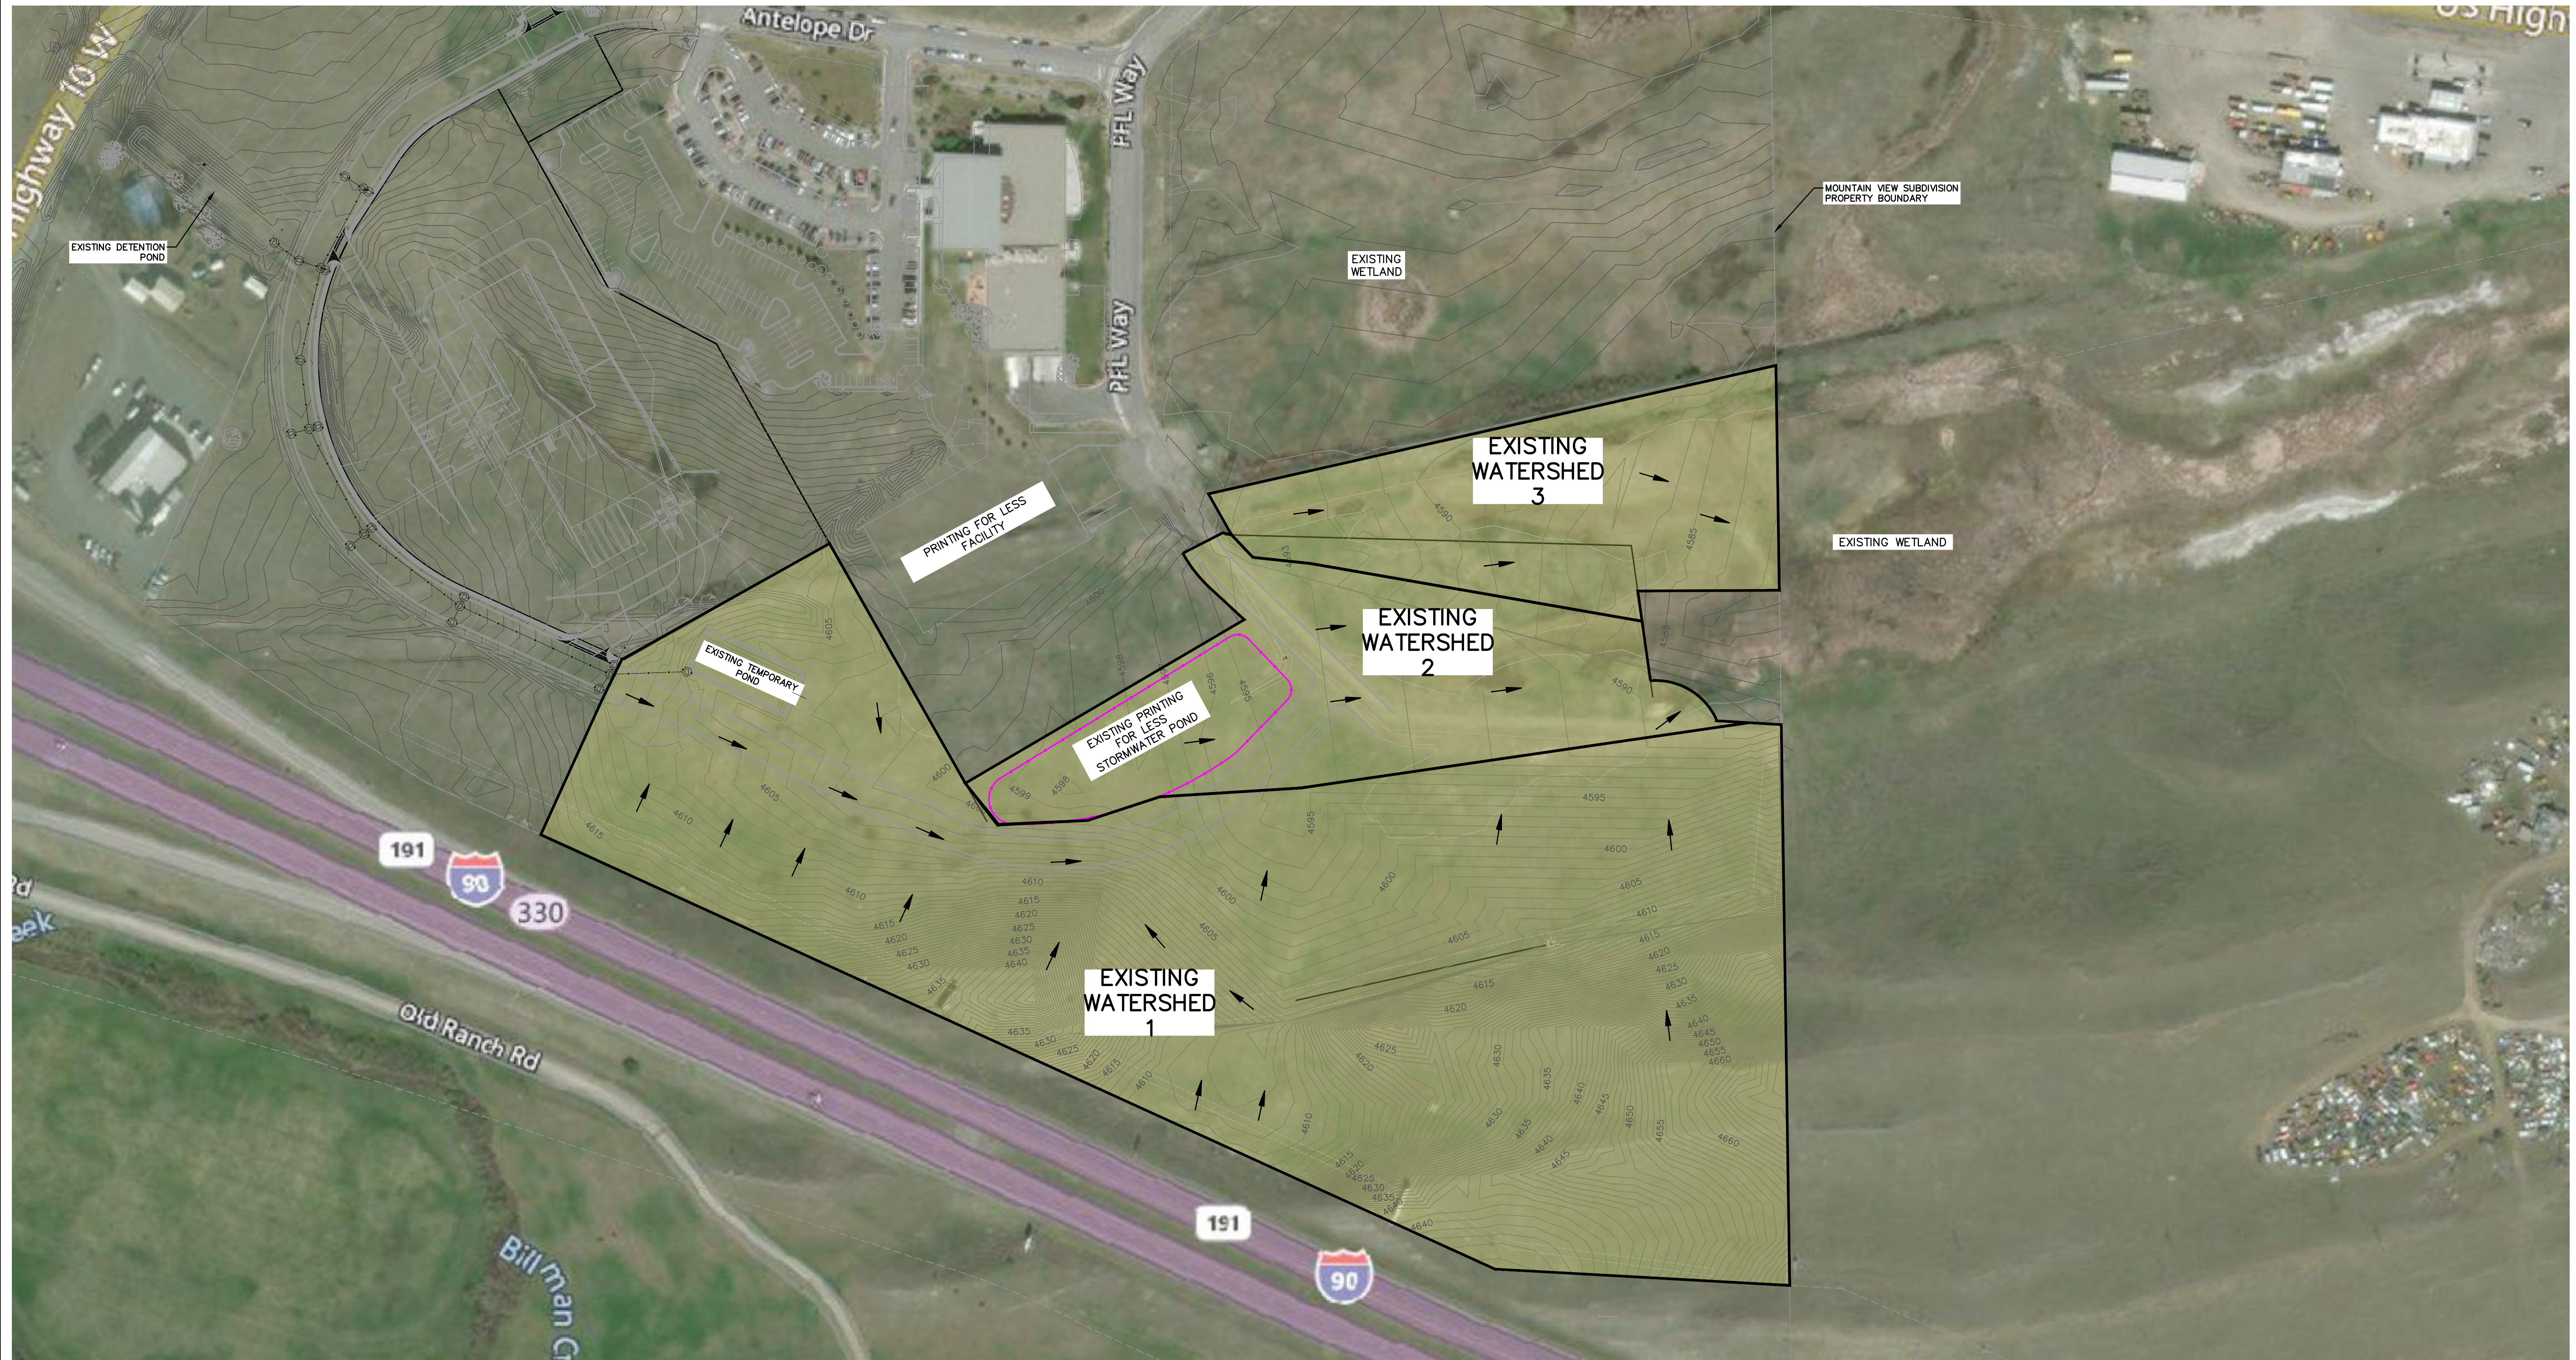
EXHIBIT B

POST-DEVELOPMENT
WITHIN
MOUNTAIN VIEW SUBDIVISION

The new development area of the subdivision has been broken into five (5) total basins as shown on Exhibit B in Appendix A. Preliminary hydrologic calculations for these watersheds can be found in Appendix B.

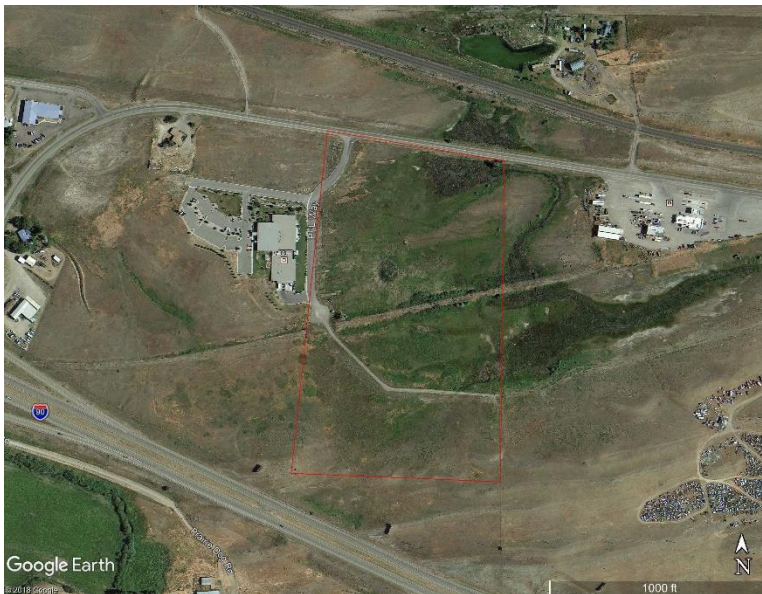
Figure 1: Location of the Printing for Less Wetland Delineation Site relative to US Interstate 90 and MT Highway 10.

The PFL Wetland Delineation site is located in the northwest quarter of Section 22, Township 2 South, Range 9 East, approximately 2.15 miles west of Livingston, Montana. The property is located immediately east of the Printing for Less headquarters on PFL Way. Upland communities are comprised of pasture grasses, Montana State Listed noxious weeds, small shrubs and other weedy species. Wetlands communities are dominated by mixed grasses, rushes, sedges and cattails. Four wetland types and one upland type were identified within project boundaries.

Directions to site from Bozeman: From North 7th Avenue take Interstate 90 east for 22.7 miles, exiting at Livingston Exit 330. Turn left onto 1-90 Business Loop/MT Highway 10 for 0.5 miles. Turn right onto PFL Way, the project area is on the left.

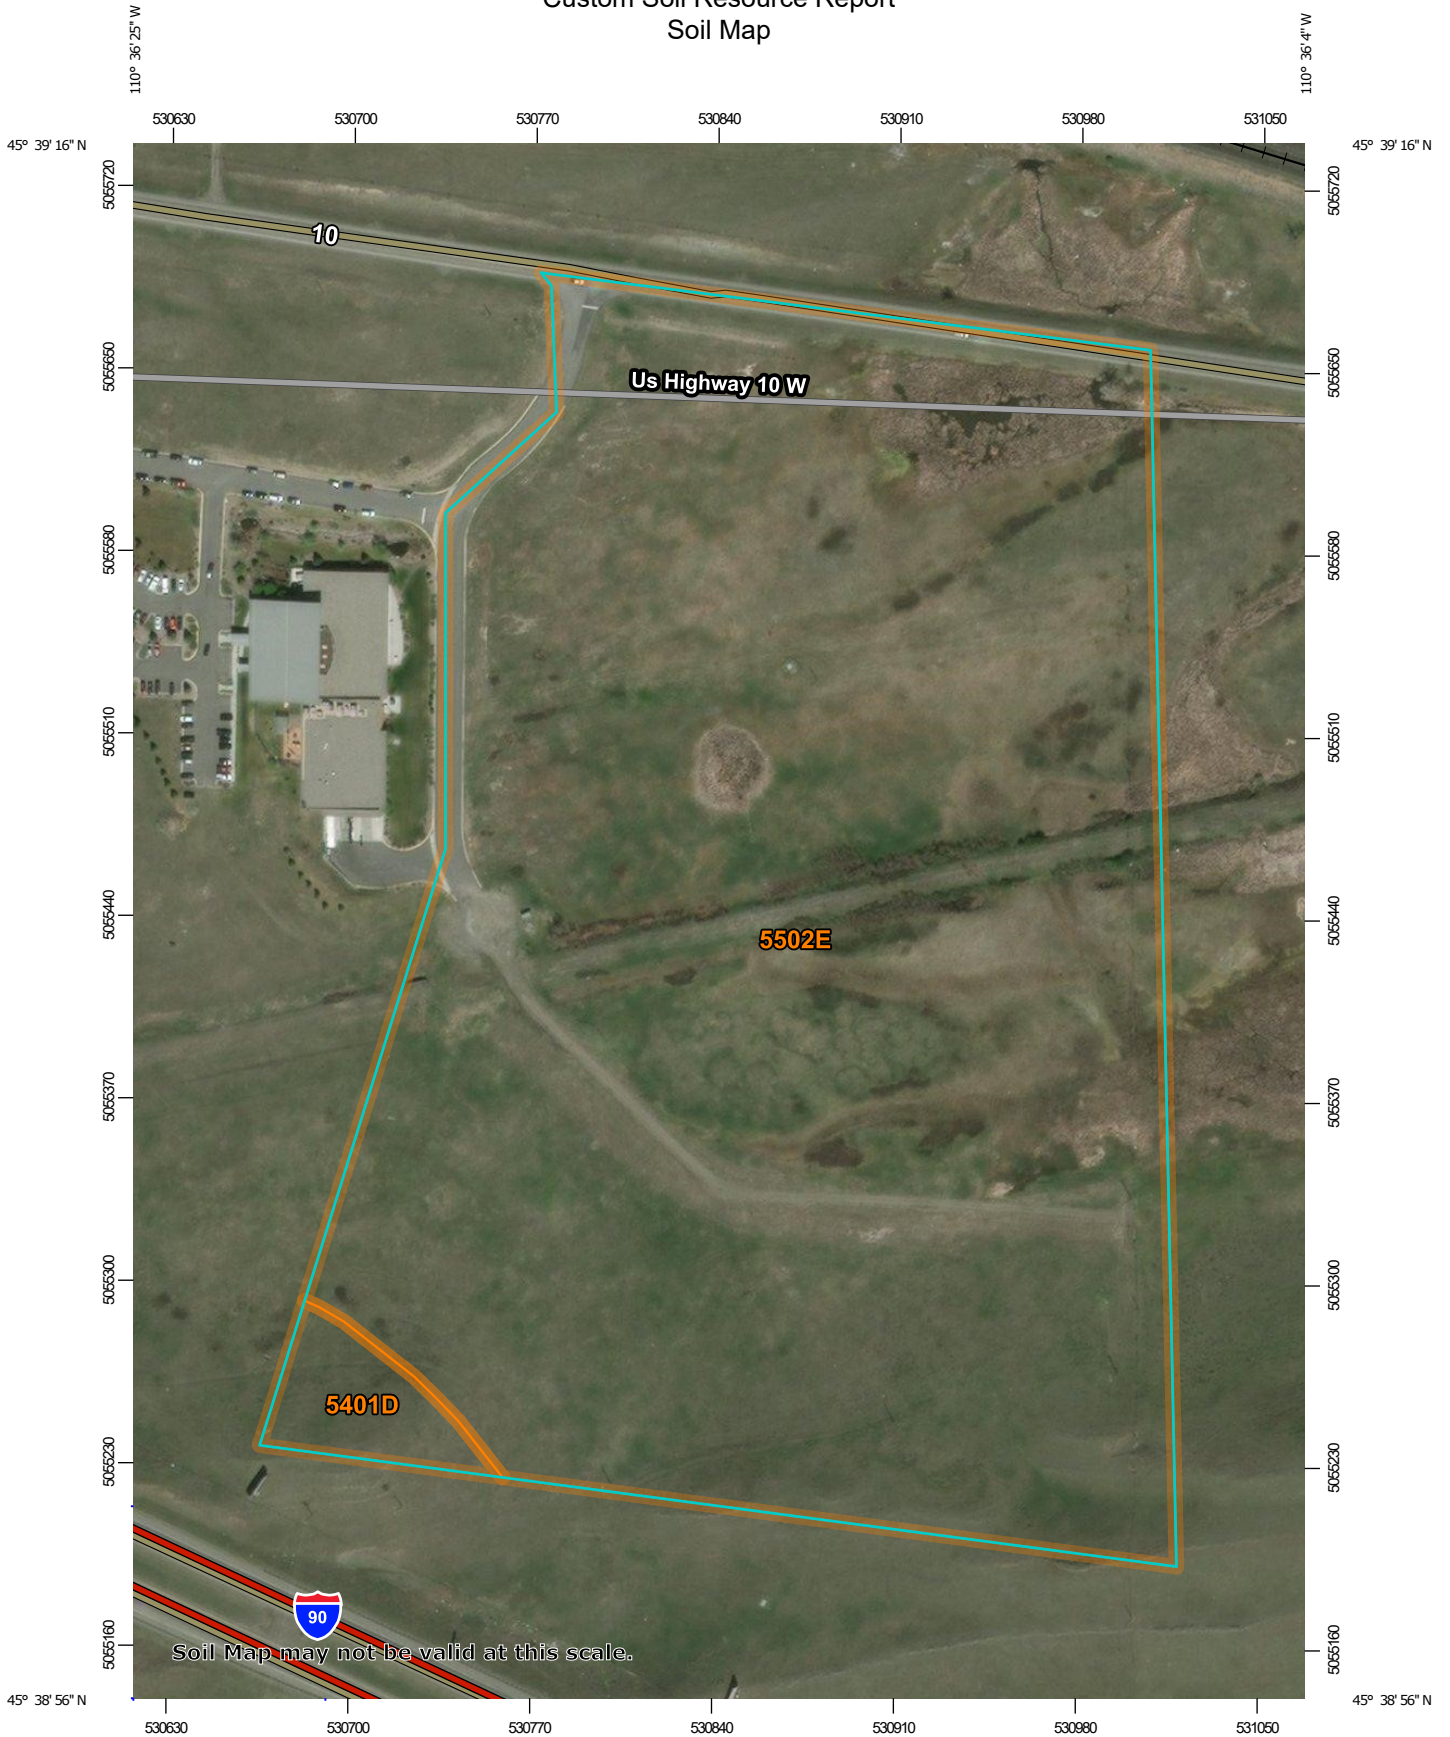
Custom Soil Resource Report Soil Map

The soil map section includes the soil map for the defined area of interest, a list of soil map units on the map and extent of each map unit, and cartographic symbols displayed on the map. Also presented are various metadata about data used to produce the map, and a description of each soil map unit.
